Castletown Mill, Castletown, Caithness

Standing Building Recording

Buildings Archaeology Ltd

November 2022

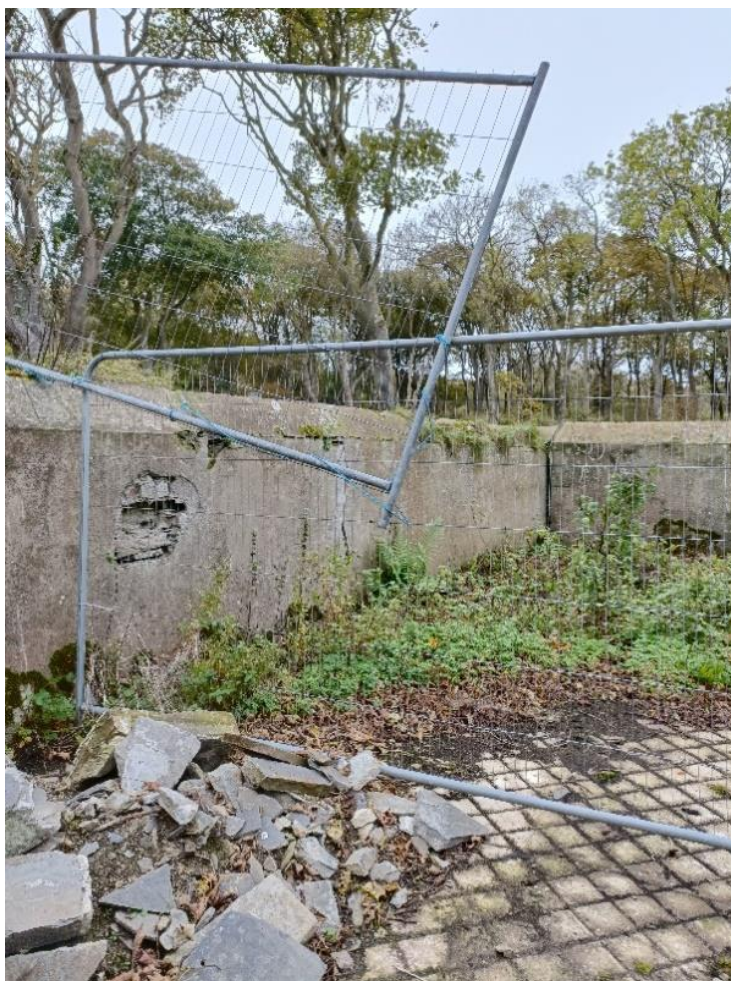
Figure 38: Boundary wall to rear of slaughter-house

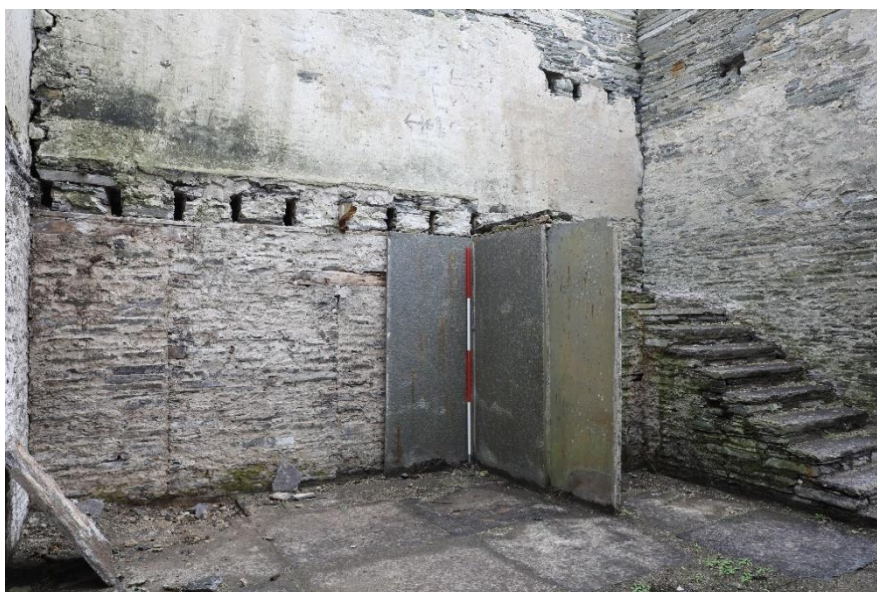
Figure 40: Western wall of Grain Store 1 showing blocked door openings with the right hand side one being partial obscured by the later Caithness Flagstone structure

The advert indicates that the “meal mill and barley mills at Castlehill are to be let” and described the mills as having been “recently re-erected on the most modern and improved principles, and are now in full operation” (see Figure 39). Further details provide information on the mill buildings and their fixtures and fittings. It would seem likely that whilst the fire did not destroy the original stone structure it would have gutted much of the interior of the mill and kiln buildings. With the interior cleared new “modern” features could have been easily installed into the existing building envelope. The stone transverse walls between Grain Store 1 and the kiln and between the kiln and the mill, were probably built to compartmentalise the building as a fire safety feature. Within the wall between Grain Store 1 and the kiln are two blocked doors which could have been altered as part of the 1860 remodelling to further deter the spread of fire. One of the openings today is partially obscured by the structure formed with large Caithness flagstones in Grain Store 1 which was a later insertion (see Figure 40).

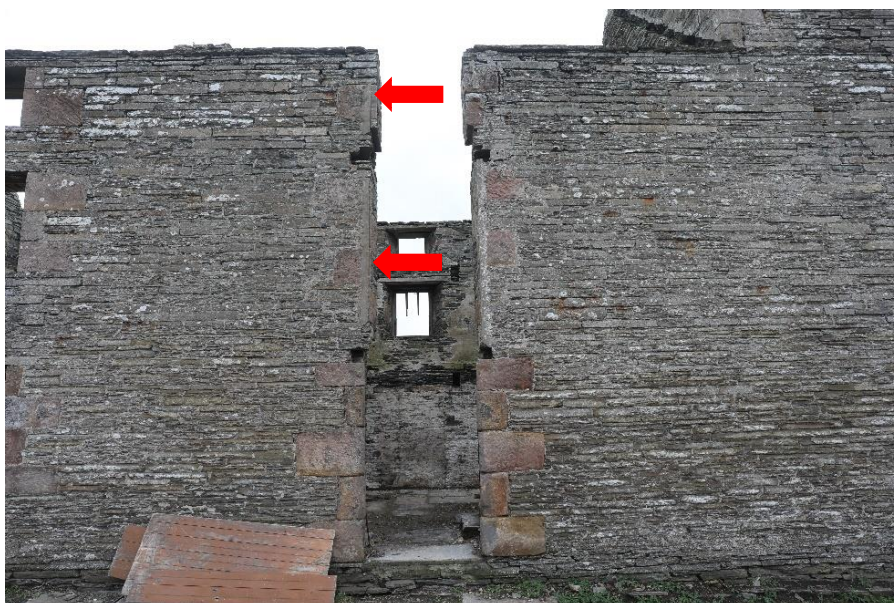
Figure 41: Building break left by insertion of Chute 1 into Drying Kiln 1 with evidence of red sandstone margins from previous windows

The chutes attached to the northern elevation were later additions into the earlier structure, as clearly evidenced by the remains of red sandstone dressings from two earlier window openings and a door on chute 1 (there are windows on the rear elevation that reflect what would have been on the front elevation too) and the infilled windows and building break evident at the insertion point of chute 2 (see Figures 41 and 42).

The line created by utilising the windows and door opening would have necessitated far less intervention to remove stone than inserting an opening into a complete wall. The breaks created in the northern wall for the chutes would also have weakened the stability of the existing structure and perhaps necessitated the insertion of the wall ties which are still seen on the elevation today. The inclusion of details about the elevators and sack tackles in the 1861 advertisement (see Figure 39 above) may well indicate that these were all new features and part of the “most modern and improved principles” of the “re-erected” buildings. A number of new openings and blocked older windows may also date to these alterations taking place. A smaller ground floor opening (now blocked) in the kiln wall was added. The row of blocked windows (see Figure 42) were presumably due partly to a reconfiguration of the mill building and to add rigidity to compensate for the new chute opening. The doorway below the blocked windows was left as it would have been the only access into the mill building from this elevation. In an early photograph of this range (see Figure 43) the chutes appear to be constructed of vertically boarded timber with slate roofs and ridge tiles, whereas in John Hume’s photographic survey of the building in the 1970’s the chute walls and roof appear to be covered with corrugated iron (see Figure 44), a fact confirmed by M Calder in 2019 (Howdle, 2019). These features can be seen in the historic photograph of the mill below and therefore this photo must post date the 1860’s alterations (Figure 36). The historic photo also indicates that there is a structure with a gabled roof in the location of the “slaughter-house” and a pitched roof over the wheel-house. It seems highly likely that any alterations to the Mill buildings would have been undertaken by William Ross, a millwright residing in Castletown. William Ross is spoken of in a letter which appeared in the *John O’ Groat Journal* on the 16 June 1859 as “Of late years none in this country has made more fame and popularity in the construction of mills both in this county as well as in Ross, Sutherland and Orkney, than has Mr William Ross, millwright, Castletown....As a millwright his practice has been large and varied”.

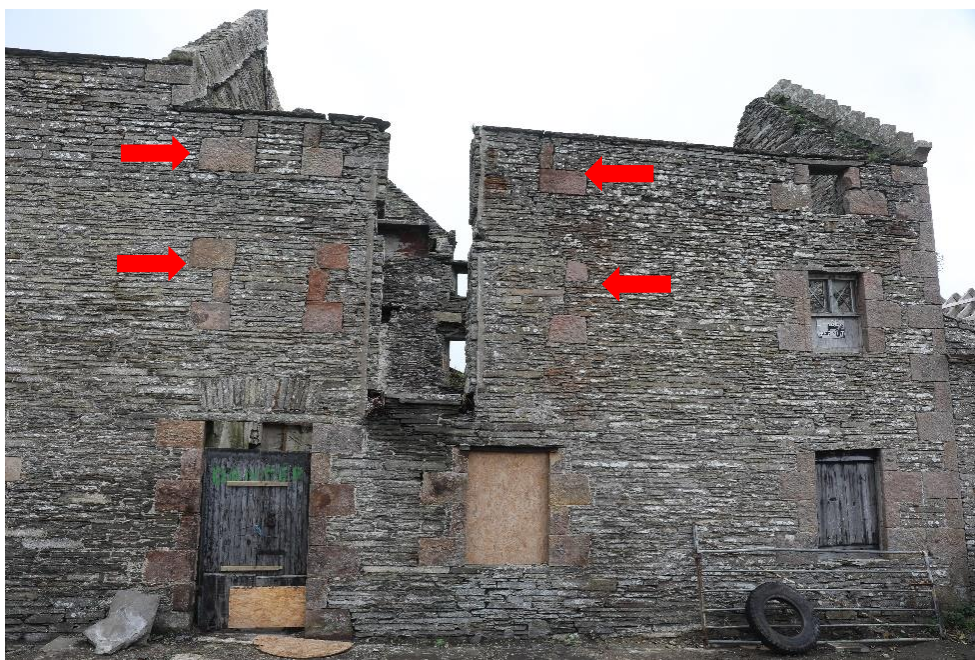
Figure 42: Building break left by insertion of Chute 2 into Drying Kiln 1 with evidence of red sandstone margins from previous windows

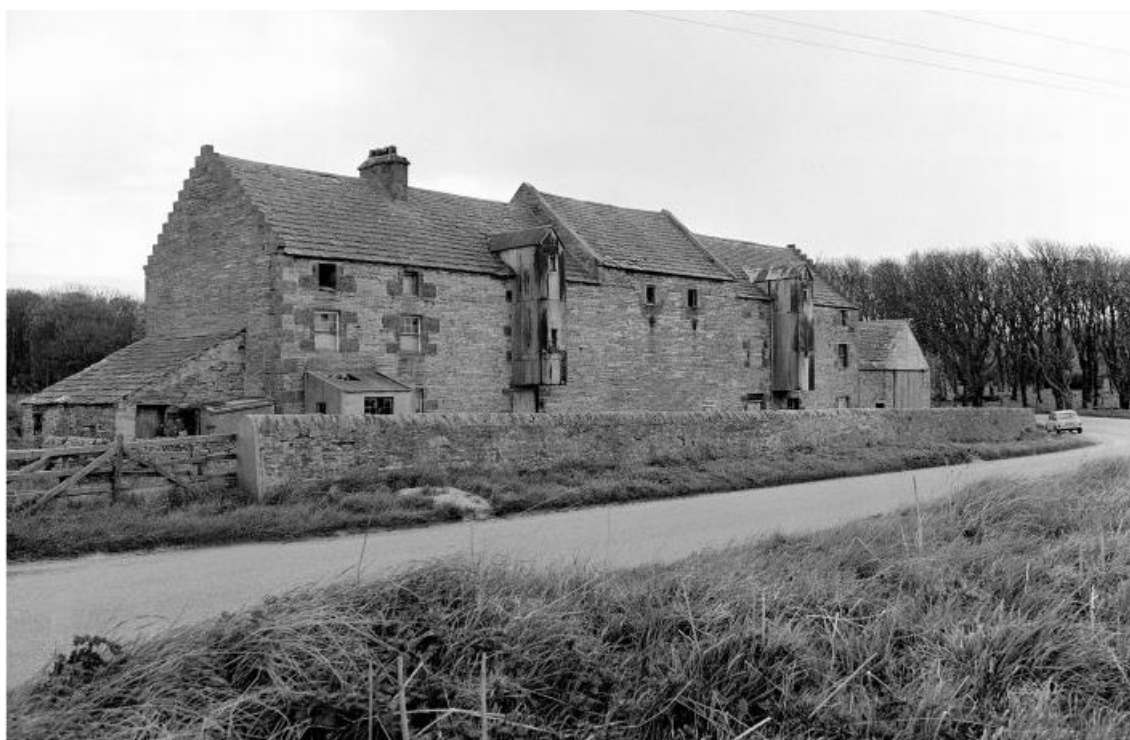
Figure 44: Northern elevation from John Hume Survey (Hume, 1974)

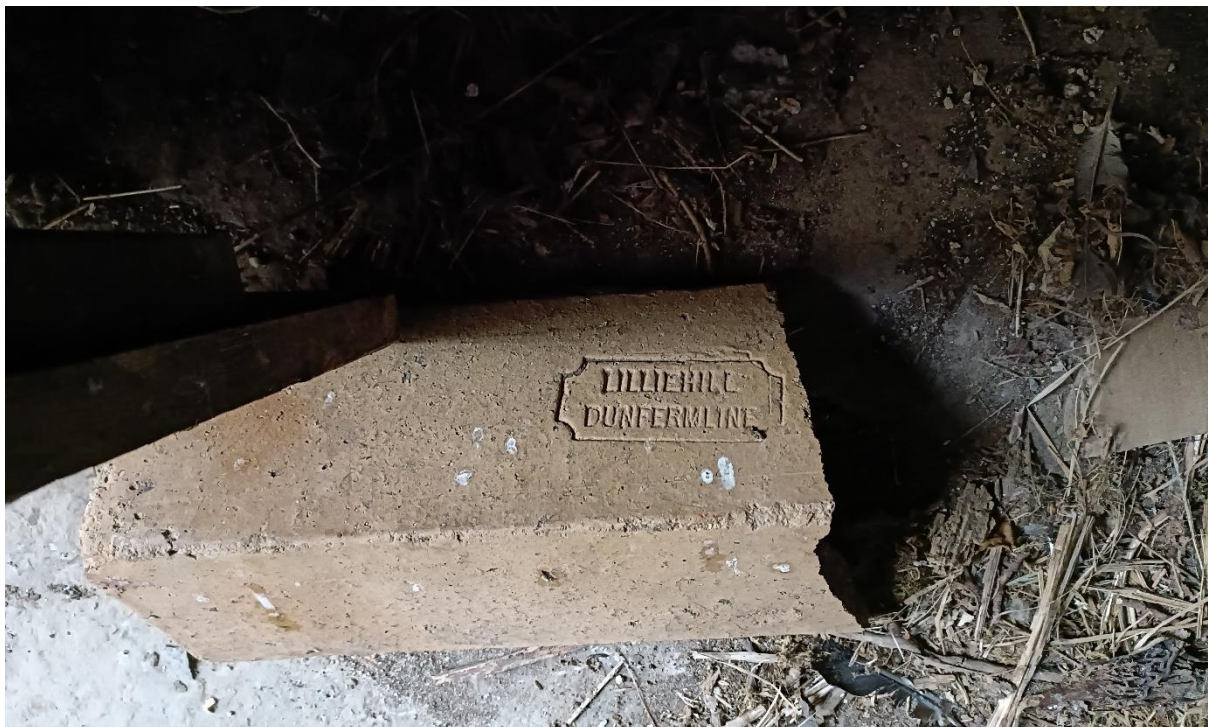
Figure 48: Example of ridge tile from 1888 range

In an article in the same paper from the 21 September 1888, under the heading “Improvements in Castletown”, the correspondent relates that “Mr William Purves has arranged to have Castlehill meal mill, which he has leased, made adequate to the wants of the place, and we have no doubt of his making a complete job”. The proposed addition to the mill range must have been the rear north south range which brought the addition of a further kiln, grain stores and a gabled chute/sack hoist. The extension whilst still constructed in Caithness rubble lacks the red sandstone quoins and margins of the earlier range and is roofed in Welsh slate and as such makes it easily distinguishable. Ridge tiles found in the debris on site which match those seen on the 1888 range are stamped Lillie Hill Dunfermline (see Figure 48).

The Lillie Hill Fireclay Works began trading in 1867 and were based in Townhill, Dunfermline, Fife where they manufactured an extensive range of products for the building trade which were sold by agents, including T Corston in Oban (<https://www.scottishbrickhistory.co.uk/lilliehill-fire-clay-works-dunfermline-fife/>). The Millwright William Ross was still resident in Castletown at this time and was probably also involved with the additions to the mill building.

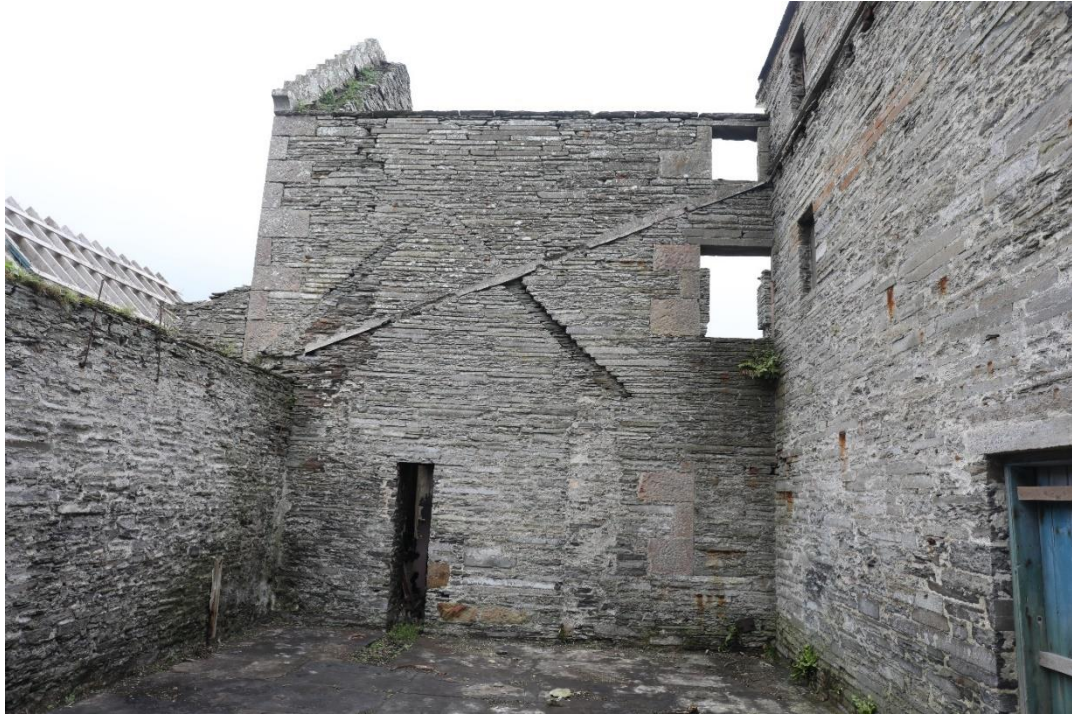
Figure 50: Rear elevation of c.1818 range from within the Sawmill extension

The 1905 map was also the first time that an infill extension in the re-entrant between the western gable of the 1880's extension and the 1818 range was shown. Building scars on the rear wall of the 1818 range (see Figure 50) indicate that there have been at least two phases of extension in this location, which must both have been built after the 1872 Ordnance Survey map but prior to the 1905.

The building scars indicate that there was a first narrow gabled single storey extension which extended to the edge of the c.1818 range but did not extend all the way across to the rear wall of the 1880's range. A shadow in the stonework is left where the eastern wall of this building once stood. This extension respected the original 1818 window openings and suggests that the original extension pre-dates the 1888 range (and may have been part of the 1860 works), and then was altered to meet the 1888 range as part of that range's construction. The building scars show that a monopitch extension replaced the gabled structure and this took in the whole of the area between the side wall of the 1880's range and the rear wall of the 1818 range. Coursed recesses for rafters for the monopitch roof are evident on the rear western elevation of the 1880's range. There is no evidence of disturbance in the surrounding stonework which indicates that the roof was contemporary with the building of the 1888 range. Photographs from John Hume's survey in 1974 (Canmore <https://canmore.org.uk/site/8825/castletown-mill>) shows the monopitch extension roofed in corrugated iron although it was presumably roofed in Welsh slate originally. The rear (southern) wall of this monopitch structure remains and an arched entrance (now blocked) in this wall (see Figure 51) has similar detailing to one on the eastern wall of the 1888 range. The padstone for this arched opening and the end of the southern wall of the sawmill extension are well keyed into the rear wall of the 1888 range and have similar skew stones to the 1888 range, which indicates that this was all part of William Purves additions.

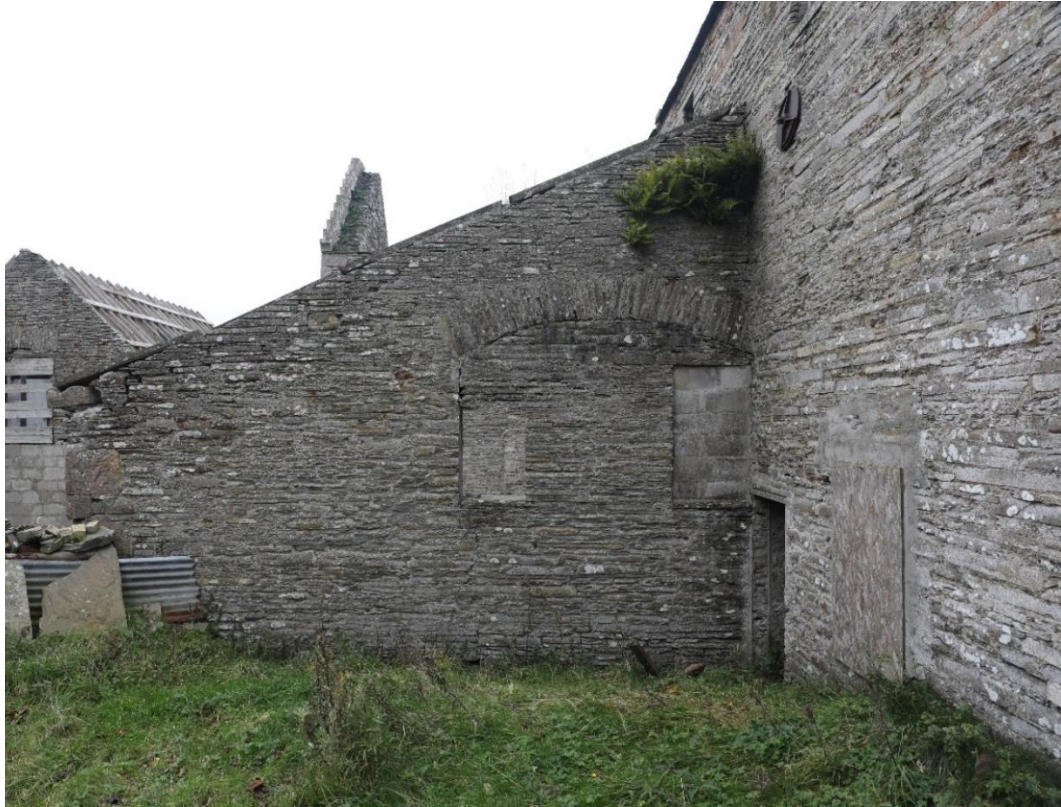
Figure 51: Rear (southern) wall of the Sawmill

The irregular use of red sandstone blocks in the end of the southern wall of the sawmill extension indicate reuse rather than being part of the original c.1818 construction phase. The disorderly edges to the wide opening in the western wall of this range also indicative that this was a later insertion rather than part of a planned structure, and is shown as a new opening on plans proposed for the building in 1932 (see below).

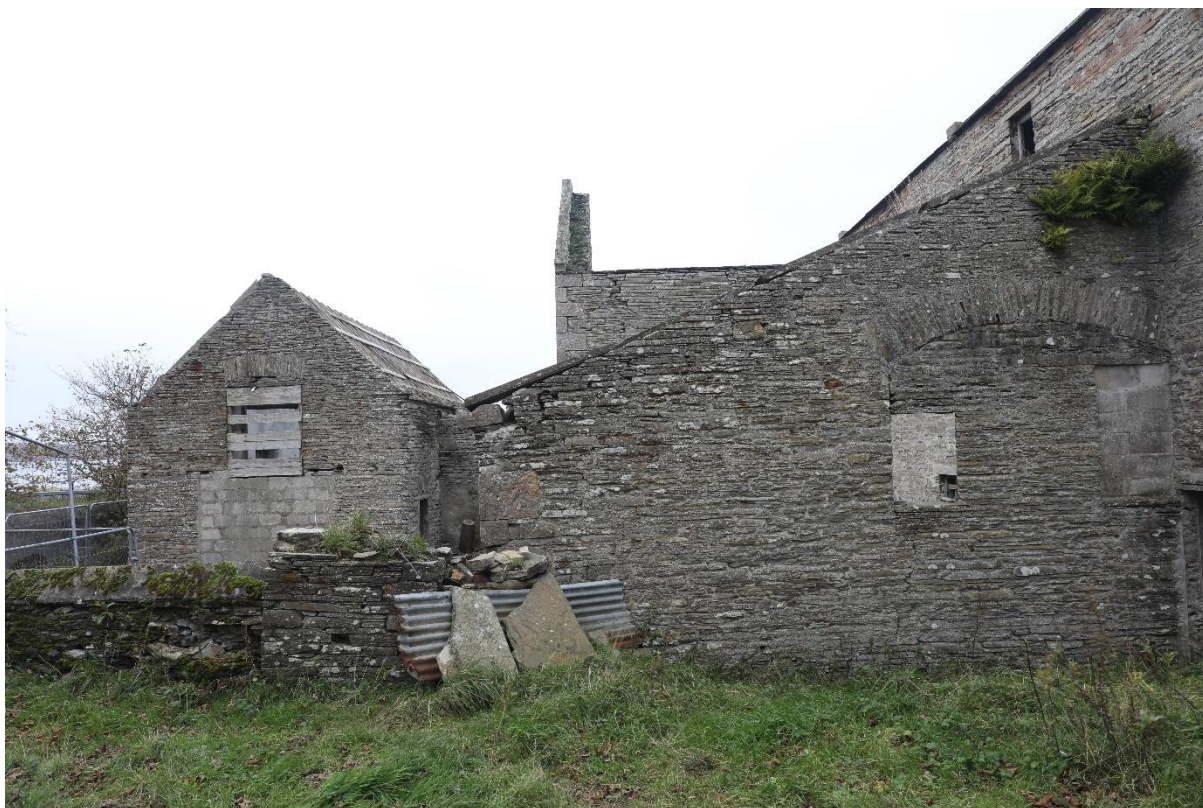
Photograph 93

93	Western Elevation 1888 range, sawmill and c.1818 rear range	E	
94	Western Elevation 1888 range, sawmill and c.1818 rear range	NE	
95	Western Elevation 1888 range, sawmill and c.1818 rear range	NE	
96	Western Elevation 1888 range, sawmill and c.1818 rear range	SE	
97	Slaughterhouse, wheel-house and rear of c.1818 range	N	
98	Mill Lade and Stannergill Burn	SW	
99	Western Elevation 1888 range, sawmill and c.1818 rear range	NE	
100	Western Elevation 1888 range, sawmill and c.1818 rear range	E	
101	Mill Lade and Stannergill Burn	SW	
102	Stone lined mill lade	NE	
103	Eastern Elevation 1888 range and rear elevation of c.1818 range (context)	N	
104	Eastern Elevation 1888 range and rear elevation of c.1818 range (context)	N	
105	Eastern elevations	NW	
106	Hen House	N	
107	Hen House and coal store	W	
108	Northern elevation c.1818 range	W	
109	Northern elevation c.1818 range	W	
110	Northern elevation c.1818 range	SW
