Roshven Farmhouse, Glenuig, PH38 4NB

Standing Building Recording

BAL 1447

Buildings Archaeology Ltd

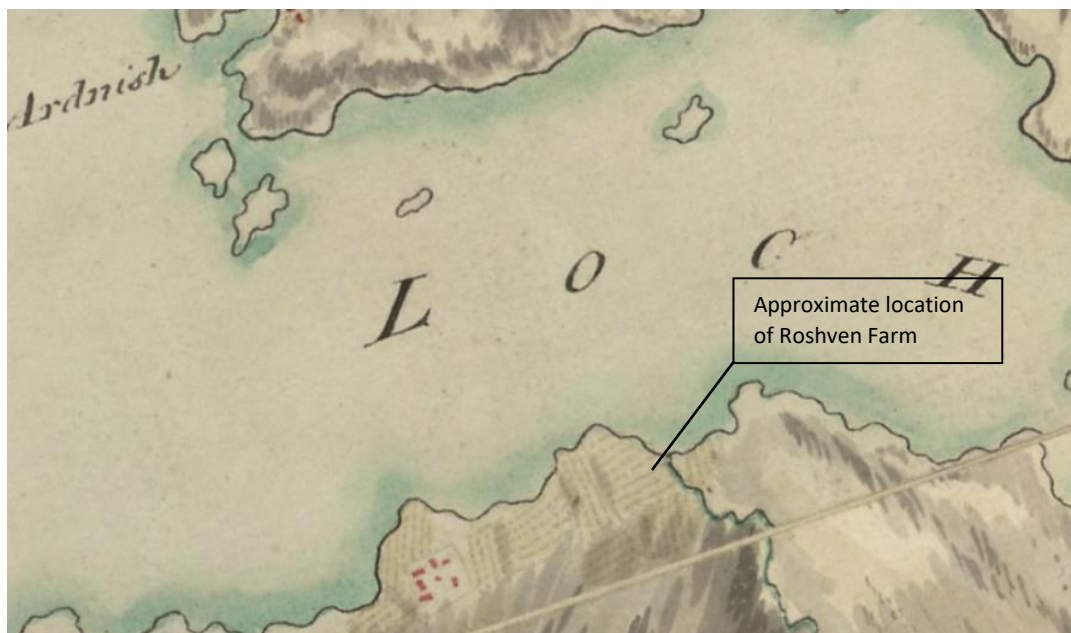
The first cartographic evidence for a settlement within this area comes from Roy's Military survey map (1747-1755) which shows an unenclosed farmed landscape with a settlement to the west of the site. Documents survive which indicate that the MacDonald family of Clanranald owned and were leasing out the lands of Irene from at least 1759 (National Records of Scotland GD201/1/284 and GD201/1/267). A settlement and crossing point on the Irine Burn would have been a strategic site. Despite this documentary evidence for the lands of Irine, no indication of a farm or settlement are marked on Roy's Map near the burn (see Figure 3).

Figure 3: Detail from Roy's Military Survey of Scotland 1747-1755 Courtesy of National Library of Scotland Map Collection

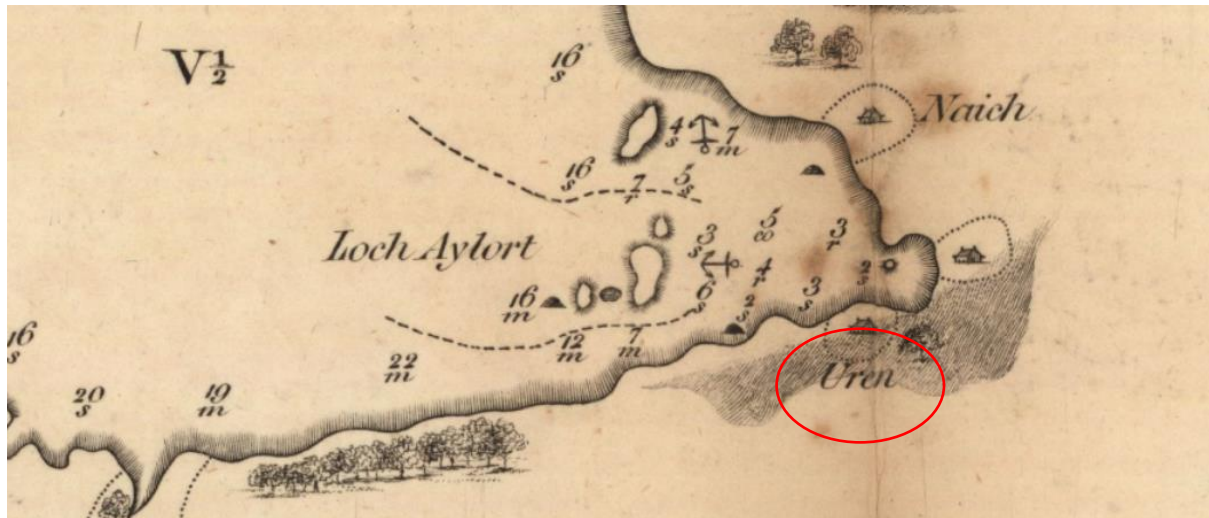
A document of June 1780 indicates that John McEachin of Drumnarach, Arisaig was to be leased the Farm of Irin “and as much more as will be equivalent to the rent of Ardnafuran” (National Records of Scotland GD201/5/974). Murdoch Mackenzie’s marine chart of The Sound of Mull dated 1775 may provide an early depiction of a township or building at “Uren”, at the foot of a shadowy representation of a mountain, presumably Rois Bheinn (see Figure 4). As with many historic maps spellings vary and are usually phonetic so that “Uren” may well represent a derivation of “Irine”.

Figure 4: Detail from Murdoch Mackenzie (Senior) Marine chart of The Sound of Mull 1775 Courtesy of National Library of Scotland Map Collection

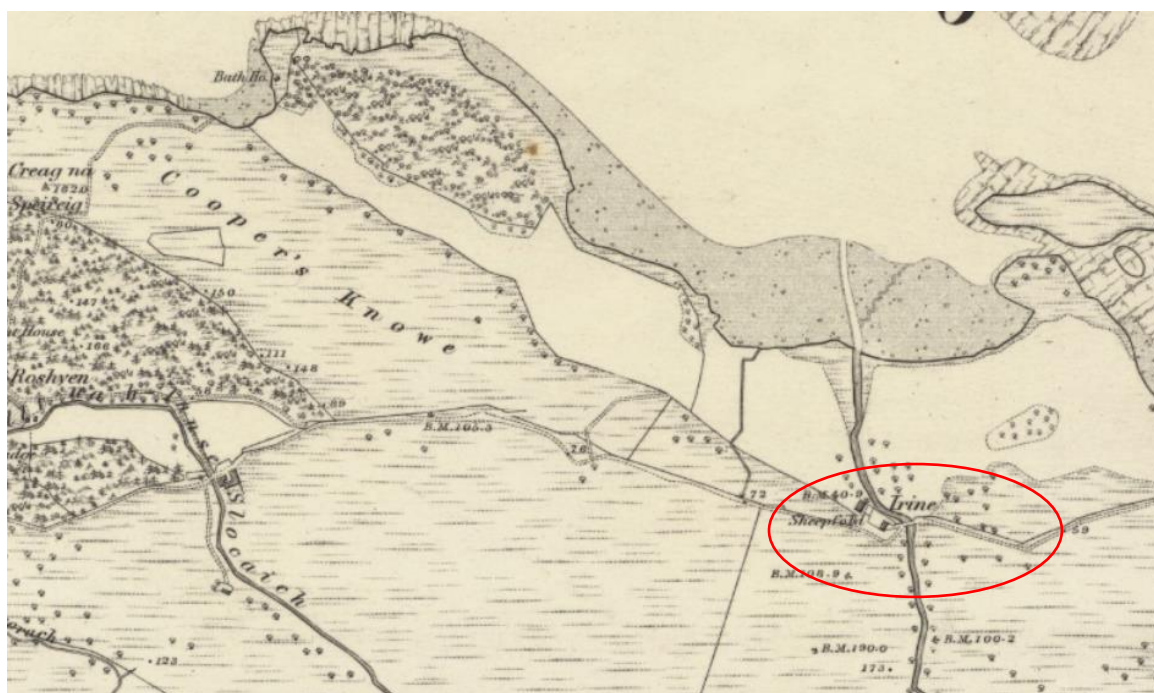
Figure 7: Detail from First Edition 6 inch Ordnance Survey Map Inverness-shire (mainland), Sheet CXXXV Surveyed 1873 and Published 1876 with Irine highlighted in red Courtesy of National Library of Scotland Map Collection

Traditional rural buildings in the Highlands during the 17th and 18th centuries, would generally have been single storey structures of turf and clay or drystone construction, often with turf or thatched roofs. It is likely that the original farmhouse at “Irine” would have followed this vernacular style. This original farmhouse is depicted on the first edition Ordnance Survey map of 1876 (see Figure 7).

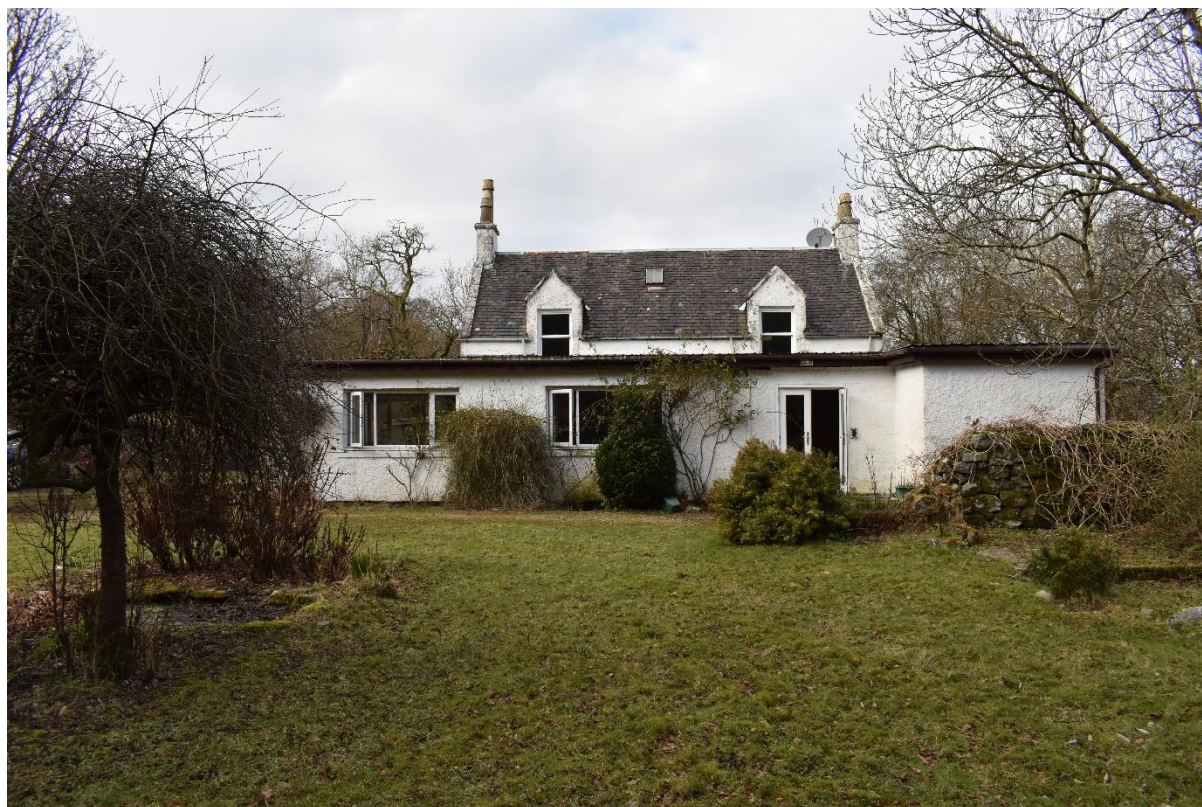
Figure 9: View of Roshven Farmhouse eastern elevation

The farmhouse comprises a one and a half storey building of three bays with a white harled finish and a slate roof. At ground floor level a later 20th century “wrap around” flat roofed single storey extension, with a metal box profile roof, obscures the original elevation. The ground floor windows are modern UPVC three light casement windows, and the front door consists of glazed UPVC double doors. There are two gabled dormers with slate hung cheeks and 1-over-1 vertical sash timber windows with painted concrete lintels to the first floor. The slated gabled roof features a central cast iron roof light and two end stacks.

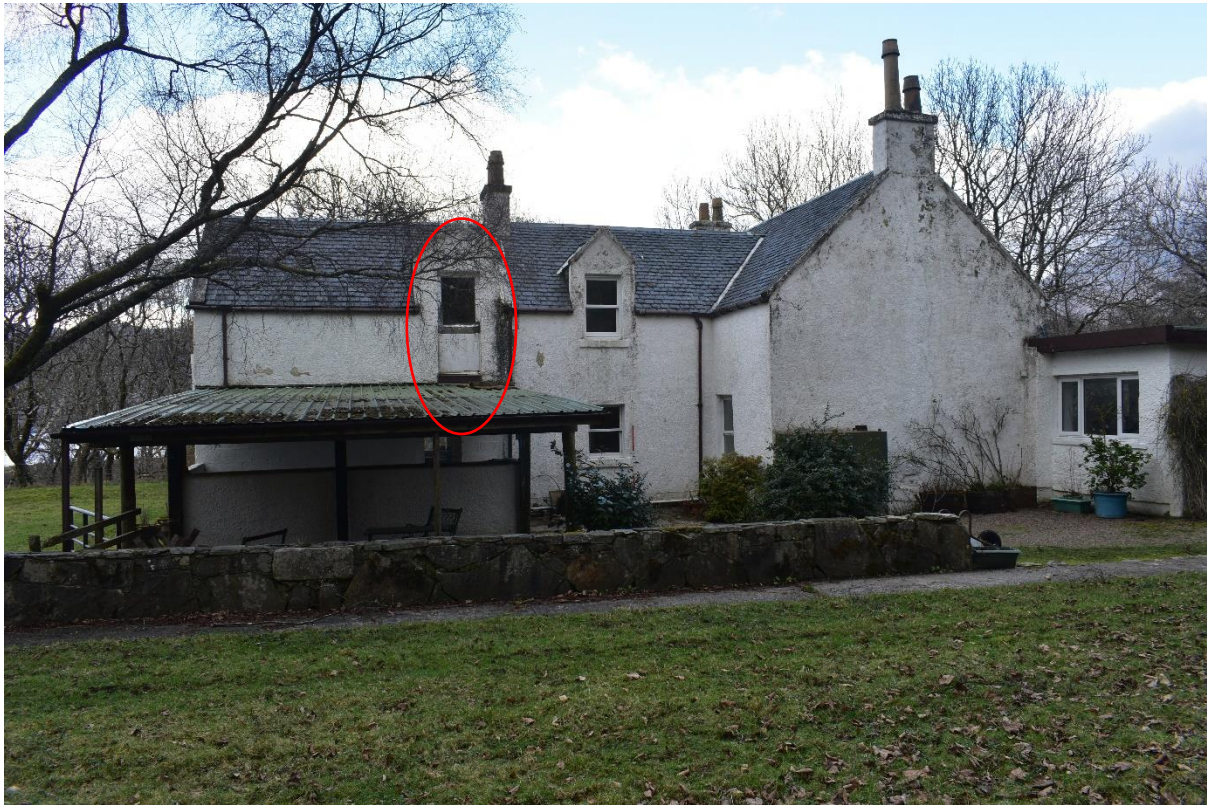
The remaining elevations are mainly white harled with a slated gabled roof to the two-storey rear extension. The rear wing has a mixture of two light sliding sash windows and modern casement windows to its ground floor along with two gabled dormers at first floor on the southern elevation. Dormer W21 contains a modern glazed opening with a blocked lower half, possibly the

remains of a blocked doorway or fire escape (see Figure 10). There is a stack to the centre of the roof, possibly marking the former extent of this wing.

Figure 10: View of Roshven Farmhouse southern elevation showing what appears to be a blocked door in one of the dormer windows (W21) outlined in red.

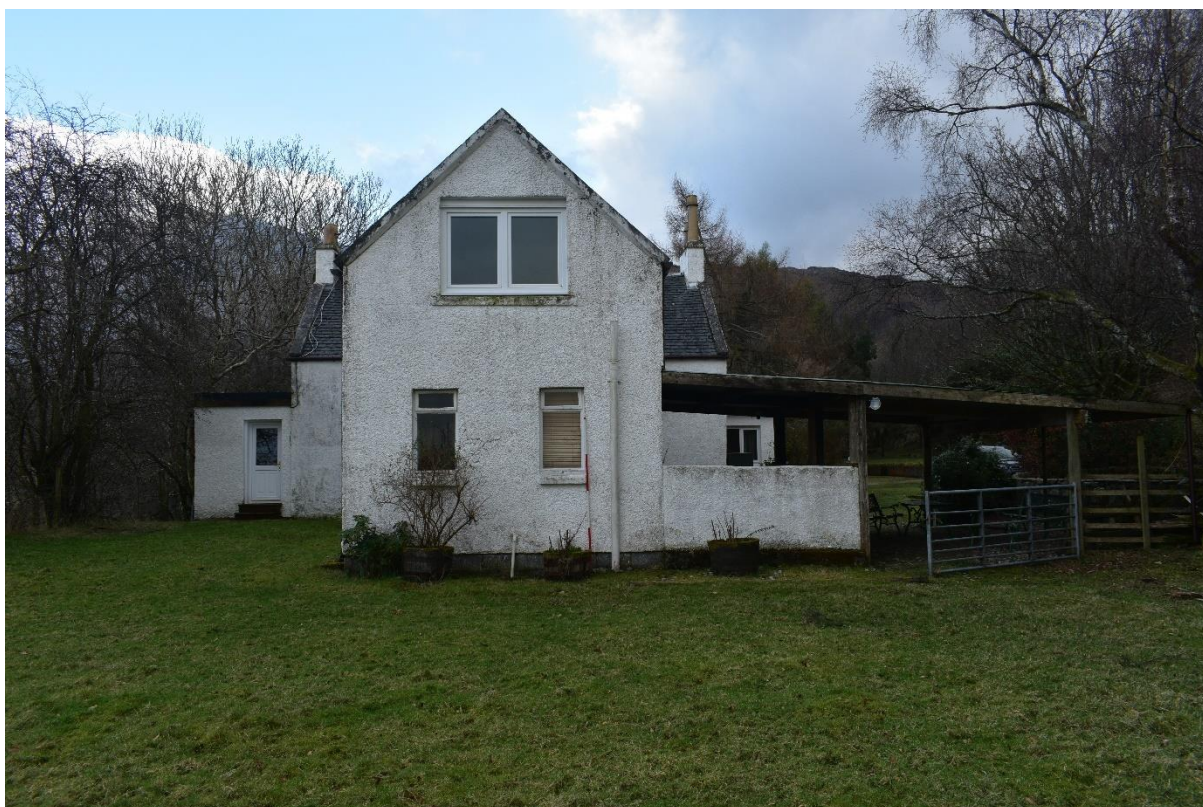
Figure 11: Western elevation

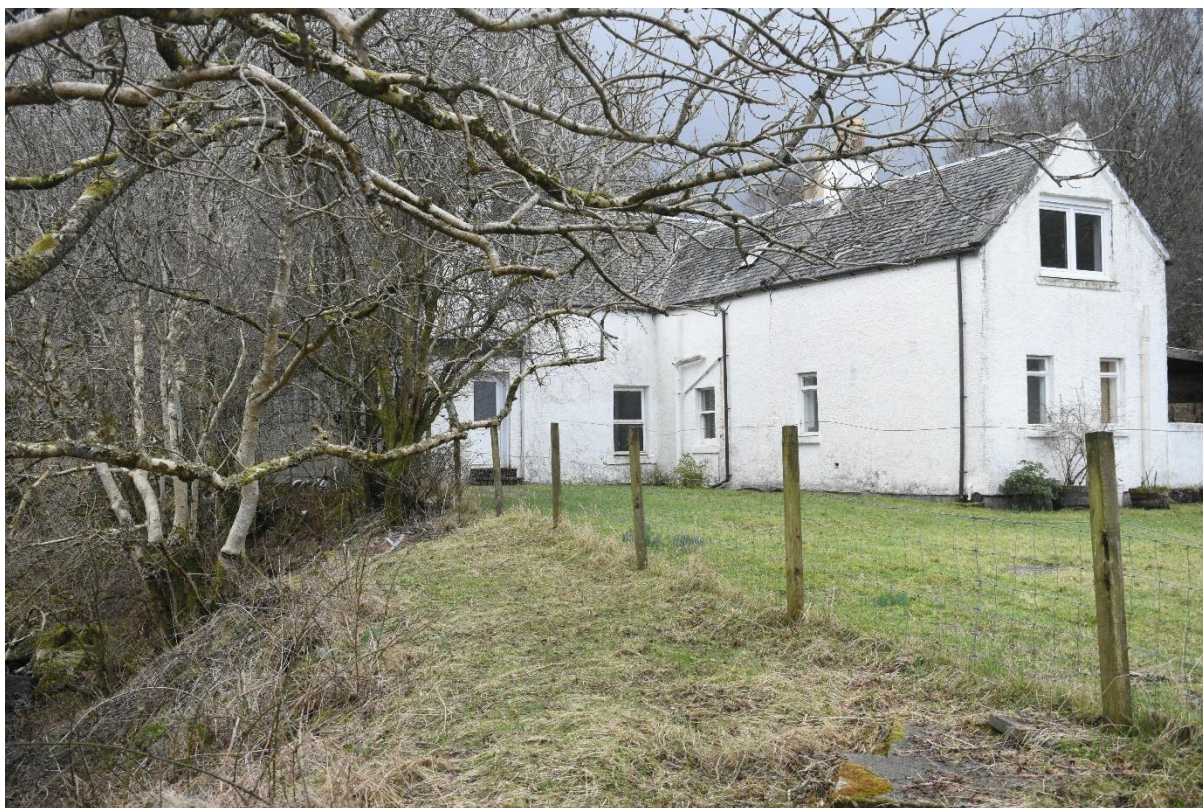
Figure 12: Northern and Western elevation

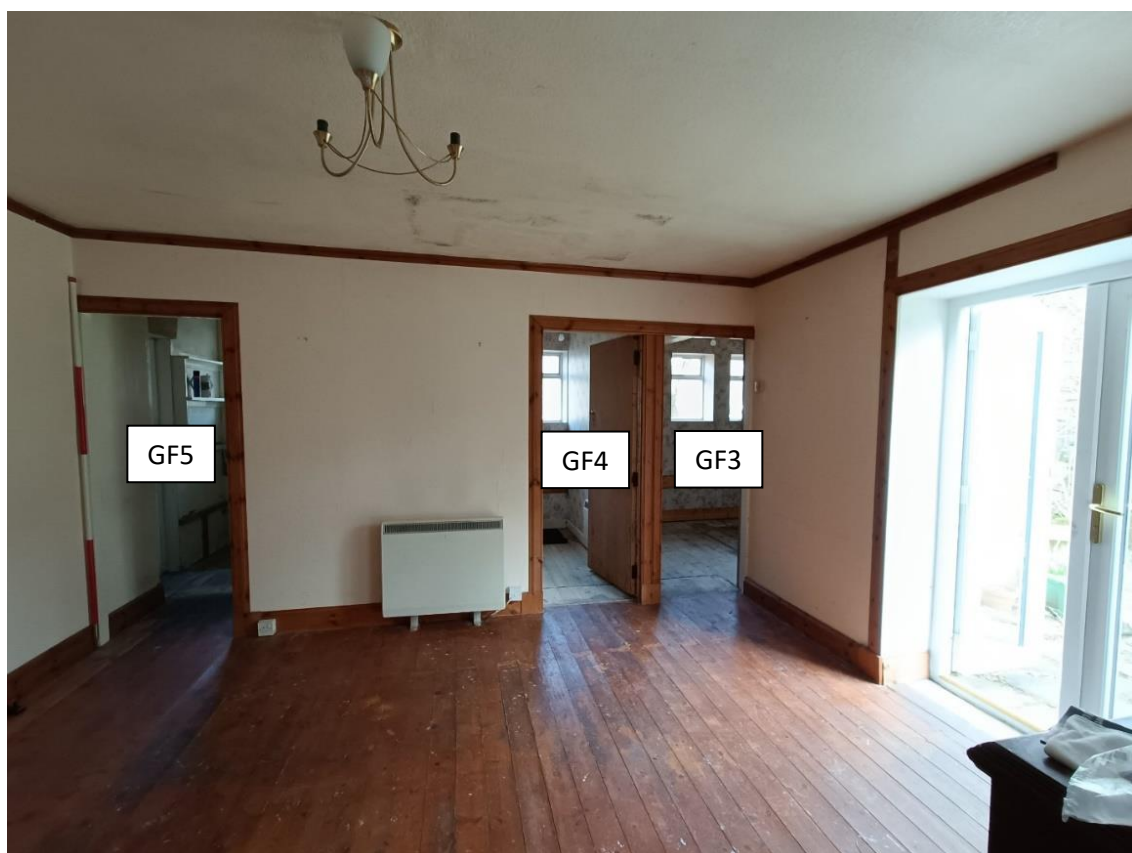
This room forms the main hallway and is situated within the 20th century flat roofed extension. The hall gives access to the modern extensions to the northern and eastern elevations and to the historic farmhouse. The walls and ceiling are boarded and painted and there is an exposed timber floor.

Figure 13: Room GF2 looking towards GF3 to 5 with D1 to right

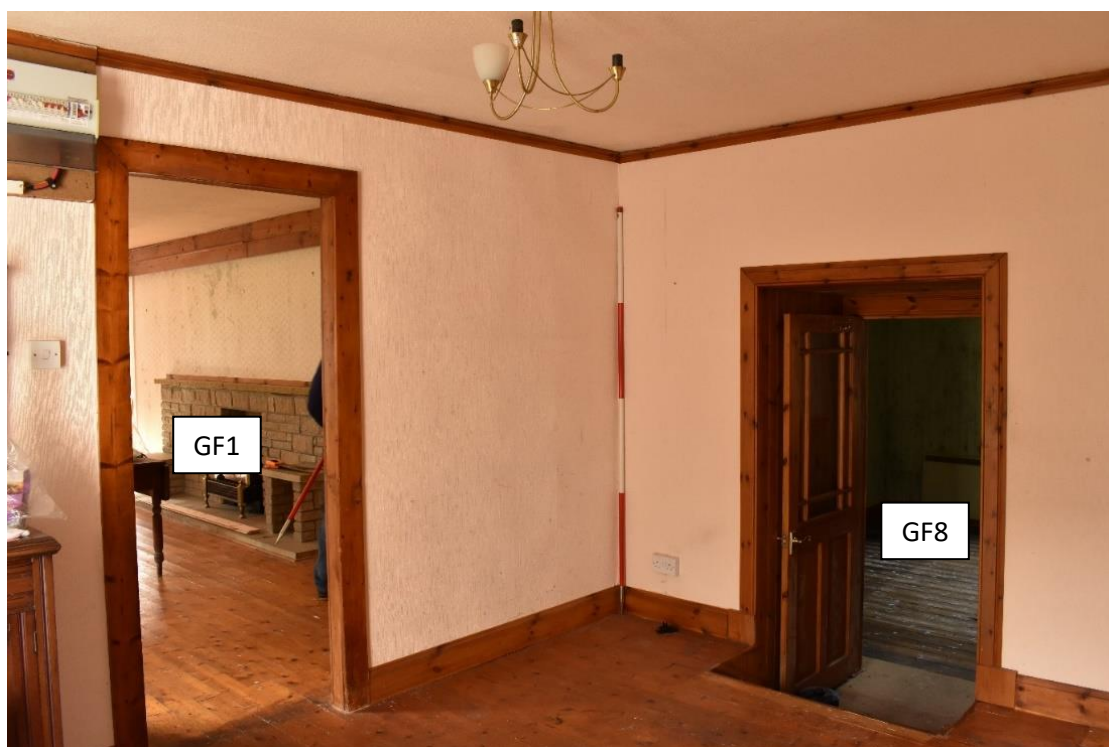
Figure 14: Room GF2 looking towards GF1 (to left) and into room GF8 within the historic farmhouse

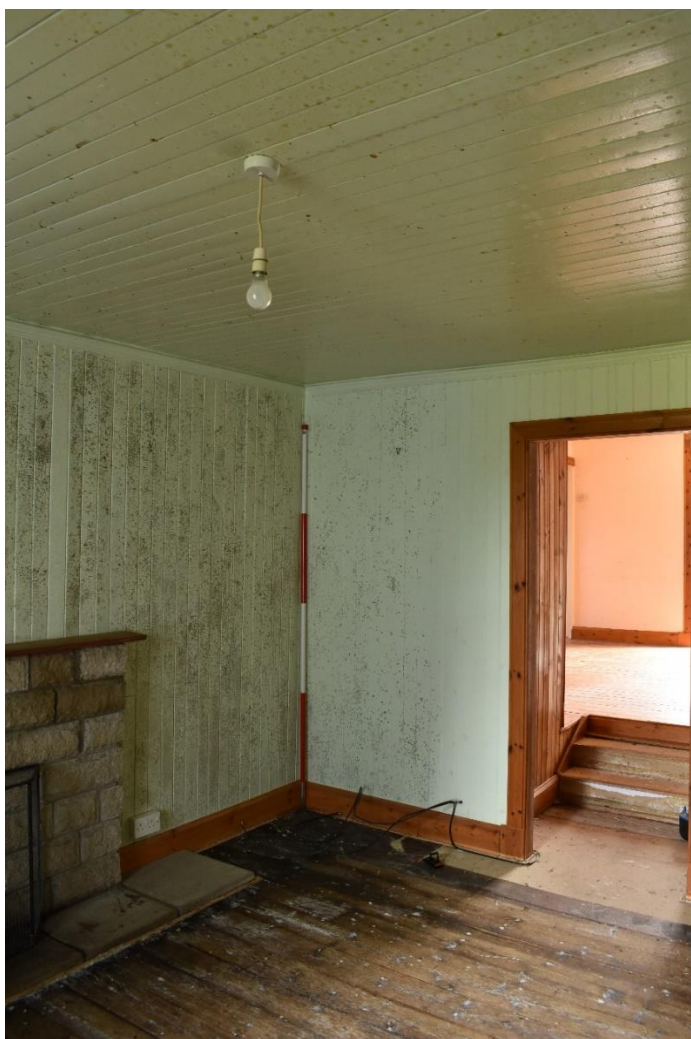
This room formed part of the c.1898 farmhouse and is entered via two steps down from Room GF2. The walls and ceiling are lined out with painted 75 mm timber boards (3 inches), and the floor is covered with 152mm (6 inch) timber floorboards. There is a moulded decorative cornice and replacement moulded skirting boards throughout the room. A later 20th century stone surround fireplace is situated on the northern wall and there is a splayed timber lined window opening on the western wall (W11). A replacement 6 panel door (D9) leads through to a small hall (room GF9).

Figure 15: Room GF8 looking through doorway (D8) to room GF2

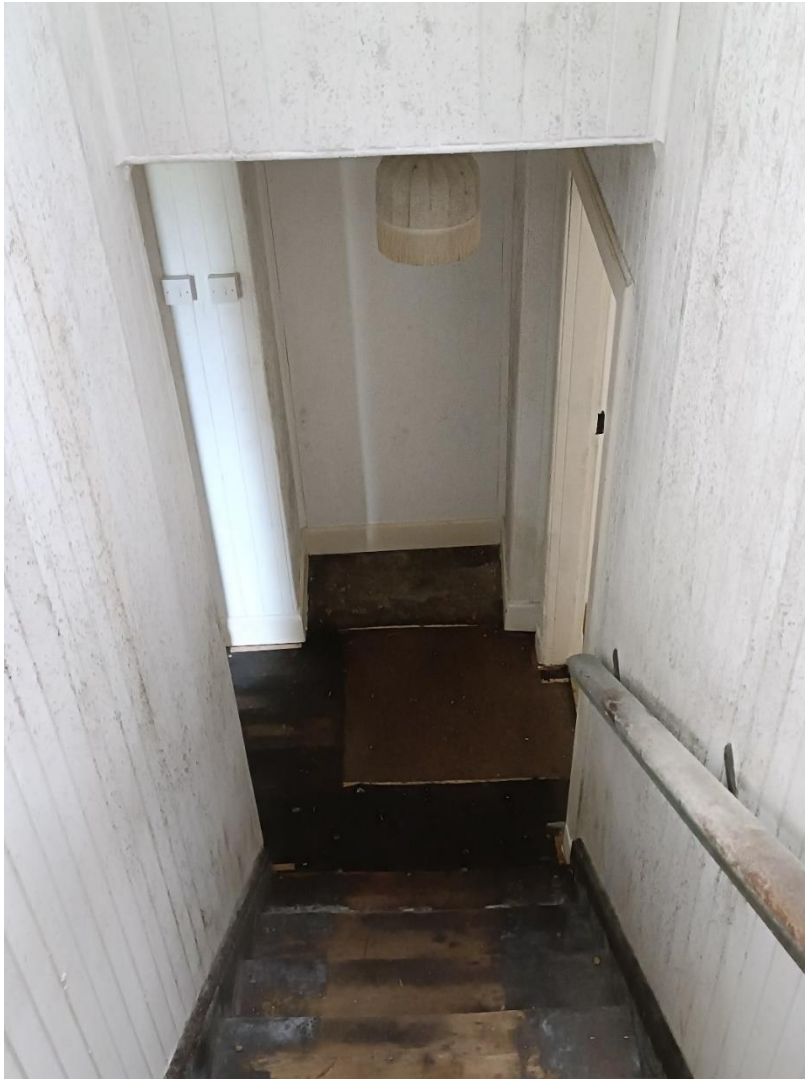
Hallway with the original front door opening (now blocked) to the eastern wall and doors leading to ground floor rooms GF8 and GF10. The staircase rises to the first floor and is lit by a cast iron roof light. The walls and ceiling are lined out with painted 75 mm timber boards (3 inches), and the floor is covered with 152mm (6 inch) timber floorboards. There is decorative moulded cornice. The timber staircase has moulded wall strings and a shaped wooden handrail to the south wall.

Figure 16: View from stairs looking towards room GF9 with D9 to the lefthand and D10 to the righthand side

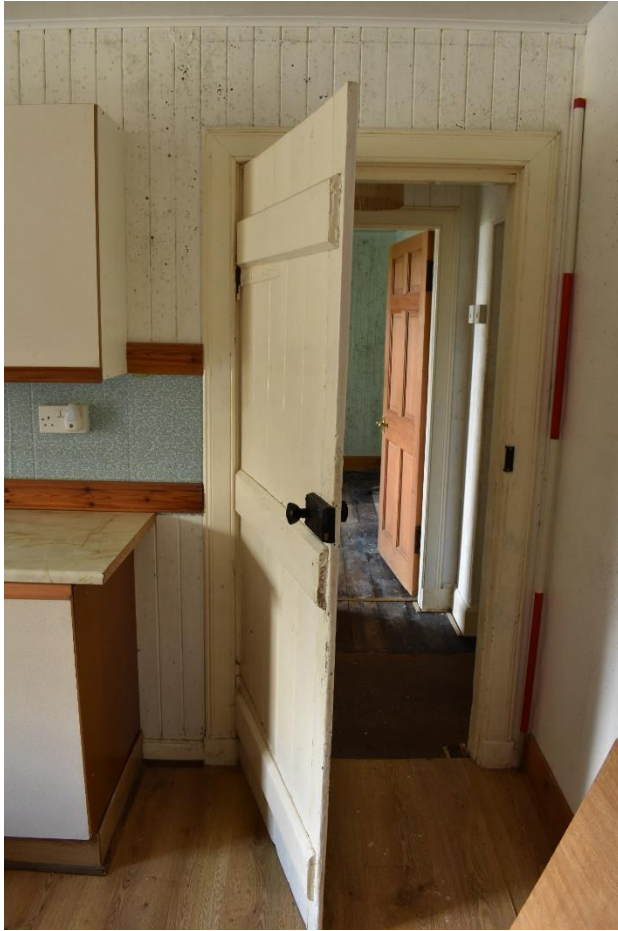
This room formed part of the c.1898 farmhouse and is accessed via a vertically boarded ledged timber door (D10 see Figure 17) from hallway GF9. The walls and ceiling are lined out with painted 75 mm timber boards (3 inches), and the floor is covered in modern vinyl. There is a decorative moulded cornice and replacement moulded skirting boards to the eastern wall of the room. An open recessed shelf unit in the eastern wall has been formed within a blocked original window opening (see Figure 18), and in the western wall is another splayed window opening. Original skirting can be seen in the small recess formed below the enclosed stairwell (see Figure 19). Door opening D11 leads from this room through to the rear extension.

Figure 17: Historic door D10

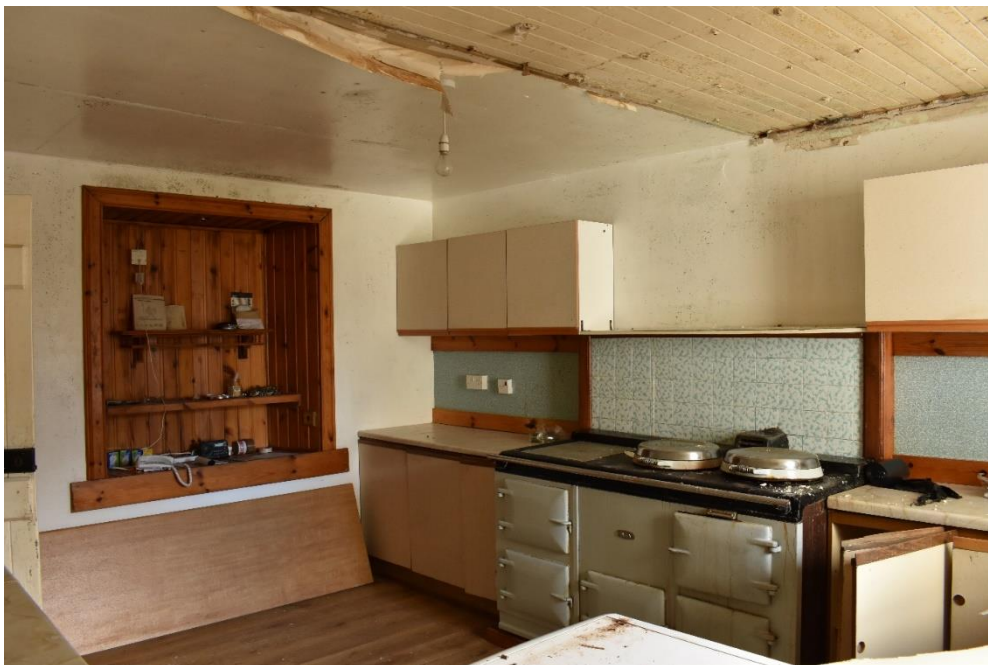
Figure 18: Room GF10 with shelf built into a blocked window opening in the eastern wall

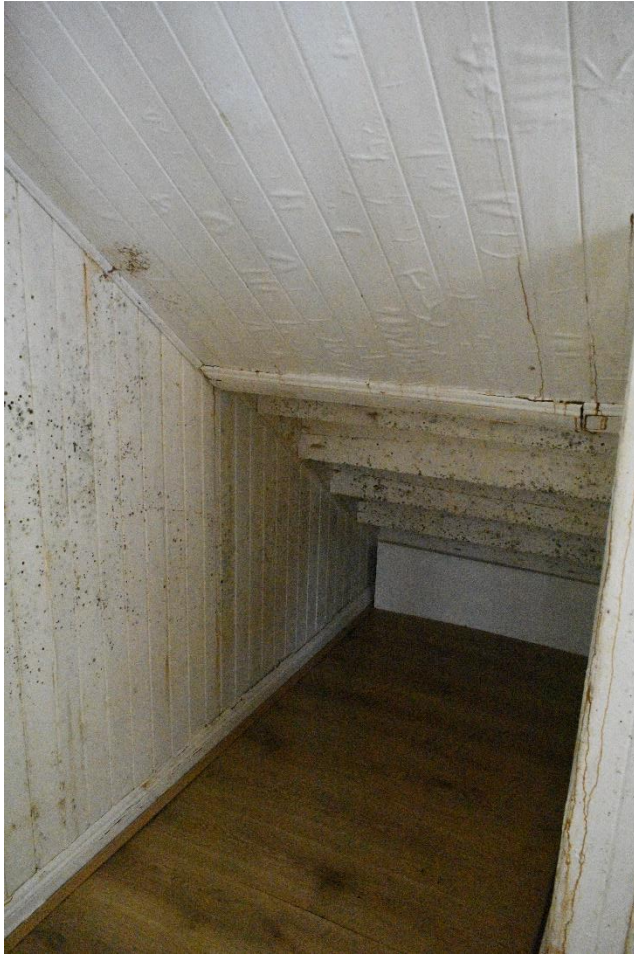
Figure 19: Recess formed below the stairwell with historic skirting board

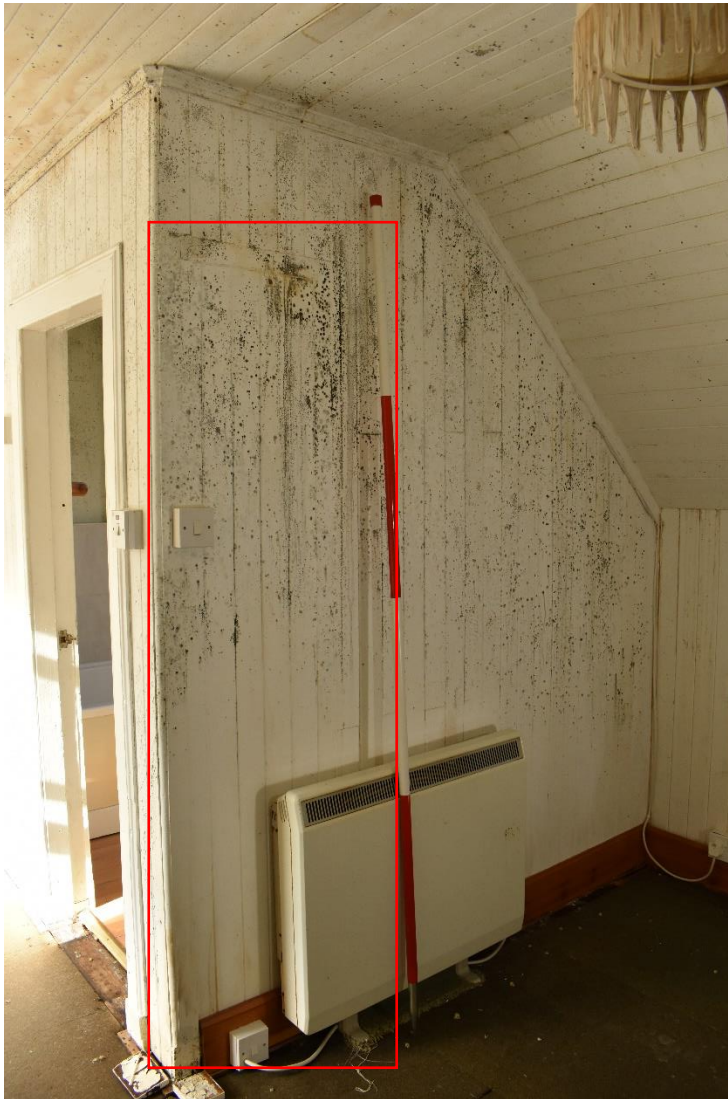
Hall formed within the rear wing leading to Rooms FF2 to 5. There is a partially underdrawn ceiling, and the walls and ceiling are lined with painted 75 mm timber boards (3 inches); the floor has been over boarded with chipboard. The eastern wall of Room FF4 bears a partial scar from a former door opening (see Figure 20).

Figure 20: Evidence of blocked door opening in wall of Room FF4

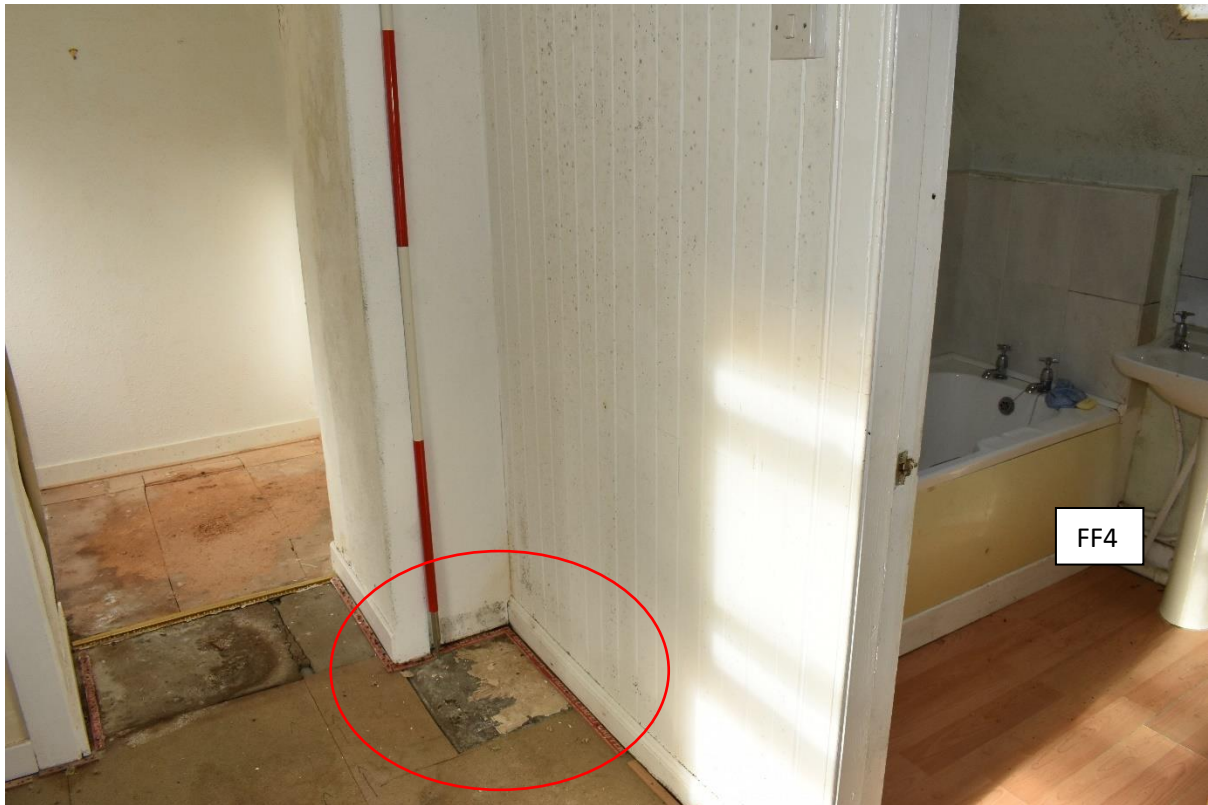
Within the floor, to the right hand side of door opening D17, are the partially obscured remains of a concrete hearth, feature F1 (see Figure 21).

Figure 21: Detail of remains of a concrete hearth which continues underneath the southern wall of FF4

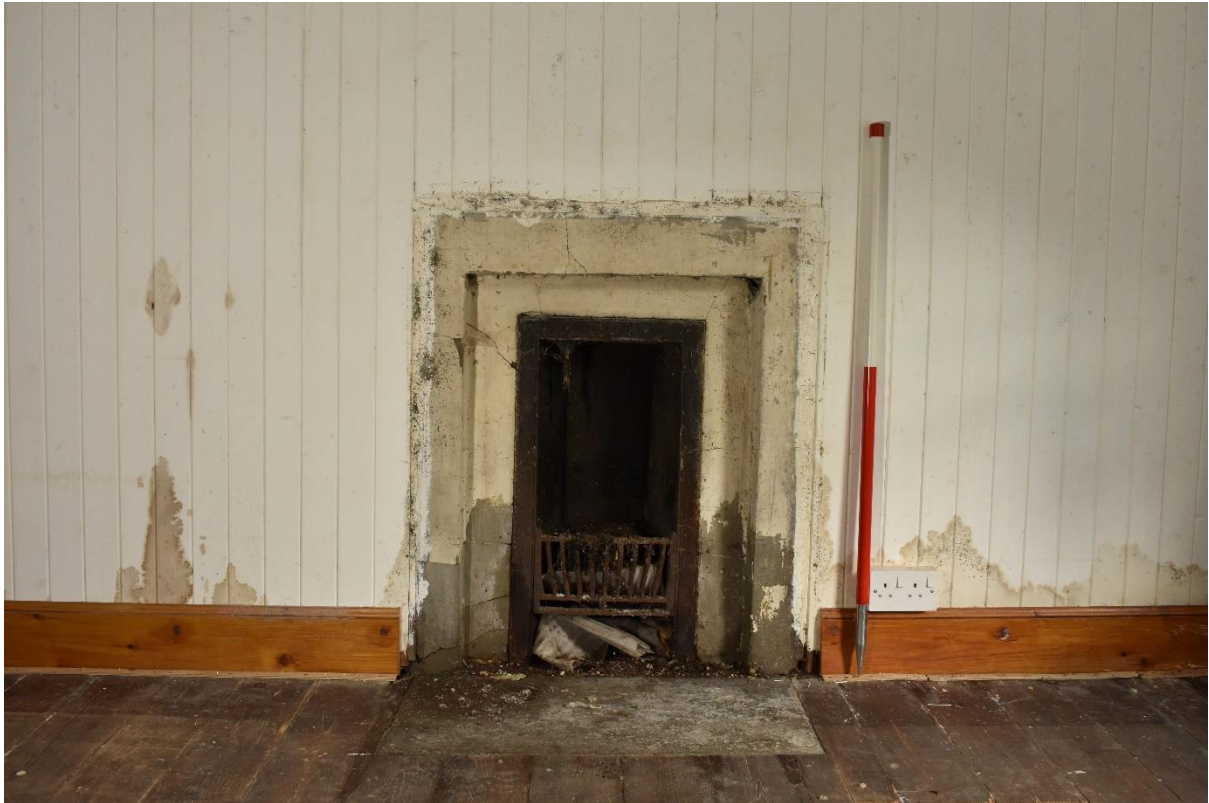
This room formed part of the original farmhouse and is accessed via a vertically boarded ledged timber door which retains an historic rim lock and metal knob. The walls and ceiling are lined with painted 75 mm timber boards (3 inches), and the floor is covered with 152mm (6 inch) timber floorboards. There is a moulded decorative cornice. The skirting board is a more recent replacement with a moulded profile. There is a fireplace to the northern wall with a small cast iron grate, the surround is formed from cast concrete, with a scar which suggests there was a further applied surround and mantelpiece, now missing (see Figure 22).

Figure 22: Room FF2 fireplace detail

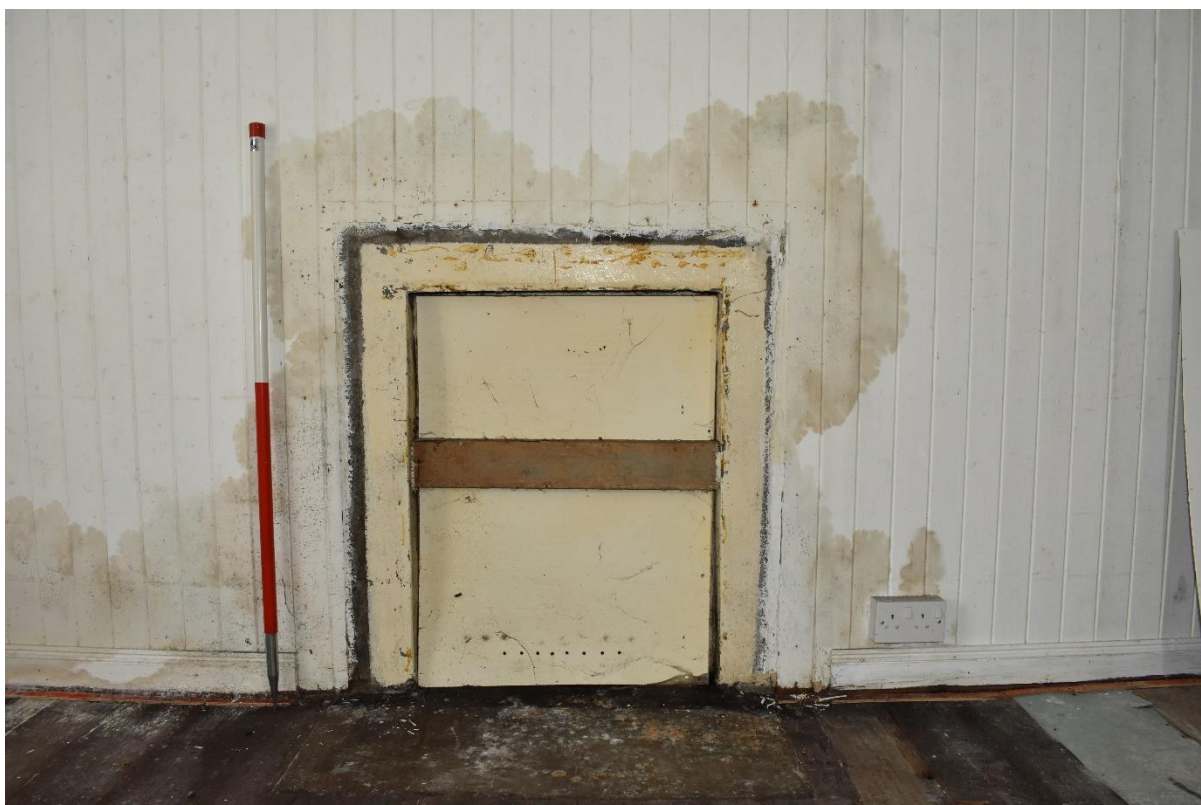
This room formed part of the c.1898 farmhouse and is accessed via a later 20th-century 6 panel door from room FF1. The walls and ceiling are lined with painted 75 mm timber boards (3 inches), and the floor is covered with 152mm (6 inch) timber floorboards. There is decorative moulded cornice. The skirting boards, which appear to be original, feature a square profile. There is a blocked fireplace to the southern wall. The fire surround is formed from cast concrete and there is a scar which suggests there was a further applied surround and mantelpiece, now missing (see Figure 23).

Figure 23: Fireplace and detail of concrete surround and hearth room FF3

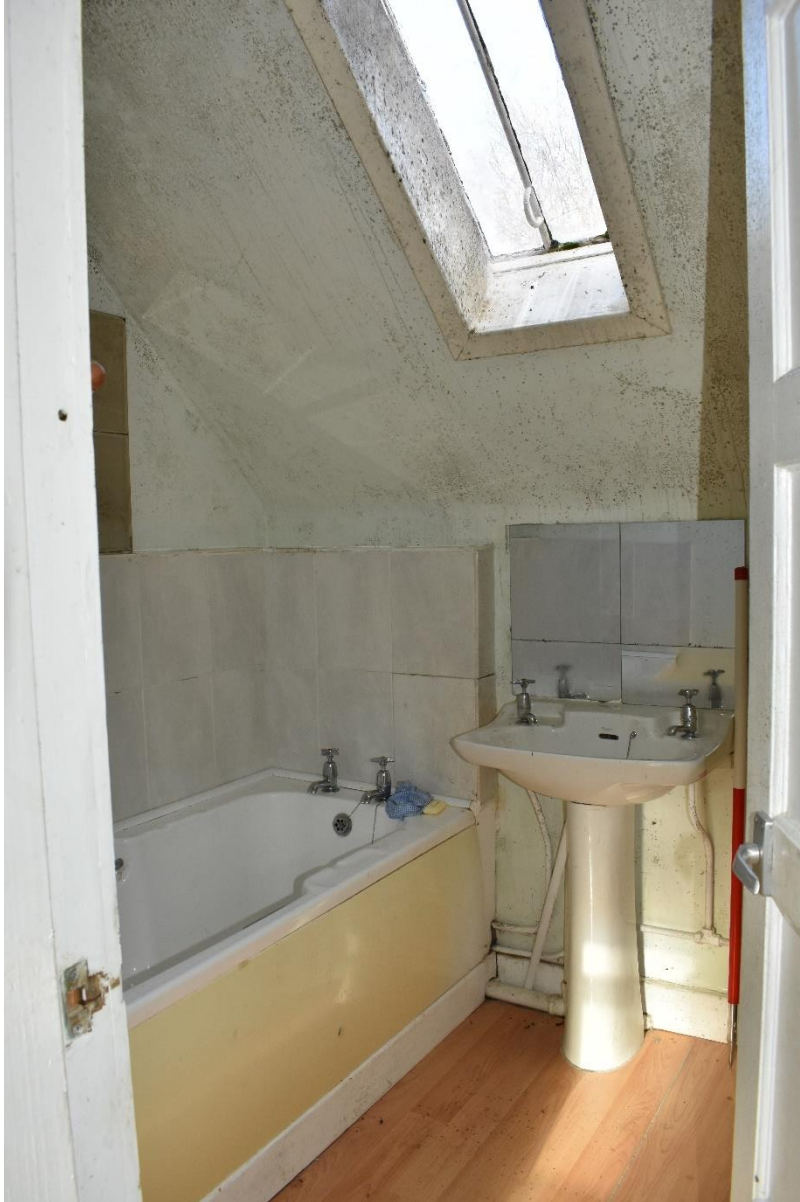
This small bathroom is accessed from FF1. It has smooth boarded and painted walls. A cast iron roof light provides the only light for the room.

Figure 24: Room FF4 with cast iron roof light

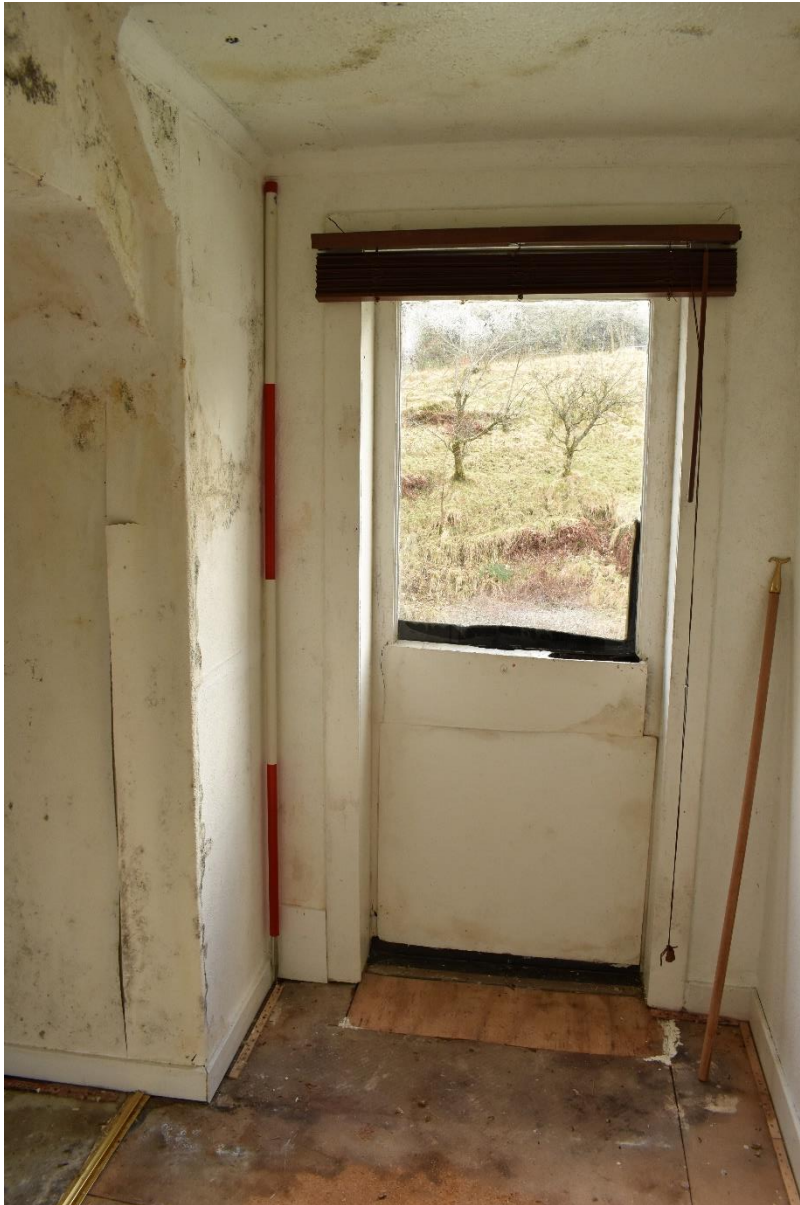
Door D16 leads from FF1 into this small lobby area. Within the dormer window opening (W21) is a partially blocked door (see figure 25).

Figure 25: W21 Doorway inserted into the dormer window opening and then partially blocked (note threshold)

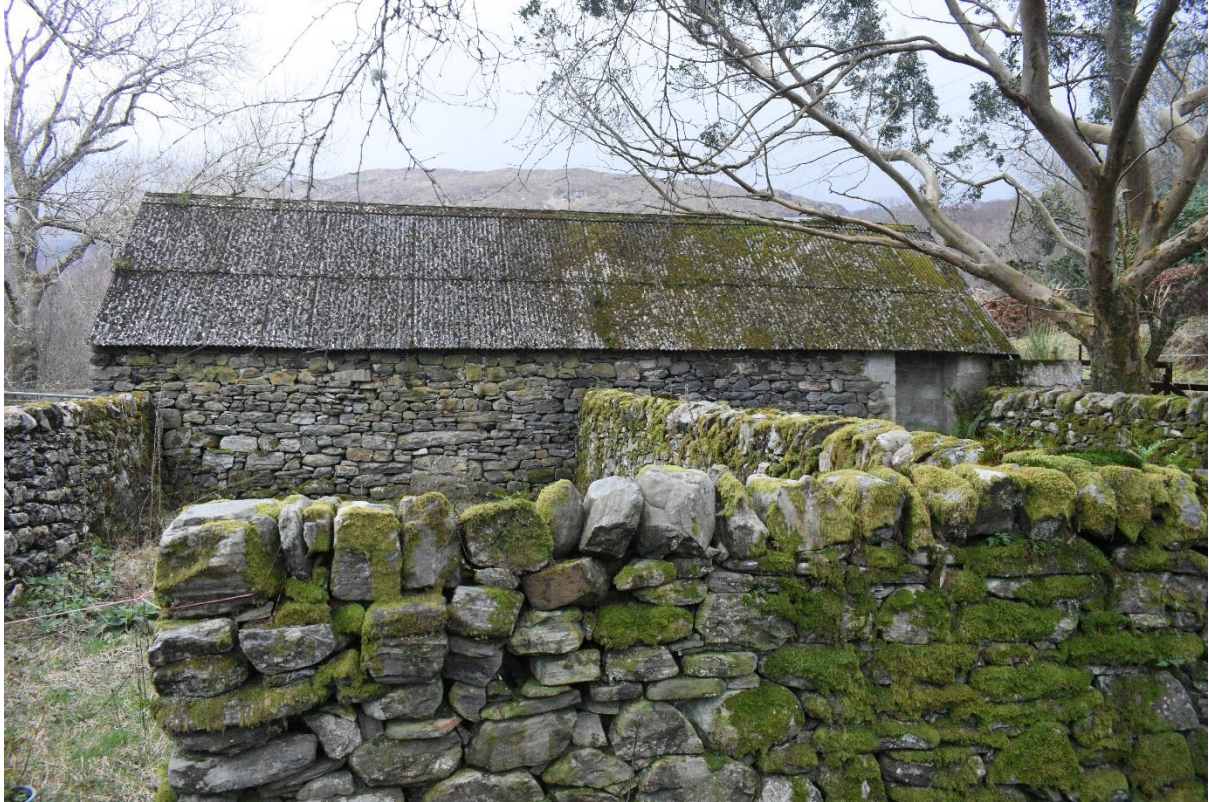
A former “sheep fold”, constructed in stone with a modern corrugated roof, is situated to the east of the farmhouse.

Figure 26: Former “sheep fold”

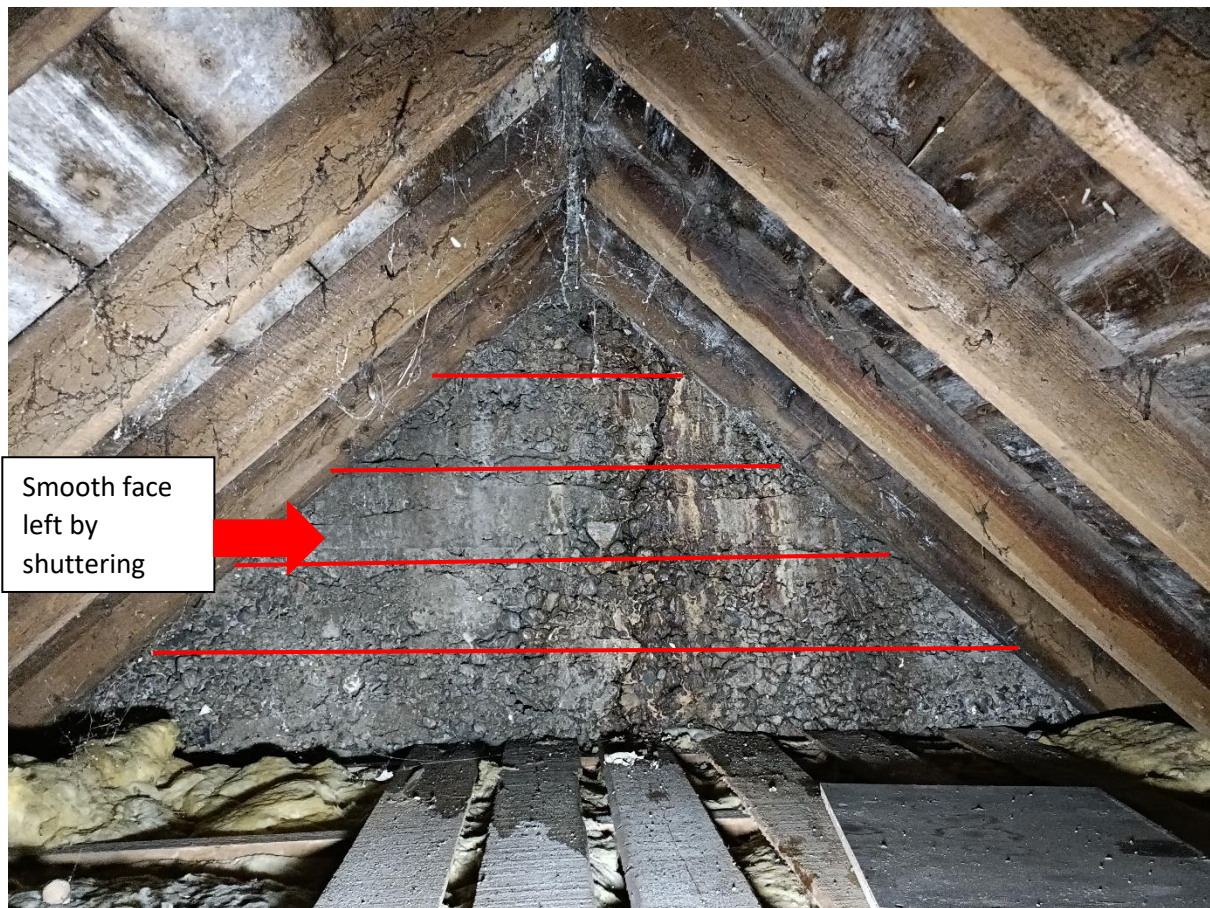
Whilst the uniform harl, applied to the external walls of the farmhouse, obscures the buildings construction method and phasing, internally there is evidence confirming the use of mass concrete construction. For example, within the roof void the concrete construction of the southern gable wall is clearly visible, shown in Figure 30, with the short vertical "lifts" of each pour and the imprint of the smoother surface left by the shuttering.

Figure 30: Evidence of concrete construction with “lifts” and evidence for the use of shuttering can be seen in the gable wall of the southern elevation.

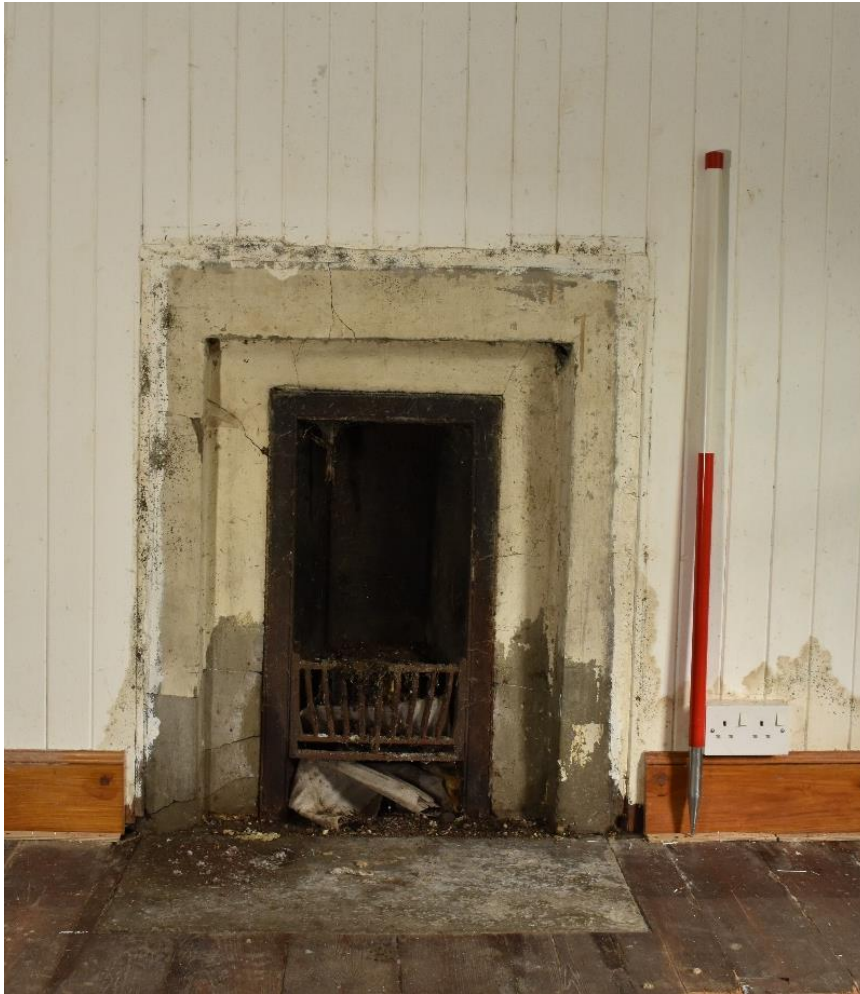
Evidence for mass concrete wall construction is not easily discernible at lower floor levels, however some features, including the integral cast concrete fireplaces in bedrooms FF2 and 3 (see Figure 31) and external cast concrete window cills confirm this method of construction having been used throughout this phase of the site.

Figure 31: Evidence of cast concrete fireplace in room FF2.
