Roshven Farmhouse, Glenuig, PH38 4NB

Standing Building Recording

BAL 1447

Buildings Archaeology Ltd

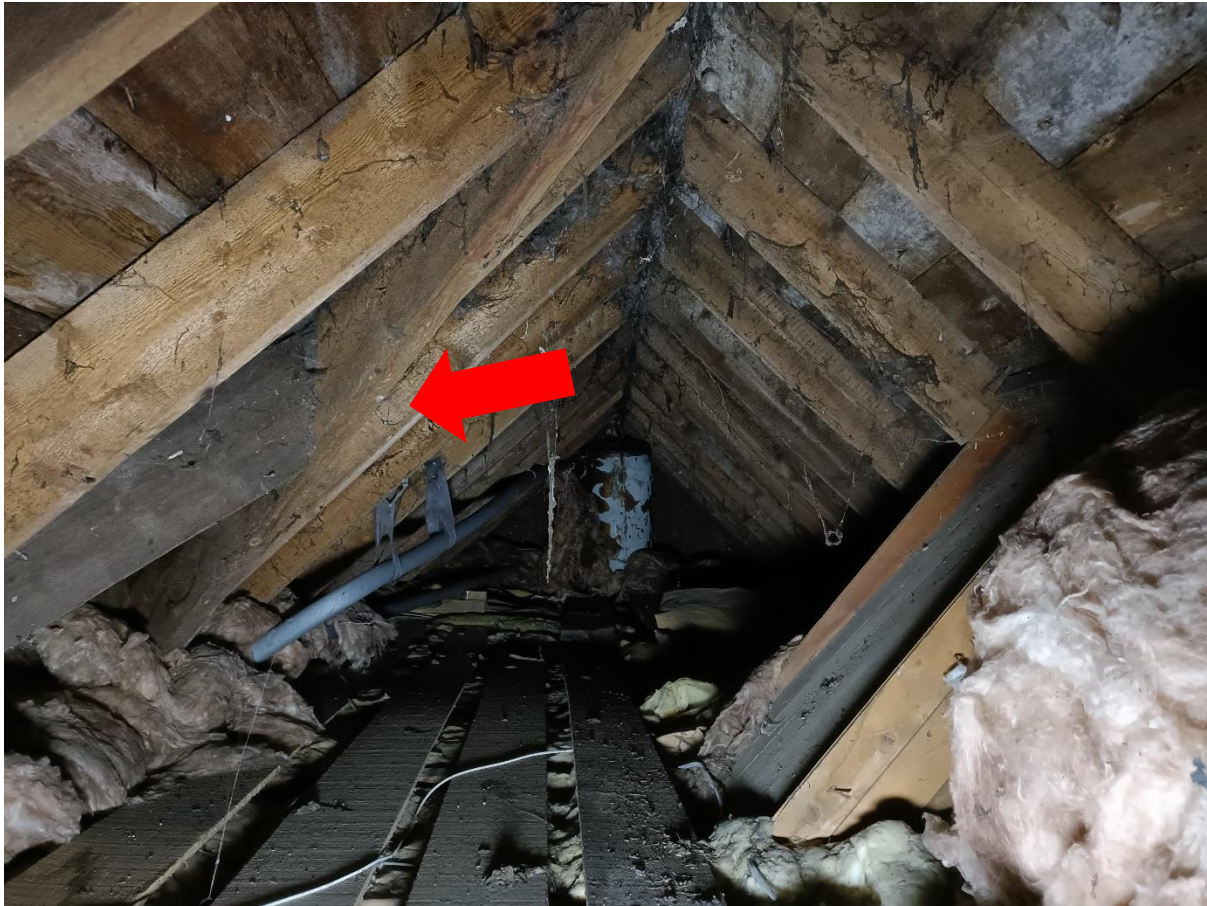
The ground floor walls of the central 3 bay structure are wide (approx. 700mm) compared to those at first floor level (approx. 350mm). This may indicate that a stepped wall was built to support the first floor floor joists. It may also indicate that the original stone structure had been incorporated into the concrete structure although no evidence to support this idea has been found. The walls of the rear wing are of a matching thickness (350mm), which together with the uniform roof structure (see Figure 32), confirm this rear wing is part of this phase of construction.

Figure 32: Red arrow indicates the roof structure of the rear wing was contemporary with the central core of the farmhouse.

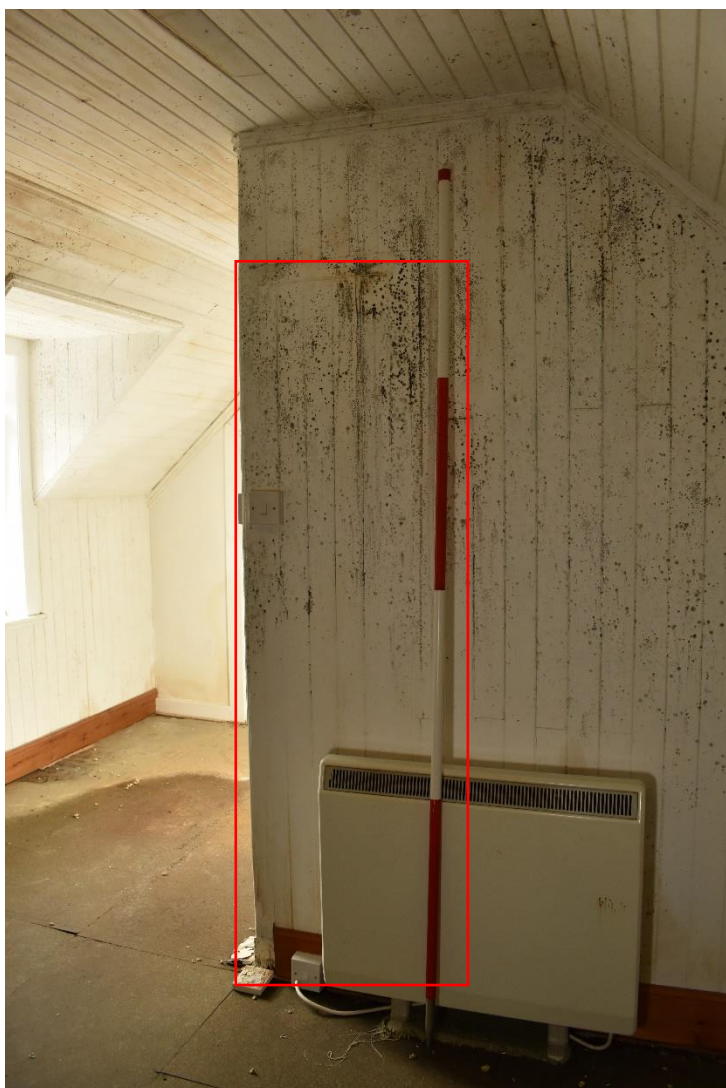
Internally much of the first phase building was lined out with vertically boarded timber, as with many properties in the Highlands of this date, providing further evidence for the extent of this first phase building. At first floor level bedrooms FF2, FF3 and hall (FF1) formed part of the c.1898 build. Evidence suggests that there was a third bedroom, opposite the top of the stairs, in the rear wing. A scar from a blocked doorway in the eastern wall of the bathroom provides evidence for this (see Figure 33). Further evidence for the existence of a third bedroom is highlighted by the remains of a concrete hearth stone (feature F1) which has been partially obscured by the later insertion of the wall to form a bathroom (see Figure 34). It therefore seems that the third bedroom was altered at a later date to provide a small bathroom (FF4), possibly when the rear wing was extended.

Figure 33: Evidence of blocked doorway in eastern wall of FF4

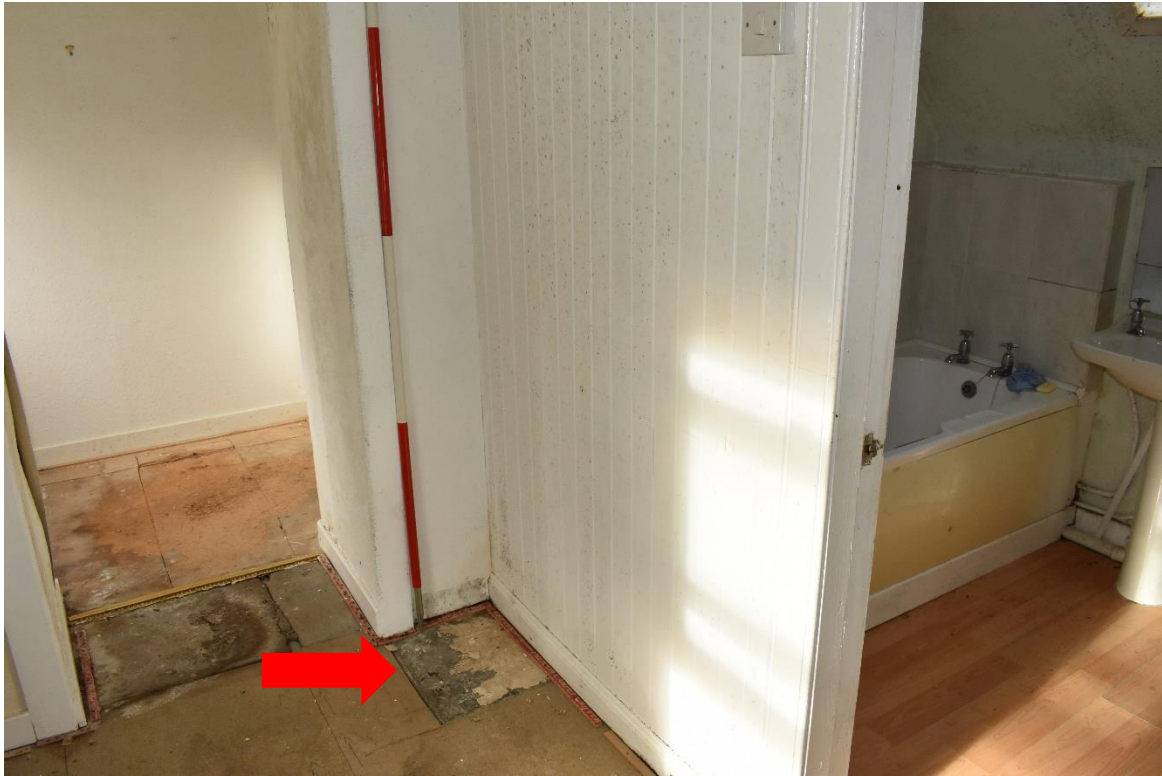
Figure 34: Evidence of hearth stone (feature F1) continuing under wall of bathroom FF4

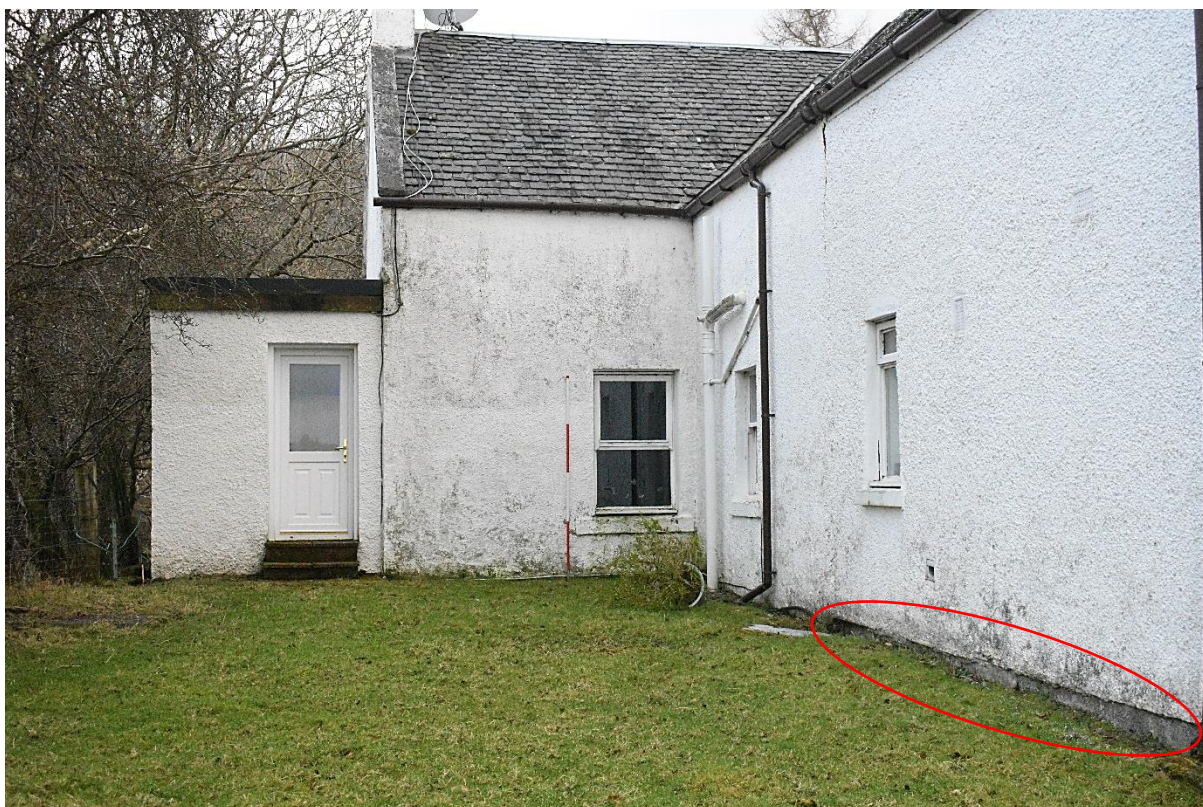
The construction of a road in 1968, meant access to this part of Moidart was greatly improved and brought much change to the area. The addition of a further rear extension to the farmhouse during the later 20th century is evident where blockwork can be seen at ground level below the harled walls (see Figure 35 and 36).

Figure 35: Block work footings of later rear extension indicated in red

Block work like this and the size and style of the window openings suggest a later 20th century date for this extension, although no records were found to confirm this.
