## Plot 14, Inverness Watching Brief

## DSR and Recommendations

<b>HAS Report No.</b>	PIC23-005
<b>Site Code</b>	PIC23
<b>Client</b>	Pat Munro (Alness) Ltd.
<b>Planning Reference</b>	20/04668/FUL
<b>OS Grid Reference</b>	NH 69658 44879
<b>Date</b>	06/03/2023
<b>Author(s)</b>	Karen Kennedy
<b>Approved by</b>	Lynne McKeggie

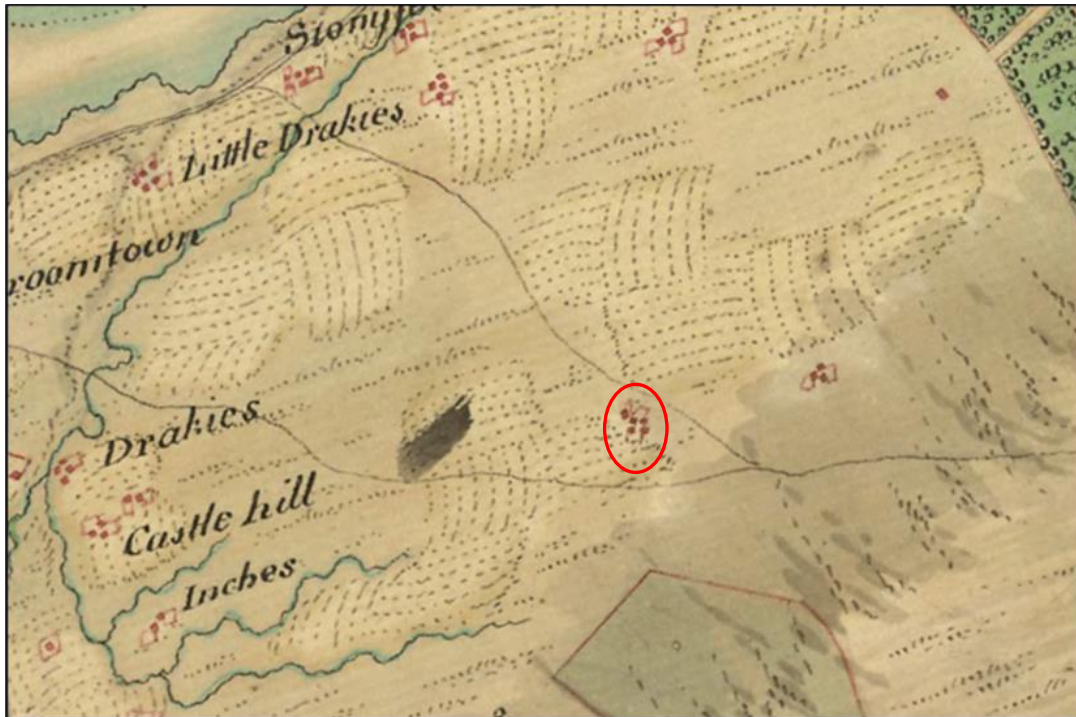
Figure 5: Section from Roy's Map 1747-52 with Cradlehall settlement highlighted. Not to original scale

Roy's map depicts the study area as open farmland with some villages such as Drakies and 'Inches' recorded and these retain their names within modern Inverness. A settlement is recorded in approximately the location of Cradlehall house (DBA1) but is not named. Several other unnamed settlements that are not named are also visible out with the study area. The roads depicted in this map may be the same as the military roads which are supposed to have been constructed around the time this map was surveyed.

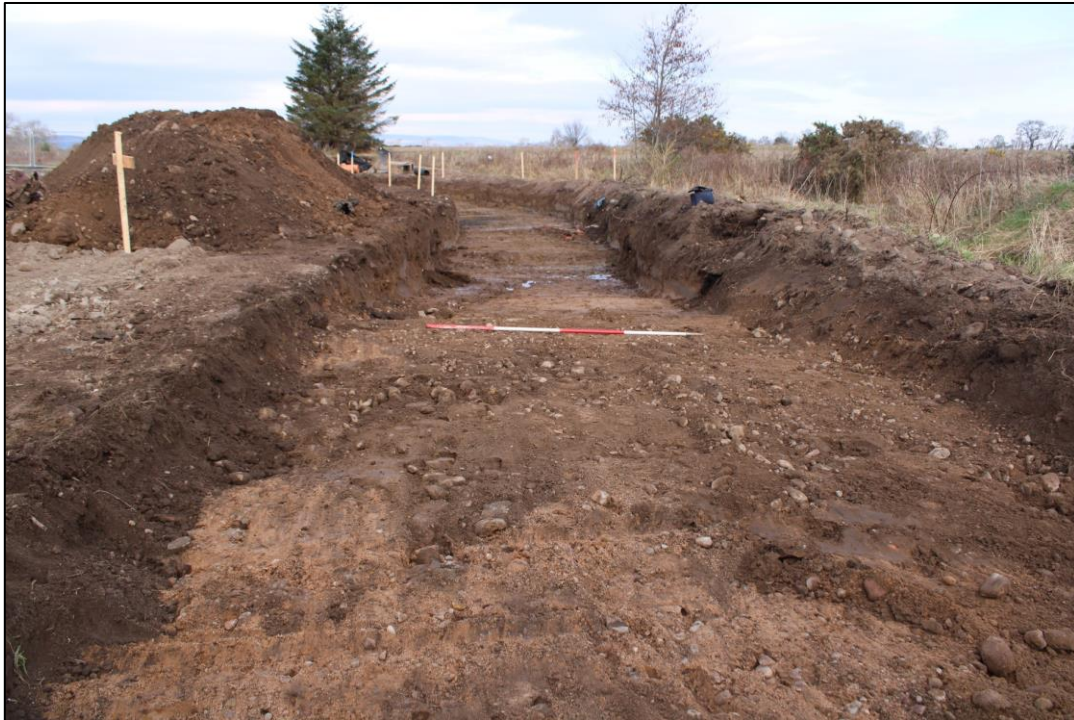
Figure 9: Photo 5184 facing N, 2m scale

The single trench measured 1409sqm. Topsoil (001) varied in depth from 0.35m-1.35m and comprised a mid brown loam with some mid sized round and subangular stones. The area to the north of the trench where the brick built feature (003) was located contained a large amount of modern detritus, including bricks, cement, plastic and the remains of a car. It was likely that this area was used for fly tipping in the past. The natural subsoil (002) was a yellowy orange sandy silt with patches of a pale grey-yellow clay with some small stones (0.5-0.20cm). Large areas of the trench filled with water very quickly which resulted in it getting very muddy in large areas.

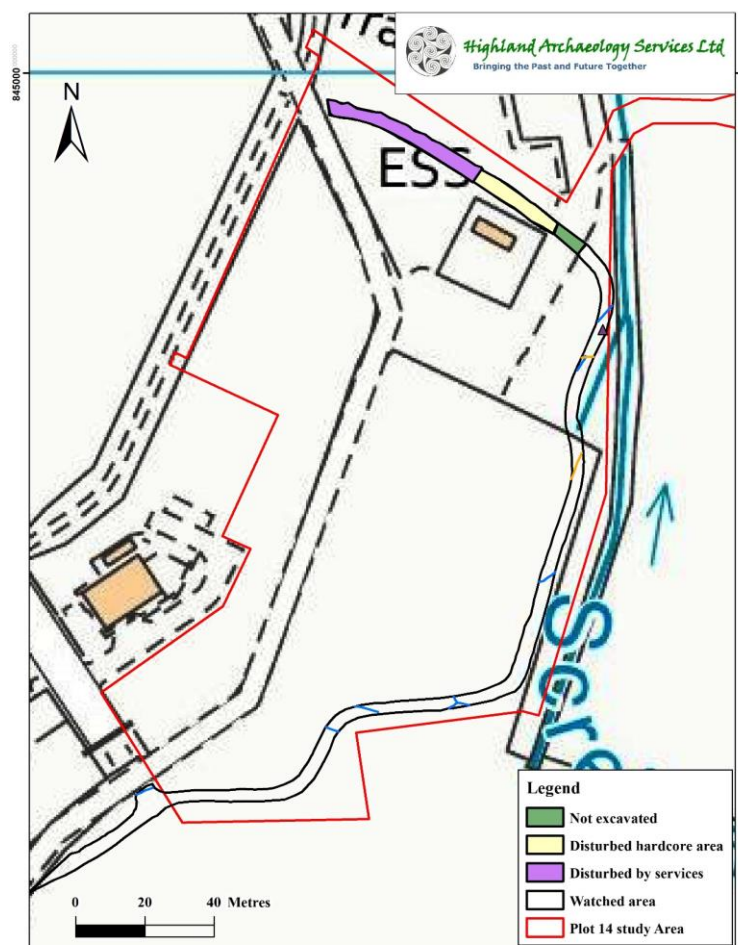
The watching brief took place on 6<sup>th</sup>, 7<sup>th</sup> and 14<sup>th</sup> February 2023 in largely dry, sunny conditions with some overcast spells. The area stripped was approximately 1409sqm covering an area where a haul road was to be built. A small area to the north east of the fiber exchange was not excavated as this was already a road and would be left insitu. The area to the north of the exchange was also heavily disturbed by a layer of hardcore obscuring the subsoil. Finally the area to the north west of the site was disturbed by fiber optic and electricity cables therefore was not excavated to the natural subsoil. (**Figure 10: Map showing watched area**)

Figure 10: Map showing watched area

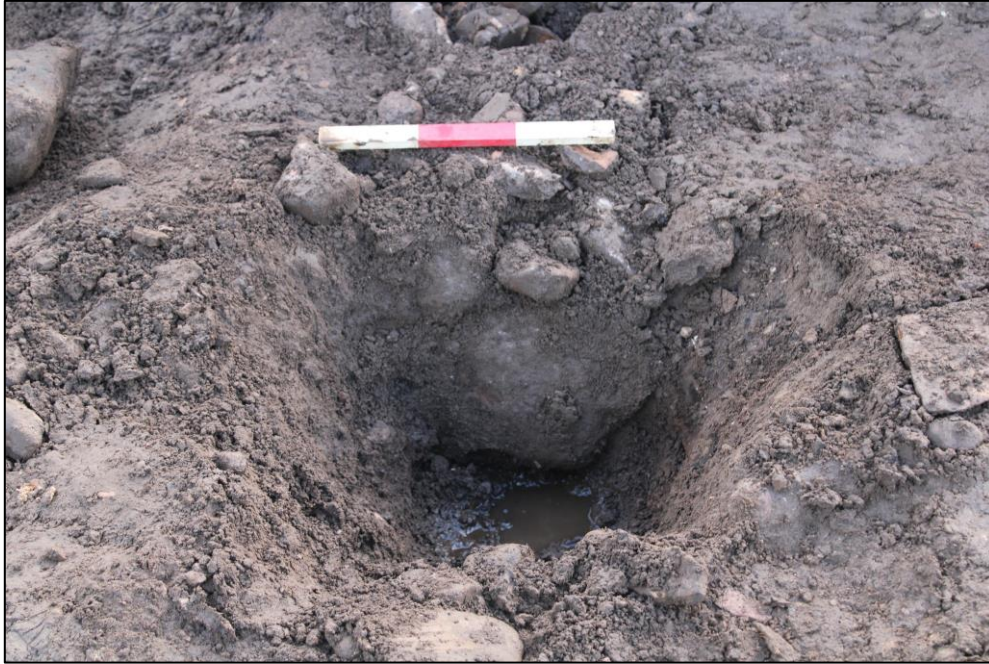
During the watching brief seven rubble and two clay drains were exposed and recorded. Due to the wet nature of the site and the fact that mostly filled with water when excavated only one section was recorded through one drain as a representative of the other drains of similar construction method. A slot was put into one of the drains (Figure 11) which showed that the drain was a shallow u-shaped cut [004] into the natural (002) and was filled with (005) which comprised a mix of frequent stones and some mid brown loam (006) probably the same as the topsoil (001).

**Figure 11: Photo 5141, facing e, showing slot through drain [004], 0.3m scale**

Nine drains in total were uncovered during the watching brief which are not considered archaeologically significant.

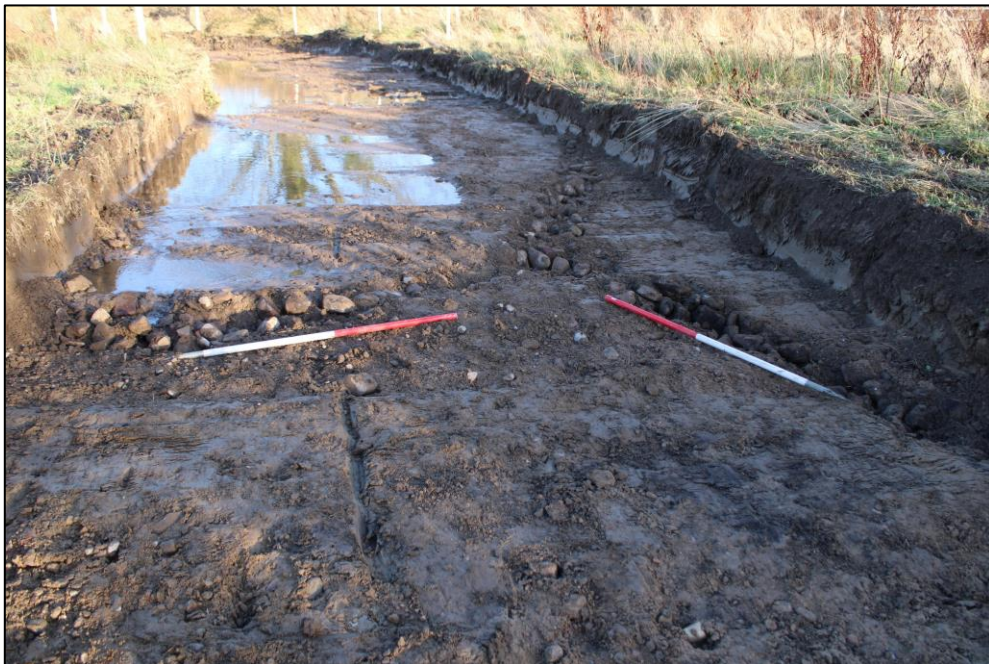
One of the rubble drains was Y-shaped in plan (016) (Figure 12), comprising a drain coming from the south east and south west joining up and running north across the trench.

**Figure 12: Photo 5146, facing NE showing Y-shaped drain. 1m scales**

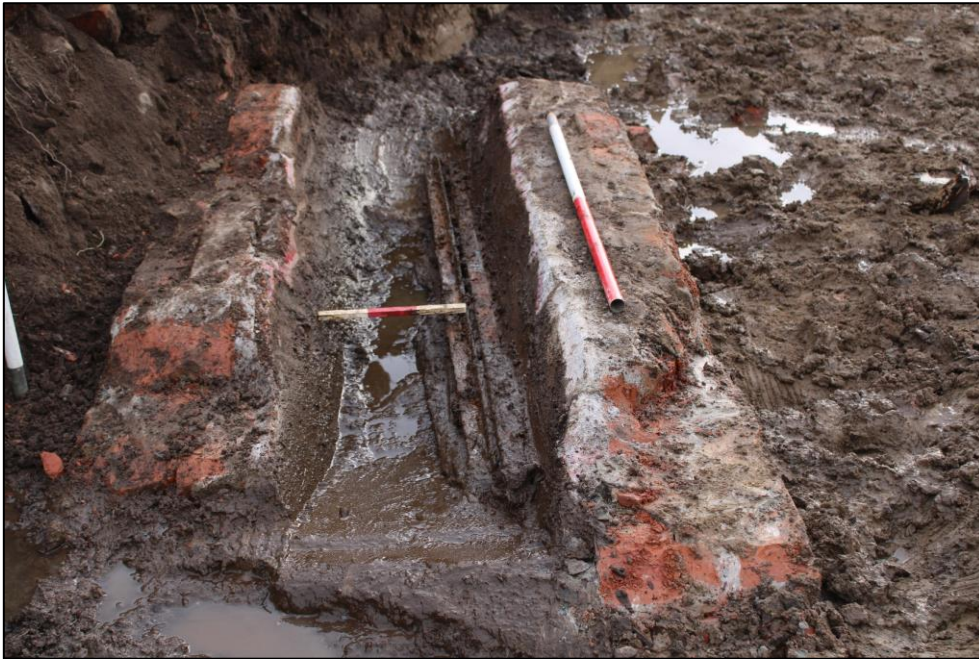
A brick feature (003) was also exposed and recorded (Figure 13, Figure 14 and Figure 15). The feature was in a particularly wet and muddy area which made exposing and cleaning the feature extremely difficult. This comprised two brick built partial walls measure 1.92m in length, and 0.38m at its deepest point, and was connected by a u-shaped concrete base measuring 0.70m in width. The concrete covered the interior of the feature and partially covered the top of the bricks but those on the south facing edge appeared completely exposed. Each end was gently sloping upwards with a flat base, resulting in a trough shape. There were two metal L-shaped poles running lengthways along the feature but these may have not been part of the structure as this was an area in which there was a lot of modern detritus. In addition, close to the area of the feature there was a layer of broken up concrete in the trench section which can be seen in Figure 15. It was unclear whether this was related, as the feature was approximately 0.8m below this layer so may have just been part of the general modern rubble within the vicinity.

**Figure 13: Photo 5192, brick feature (003), facing S, 1m and 0.3m scales**

The only noteworthy feature uncovered was the concrete covered brick feature which is thought to be agricultural in nature and is likely to have been a relatively recent structure.

There were no features deemed to be significant within the study area and while the brick feature could be part of the wider story of the land use of the area it is not felt that any useful further investigation could be undertaken from the evidence gathered. There was no evidence of prehistoric activity on the site. Therefore, no further work is recommended.

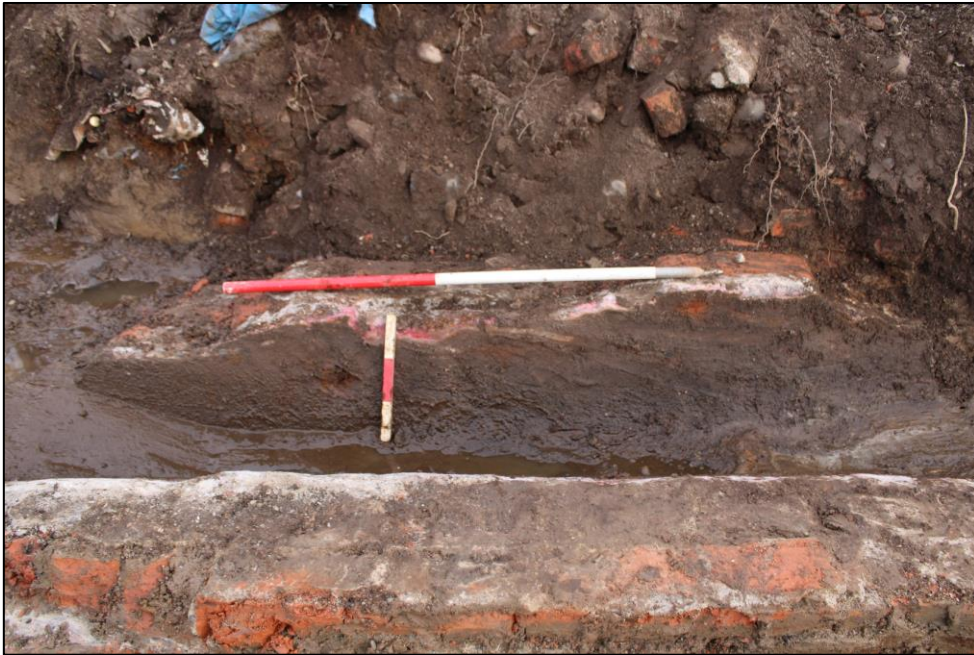
Figure 14: Photo 5195, brick feature (003) facing NE, 1m and 0.3m scale

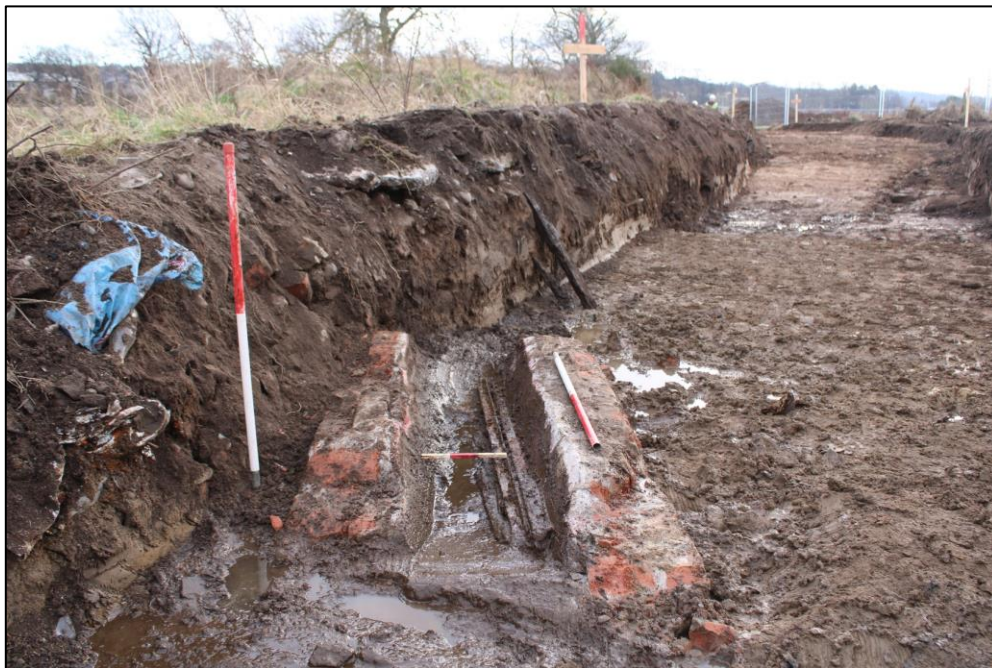
Figure 15: Photo 5191, showing brick feature (003) facing S, 1m and 0.3m scales
