**Report of Archaeological Desktop
& Walkover Survey
Ardnagrask Water Mains Renewal Project
NH 51869/48539 (centred)**

**By
Stuart Farrell
B.A A.I.F.A F.S.A.Scot.
August 2002**

This report is for an archaeological desktop & walkover survey conducted on behalf of Halcrow Group Ltd by the author for the Ardnagrask Water Mains Renewal Project, Highland.

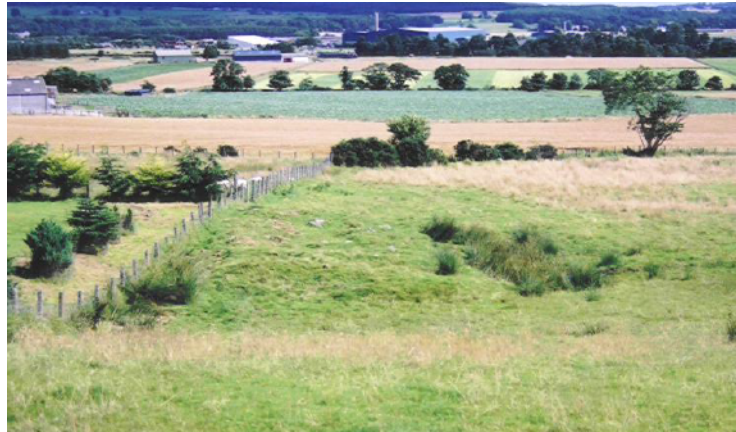
1 – Teandalloch

Type – Building

Unroofed building shown on 1st edition OS of 1881 (sheet 99) but not shown on OS map of 1988. Not shown on 2nd edition OS of 1907 (sheet 99).

Site is visible on aerial photograph of 1946 as rectangular mound (RAF CPE/Scot/Uk184/2330), visible as outline on aerial photograph of 1954 (RAF 58/A/421/5307) and as rectangular mound on aerial photograph of 1967 (OS/67/046/50).

Walkover revealed site visible as rectangular mound aligned E-W by existing fence line.

View of site facing east

No recommendations to be made as site lies out way-leave area.

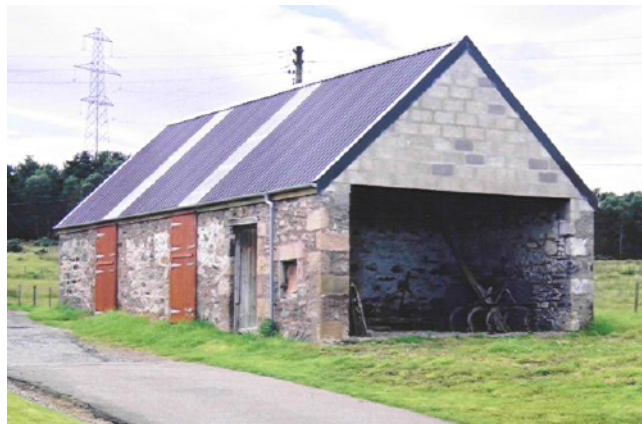
2 – Aultvaich

Type – Cruck framed House

Residential house – no other information available.

Walkover revealed house still in use as private residence. One rubble building looks to have been remodeled to form a stable block from an earlier building.

View of remodeled building facing NW

No recommendations to be made as site should be unaffected by route proposed currently.

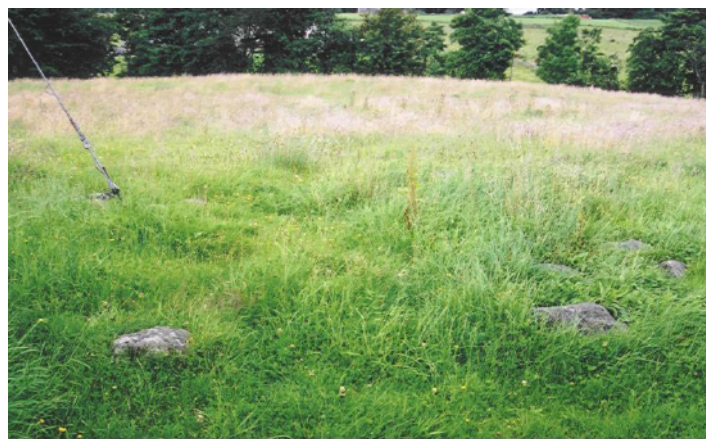
5 – Teandalloch

Type – Building, field wall

One unroofed building with an attached length of field wall is depicted on 1st edition OS 1879-81 sheet 99 but not shown on OS map of 1988. Depicted on map to lie to north side of track. Shown as roofed on 2nd edition OS map of 1907.

Not visible on aerial photograph of 1946 (RAF CPE/Scot/Uk184/2330), visible as rough mound to edge of ploughed field on aerial photograph of 1954 (RAF 58/A/421/5307) likewise on aerial photograph of 1954 (RAF 58/RAF/1424/153) and also on aerial photograph of 1967 (OS/67/046/50).

Walkover revealed possible building cut by fence-line and disturbed by strainer of electricity pole in area of long grass. To be aligned E-W of c. 5m x 6m with walls 0.2m high and 0.3m wide. Grid reference should be NH 5181/4876.

View of building facing North

No recommendations to be made as site should be unaffected by route proposed currently.

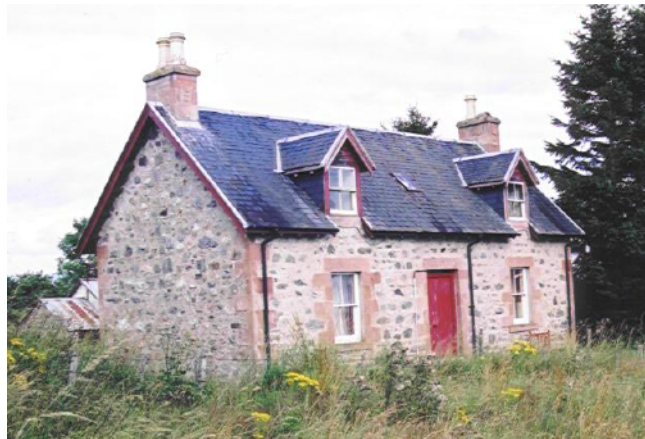
6 – Clashdorrán

Type – Farmstead

Site revealed during walkover survey. Farmhouse currently empty of late 19th century date with later additions. 3 out-buildings – 1st a long range of rubble construction and corrugated iron roof, partly harled, 2nd wooden building with corrugated iron roof, 3rd of both walls and roof of corrugated iron.

Site marked on 1st and 2nd edition OS maps but not named, likewise for OS map of 1960's.

View of farmhouse facing NE

No recommendations to be made as site should be unaffected by route proposed currently.

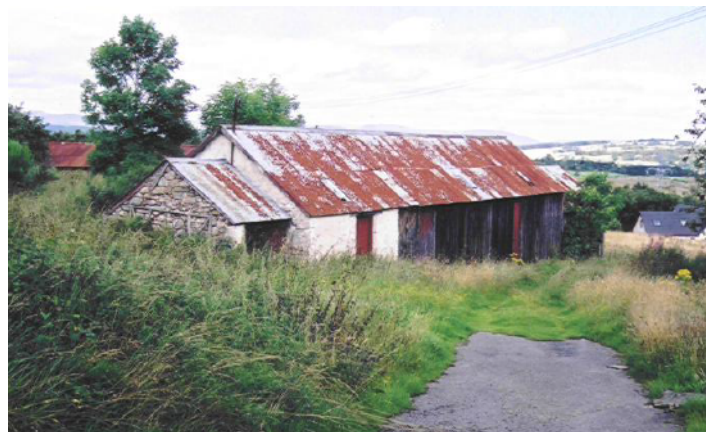
View of long out-building facing NE
