# ISLE OF RUM

PROJECT 1023

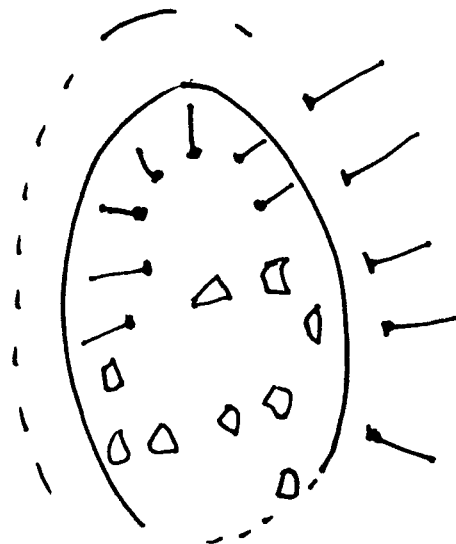
①⑦ GPS: 3521(3) 9594(0)

Note: Directly to the east of 3521(3) 9594(0) there is evidence of a very reduced wall. This wall can be noted on the GUGD 1:10,000 map but it does not note the presence of several attached cells. The wall-footings can be noted to extend in an easterly direction before turning to head south (at 3525(8) 9596(5)). The wall appears to gradually fade out as it travels south and does not seem to extend as far as the aforementioned unnamed tributary burn as the 1:10,000 GUGD map suggests. The footings are a single course of stonework clearly defined to 3527(2) 9593(9), before continuing in a sporadic fashion for a further 8.0m before disappearing completely. The maximum wall width does not exceed 0.4m and averages 0.4m in height.

The attached cells vary in size. The western most cell (GPS 3525(1) 9596(1)) is oval in shape. The exterior edge of this feature is clearly defined but the interior contains some collapse making definition of the interior walling more difficult. The cell measures approximately 2.3m by 1.7m and has a possible entrance to the north-east. This structure is in poor general condition.

Two further 'cell-like' features were also noted, one lying on the west side of the wall and the other on the east side of the wall. The wall divides the structure but they appear to be elements of the same feature. The larger of the two features lies on the western side of the wall. This oval structure measures 3.0m by 2.0m internally and the entrance appears to have been located where it abuts the wall. The structure only survives as footings, the majority of which have become turf covered over time. The smaller oval feature on the east side of the wall also survives only as stone footings and turfed over humps and bumps. The feature measures some 1.3m by 1.2m internally. The wall heights of each feature do not

exceed 0.4m while wall thickness varies. These features are likely to be associated with each other, however their reduced condition makes interpretation of their relationship with the wall difficult.

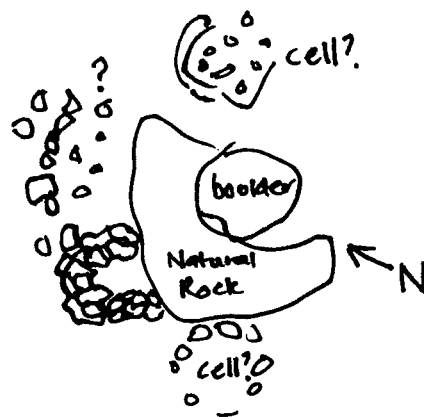
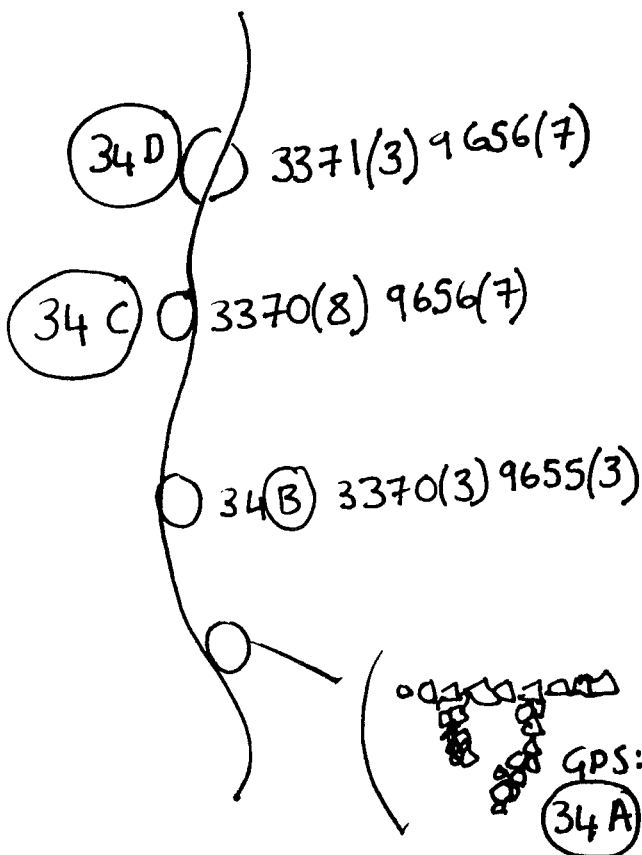
(34D) 3371(3) 9656(7)

The wall stretches up from the river (Glen Duian River) and the first cell is noted at 3369(5) 9554(3). This cell is located on the southern side of the denuded wall which exists only as sporadic footings in places. The cell measures 2.4m by 2.5m internally and the entrance is located in the south. On the east side of the entrance the walling extends out from the feature in a tail-like manner. The cell appears to be built into the wall footings, utilising the wall as the northern edge. The cell is much reduced but the shape (sub-oval) is well defined on the ground. The walls survive to a maximum height of 0.45m and measure approximately 0.8m in thickness. The walling is somewhat obscured by vegetation and is not easily located. The wall and cell are in poor general condition and are in danger of being completely subsumed by vegetation.

To the east and upslope of the aforementioned cell a further cell can be noted. This feature is again located on the southern side of the wall and measures 1.6m by 1.2m internally and

is sub-oval in shape. The interior of this cell contains collapsed walling and the surrounding structure survives only as footings. The entrance is not immediately apparent but appears to be located to the south. This cell is in poor overall condition and is largely overgrown.

East and upslope of 3370(3) 9655(3) is a third denuded cell on the northern side of the wall. This cell is quite extensive measuring approximately 3.2m by 2.2m internally. The structure appears to have been oval in shape but there is a great deal of tumbled and collapsed stonework both within and around the feature. The entrance could not be determined with any degree of certainty. In addition to the collapsed material the cell is considerably overgrown with coarse vegetation. This cell is in very poor overall condition and is not easily determined on the ground.

The final cell within this complex is perhaps the best preserved of the group. The structure measures an impressive 3.6m by 2.8m and is sub-oval in shape. The wall footings are relatively well defined on the ground and in places up to two courses of stonework remain in position. The entrance is difficult to determine however it is likely to be in the south-west or south-east. The collapsed material from the walling both within and around this cell obscures the true entrance and elements of the walling as a whole. This structure is in poor general condition.
