Results of a Desk-Based Assessment, Walk Over Survey and Watching Brief at Portree, Skye

Project Code: Portree Regional South SO35

Client: Team Aquarius.

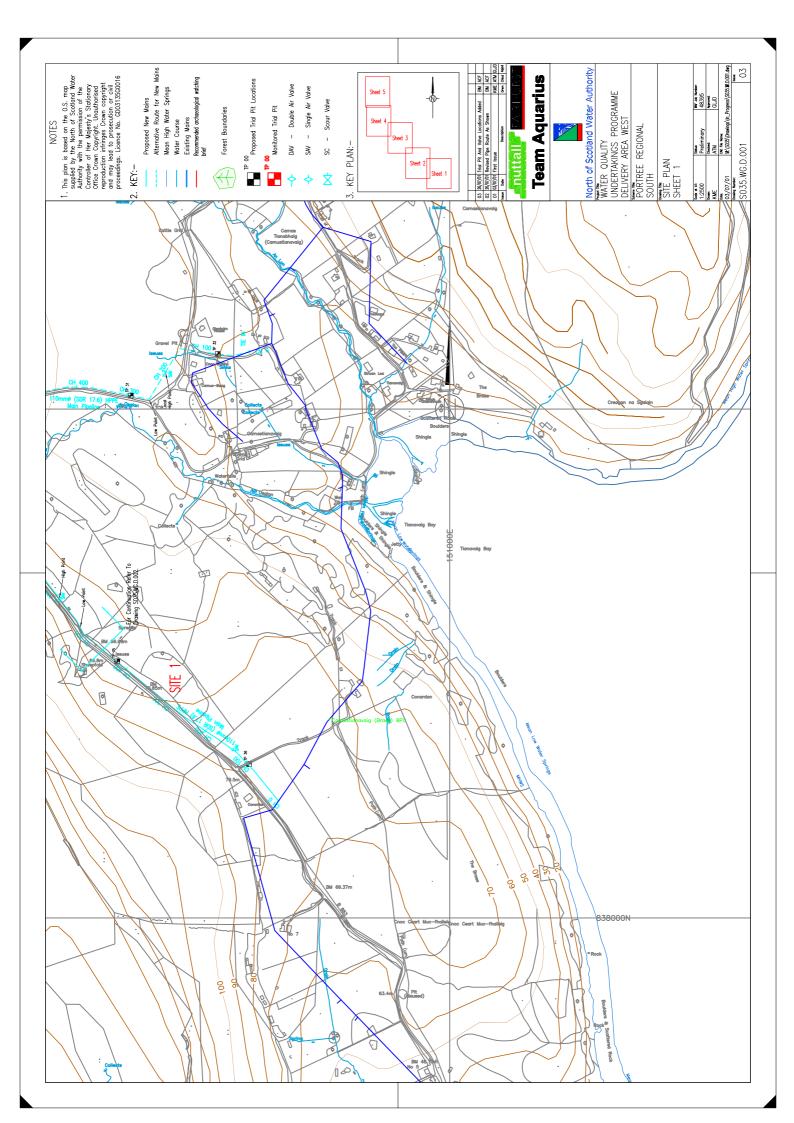
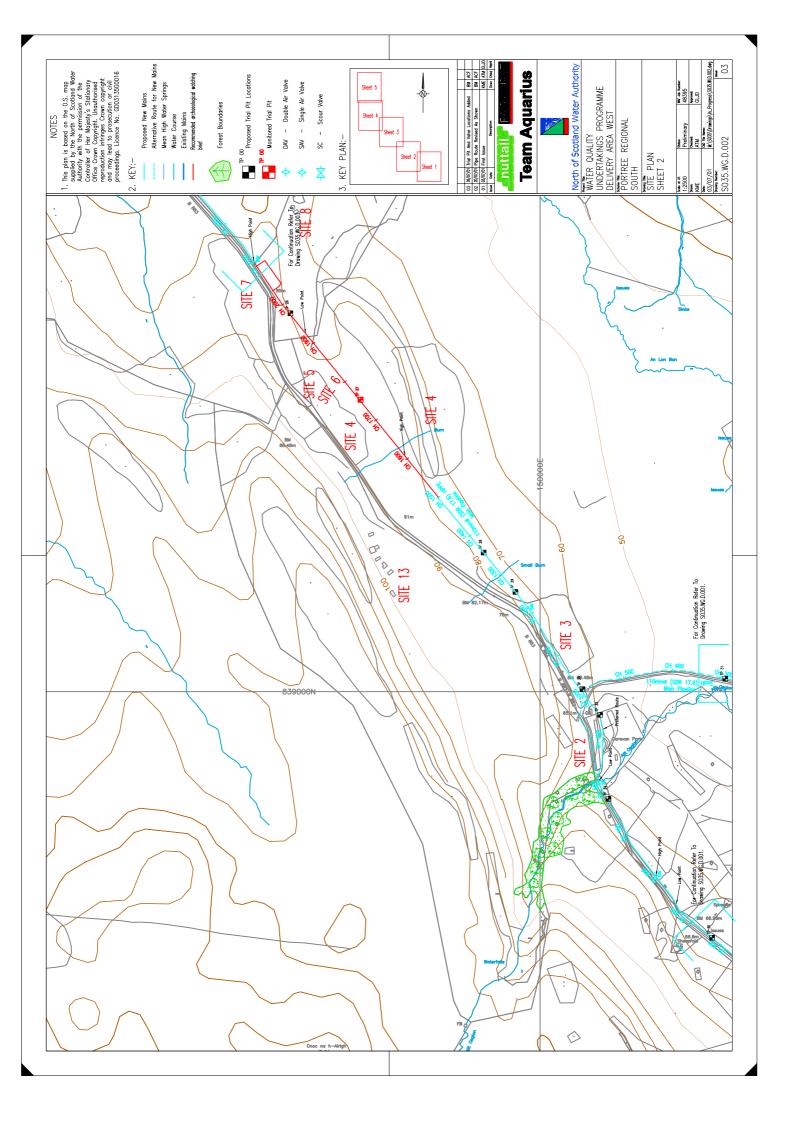
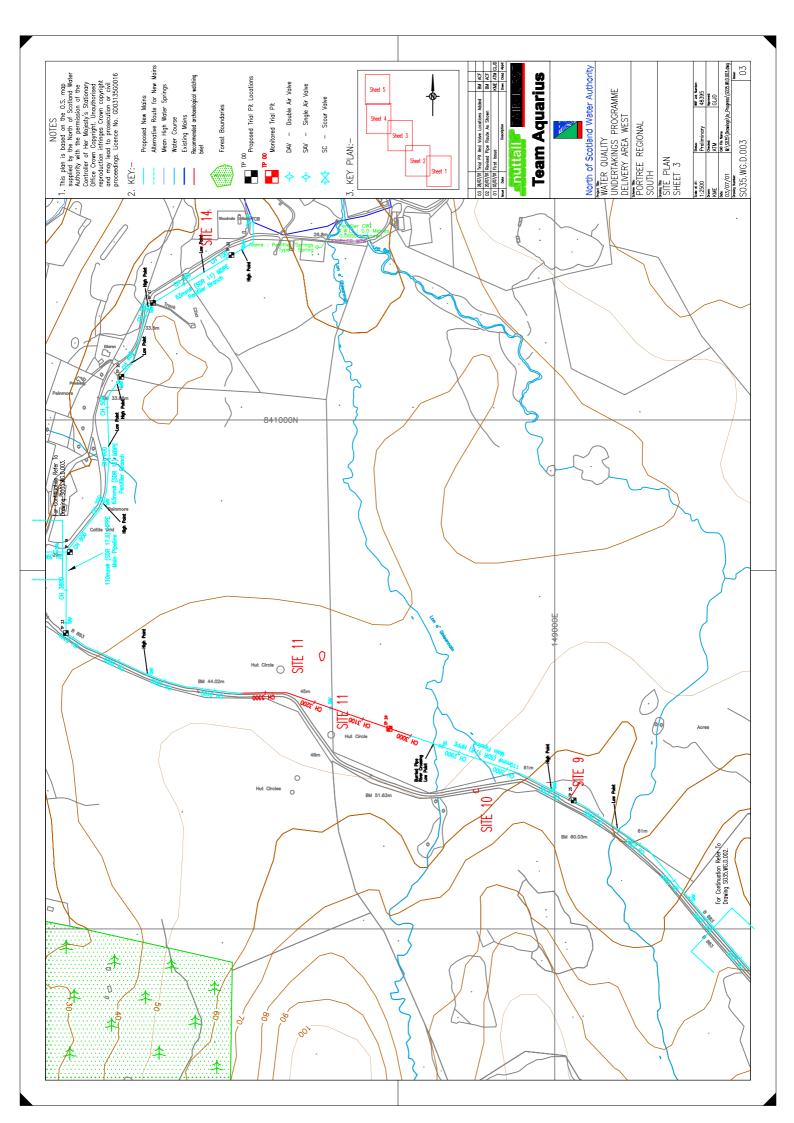
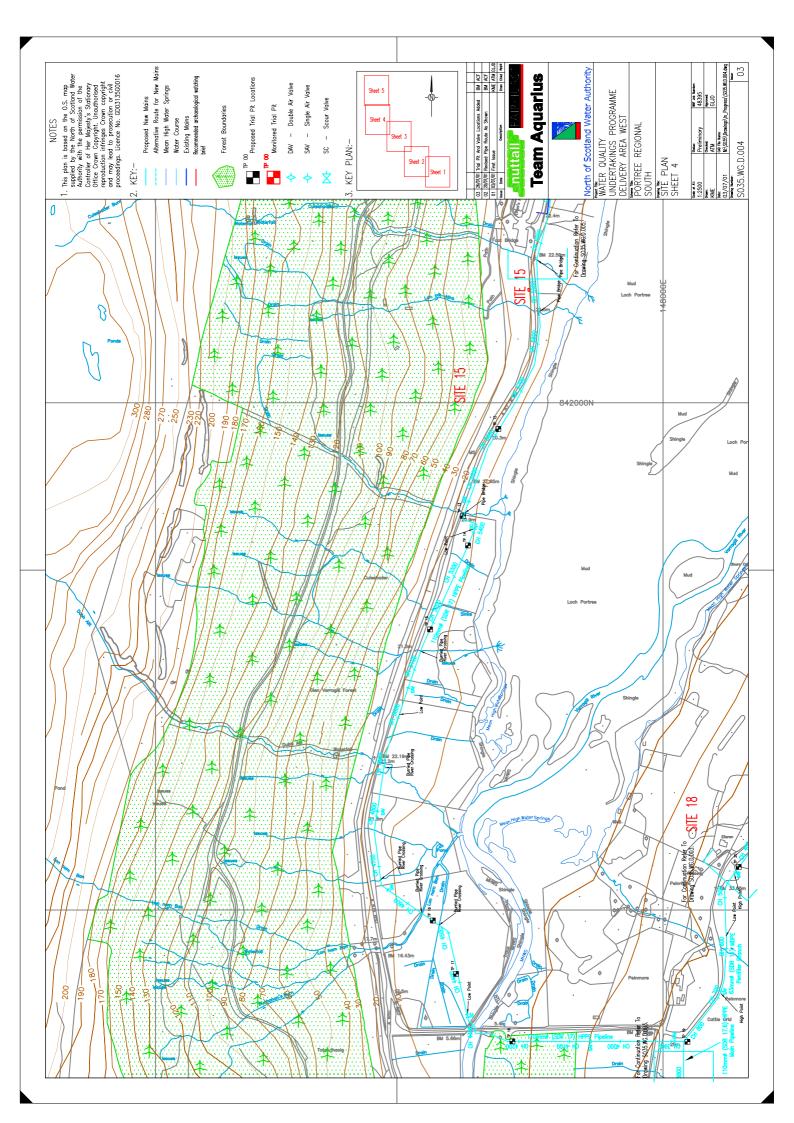
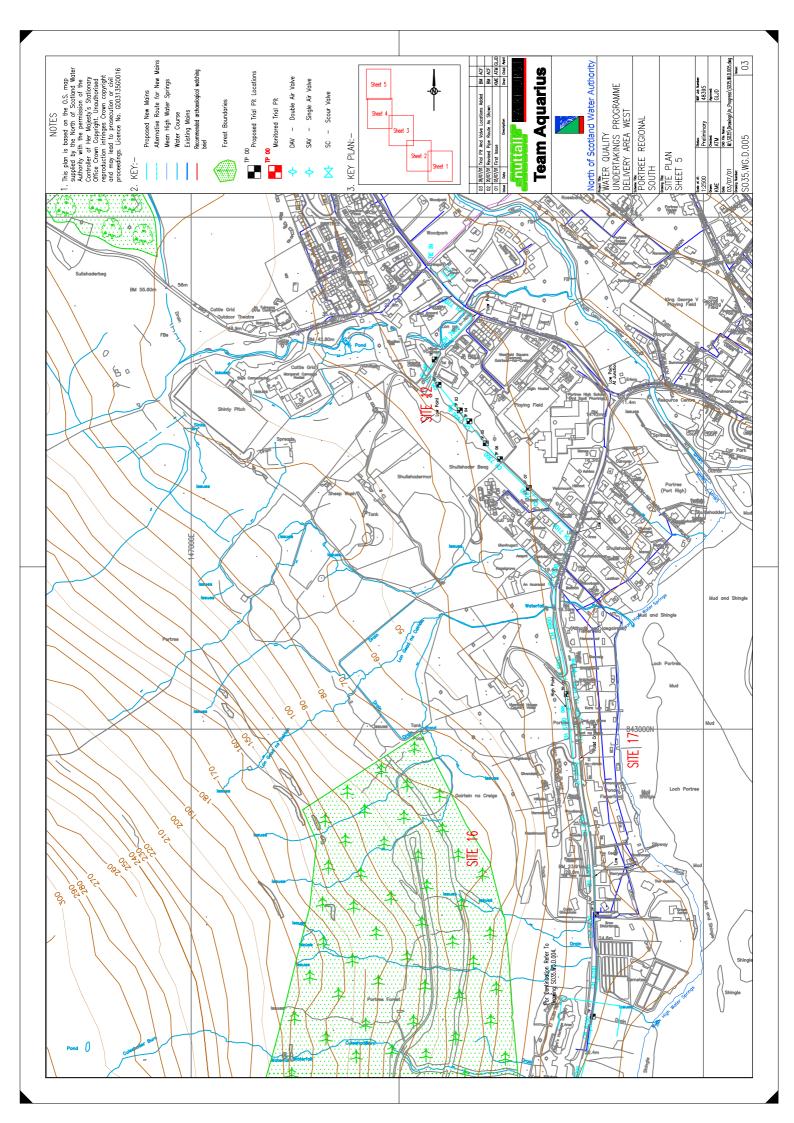
A systematic walk over survey of the route of the pipeline was undertaken in order to identify hitherto unrecognised sites and to record the condition of known sites. The walkover inspected a 12 m corridor where the route crossed farmland. Where the route ran alongside a road 5 m on each side was inspected. The survey was carried out on 23^{rd} , 24^{th} and 25^{th} July 2001. CAD drawings of the route and proposed test-pit locations were supplied by the client and have been annotated with archaeological information by Headland. These have attached as part of this report – **Site Plans Sheets 1-5**.

In light of the results of the desk-based assessment and walkover survey, a watching brief is recommended on certain sections of the pipeline route. The areas requiring a watching brief are marked up on the attached plans – Site Plans Sheets 2 & 3.
