# TRIAL EXCAVATIONS AT STROME CASTLE, WESTER ROSS

G♦U♦A♦R♦D  
184

*Excavations at Strome Castle, Wester Ross, sponsored  
by the National Trust for Scotland, Highland Regional  
Council and the University of Glasgow, carried out by*

# STROME CASTLE 1994

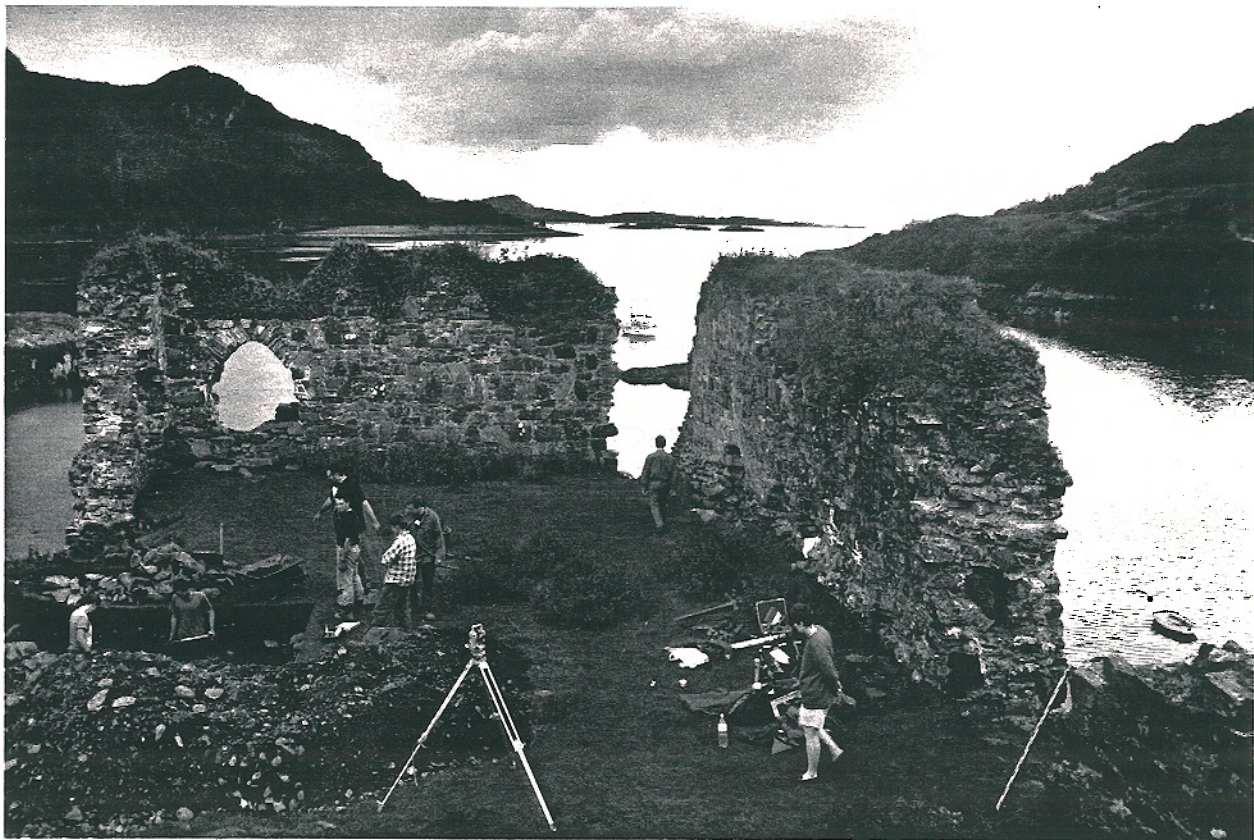
*Figure 2. View of interior of the hall from the tower looking west with Castle Bay to the right.*

3m x 4m x 5m. The interior area of the hall is level and grass covered. It appears to have been cleared of rubble which may have been dumped at the eastern end with the rubble from the tower. Outside the western wall of the hall is a small, level terrace which forms the end of the promontory, which once was within the castle.

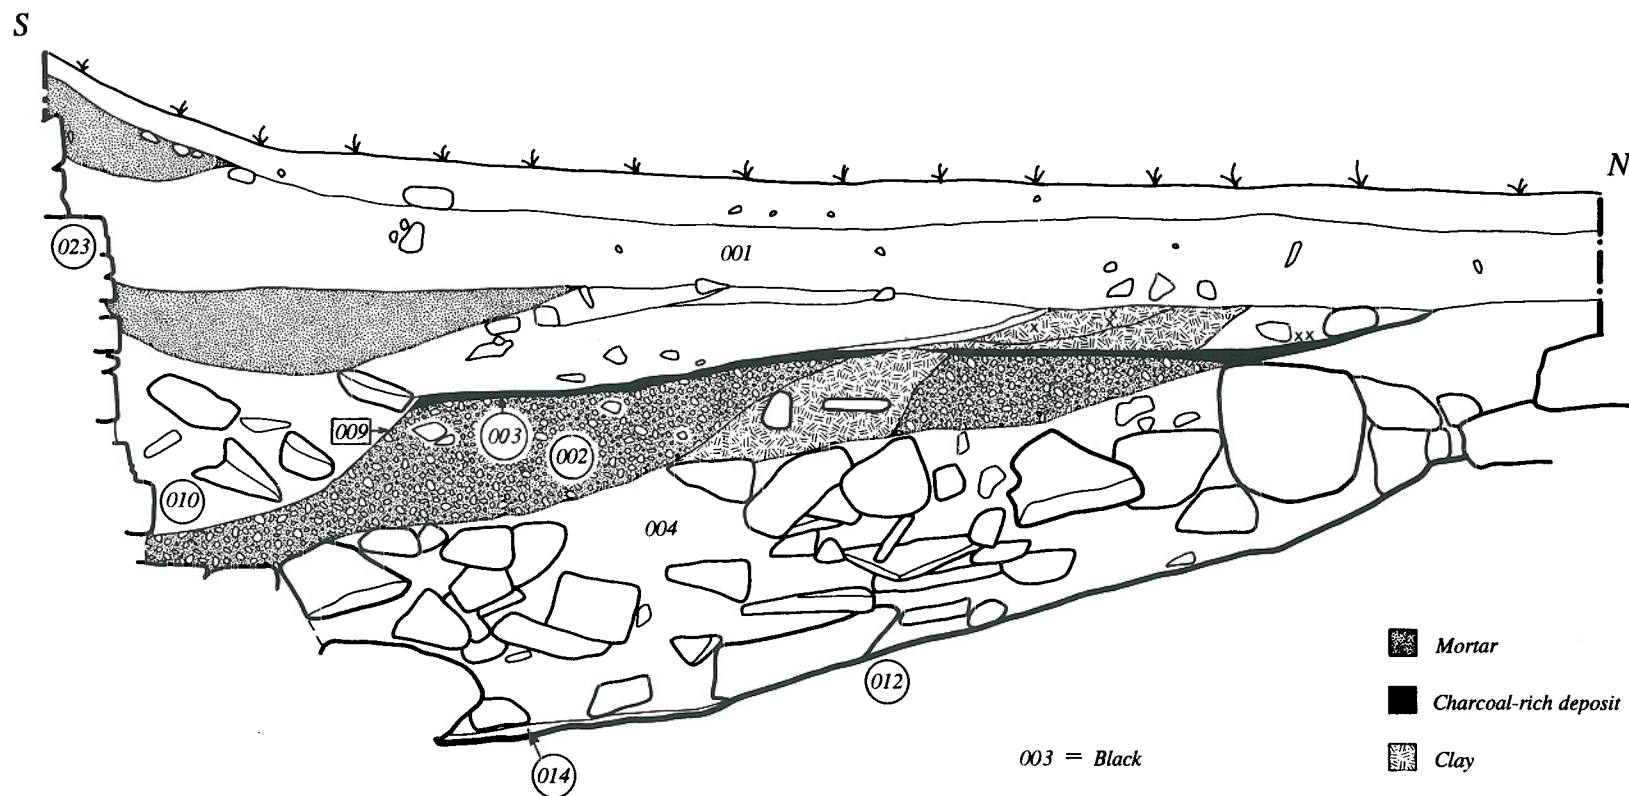
*Trench A East facing section*

**Figure 4 (facing). East facing section in Trench A.**

assess the survival of any floor or occupation deposits within the hall and to look for earlier structures. Removal of the turf and topsoil (001) revealed a layer of rounded cobbles, 5–20cm in diameter (002), which covered the eastern side of the trench. To the west was a setting of large flat stones (003) with slight concentrations of ash and charcoal in their immediate area. This seems to represent a late, short-lived hearth built over the rounded stones and post-dating the main occupation of the castle. After removal of the hearth the cobbles were found to extend over the whole trench. The stones were very loose and irregular, in a coarse gritty matrix and seemed to form no clear surface, rather they had a dumped appearance. They overlay a loose, voided jumble of larger, angular stones (004). No mortar was present amongst these stones and they appear to have been dumped after

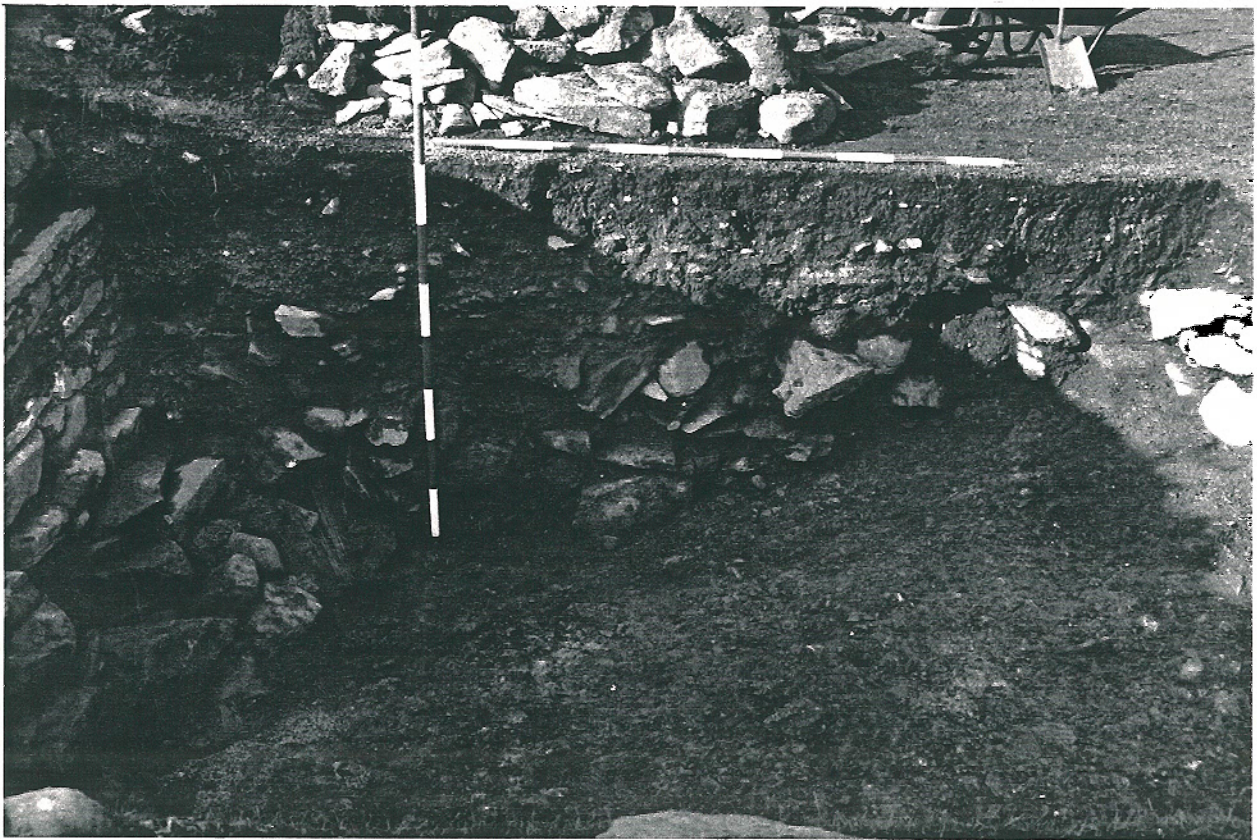
**Figure 5. Photo of east facing section in Trench A.**

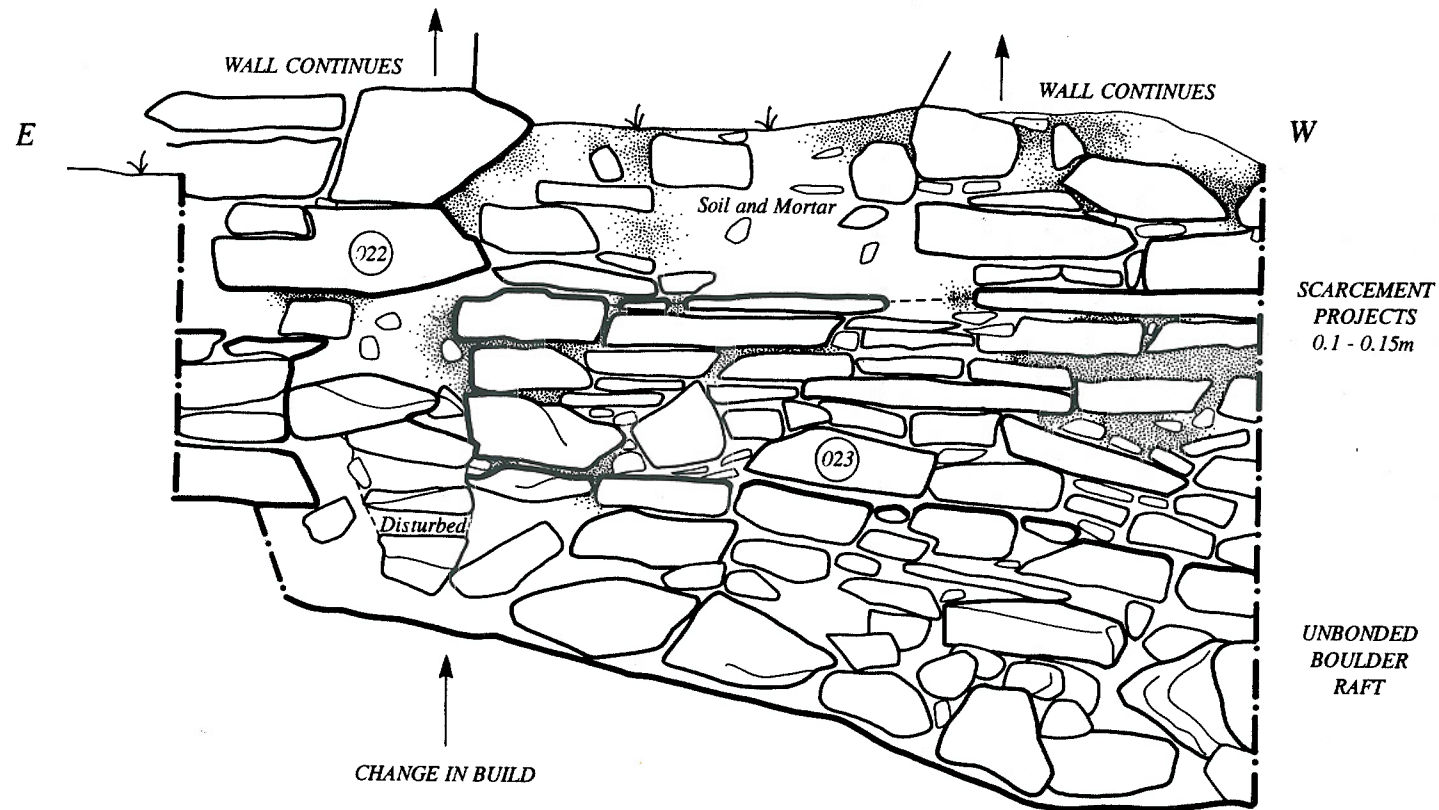
*Trench A Elevation of Interior  
of South Wall of the Hall.*

*Figure 6 (facing). Elevation of inside of south wall of hall in Trench A.*

The two sections of the south wall are not well bonded, but the western section appears to be built upon the earlier eastern foundations. This relationship confirms

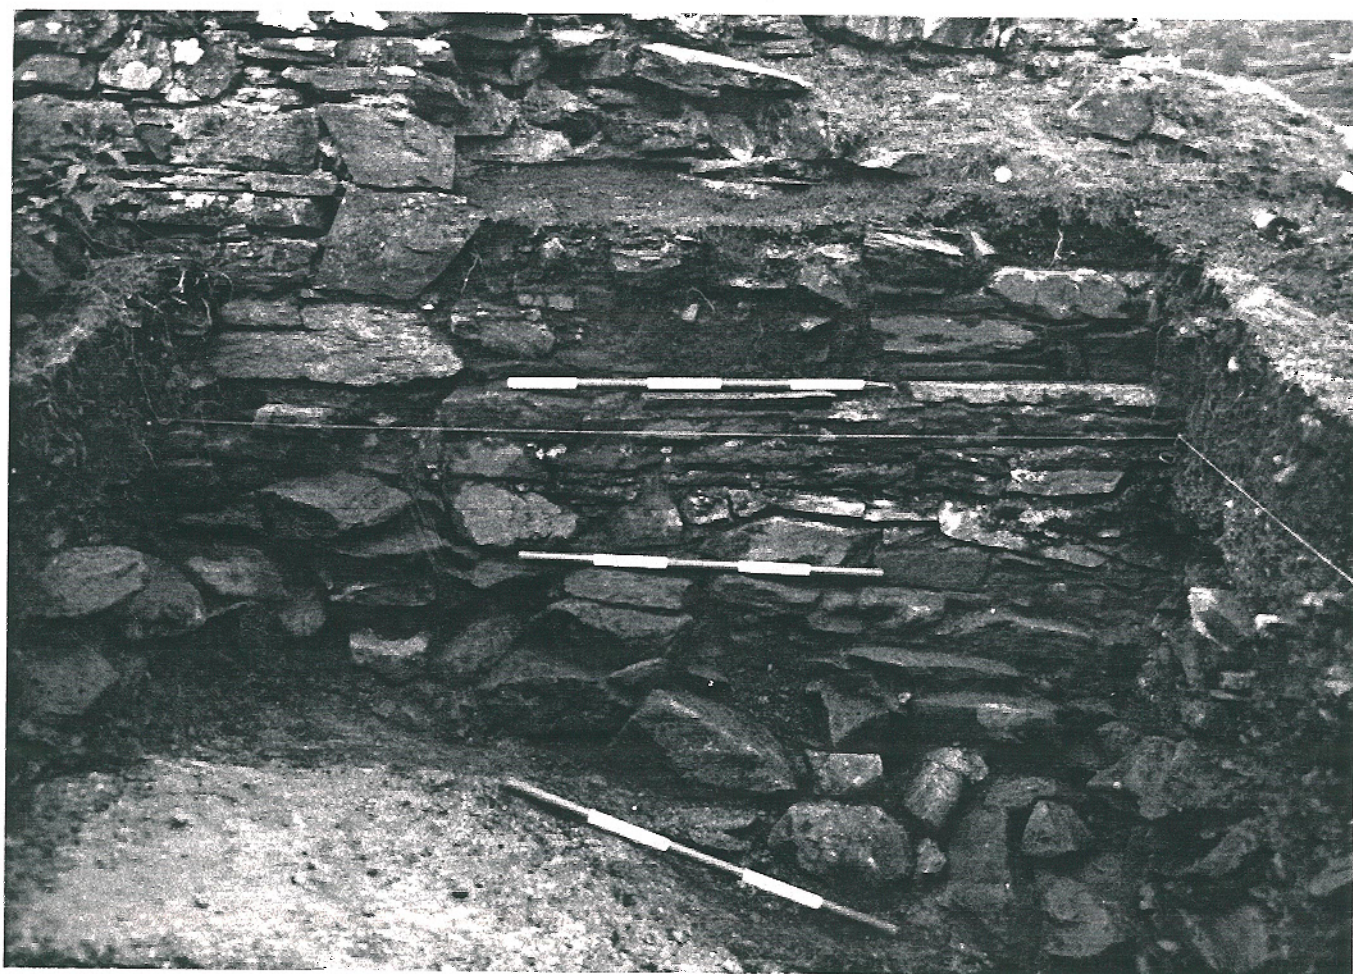
*Figure 7. Photo of inside of south wall of hall in Trench A.*

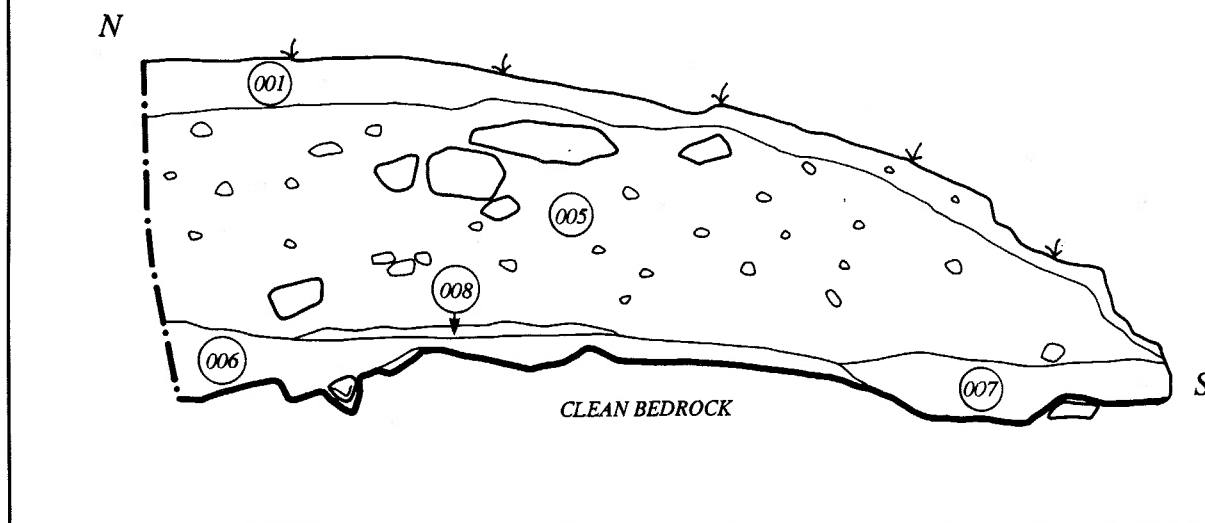
## Trench B West facing section

Figure 8. Trench B, west facing section.

Trench B (2 x 1m) was located outwith the west wall on the nose of the promontory. It was intended to determine the use of this area and to examine any remaining traces of the original structure. The turf and topsoil gave onto a deep (0.60m) layer of mid to dark brown loam (005) containing occasional fragments of rubble and pieces of charcoal. This overlay a lens of cream coloured clay (008) which in turn overlay a layer of fine black silt with charcoal (006) which lay directly on the bedrock. A pocket of yellow sand and mortar (007) to the south of the trench, also lying directly over the natural bedrock may represent all that remains of the foundations of the remainder of the south wall. The original wall appears to have slid off the bedrock. No finds were recovered from this trench.

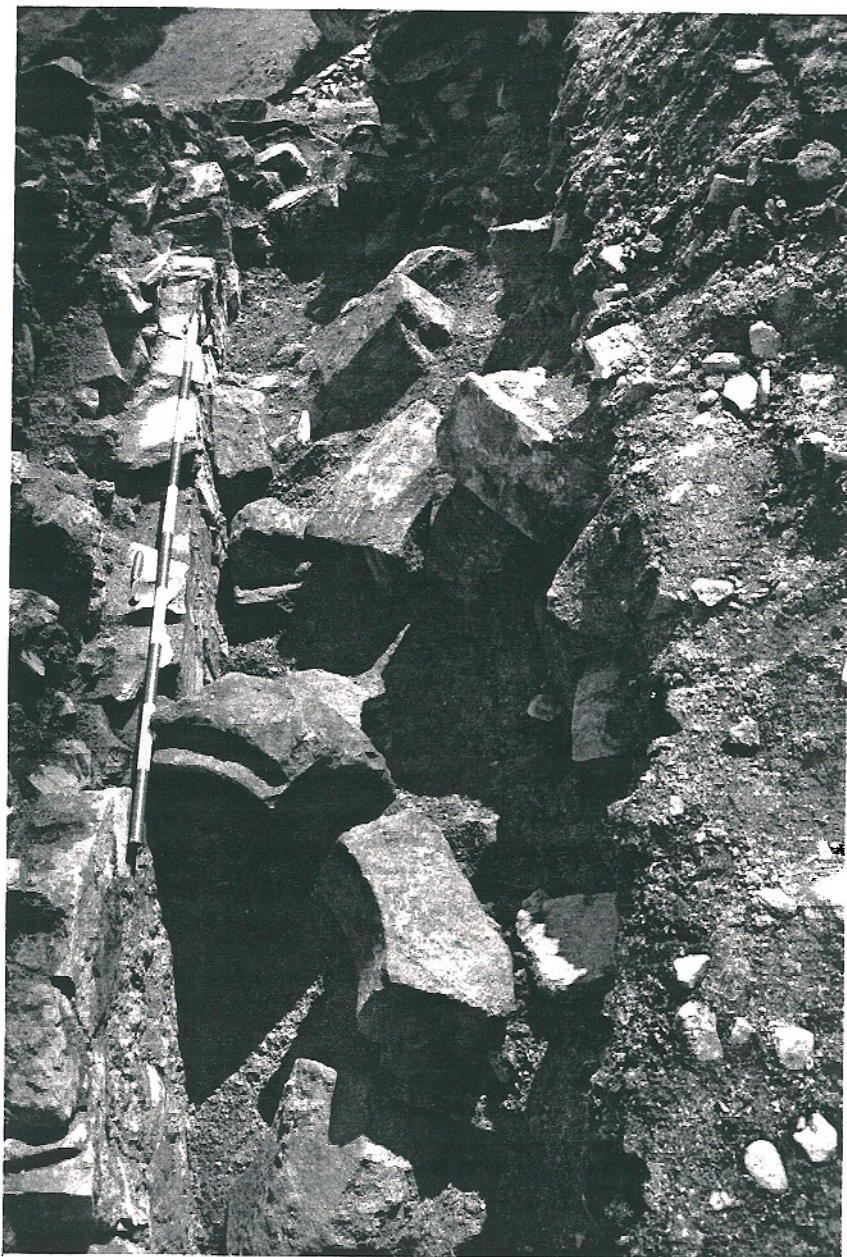
*Figure 10. Photo looking south along the wall face of the tower with collapsed architectural fragments exposed in Trench C.*

A thin layer of turf (015) was removed from the rubble (016) which consisted of a loose deposit of large, angular tumbled schist blocks in a matrix of loose decayed shell mortar. The rubble contained many voids and was excavated to a depth of 1.5m. At a depth of around 1m pieces of a yellow sandstone arch were encountered. Exposure of the tower wall showed that this arch had collapsed from its position over a blocked doorway. The irregular, vertical schist setting proved to be the relieving arch, above and behind the dressed sandstone arch. The entire opening of the doorway consisted of yellow sandstone with a simple, wide chamfer and square rebate. The arch was round headed and was dressed identically to the jambs. The closest source for this sandstone (according to a local resident) is at Applecross, a short sail of about 30 km up the coast to the north.

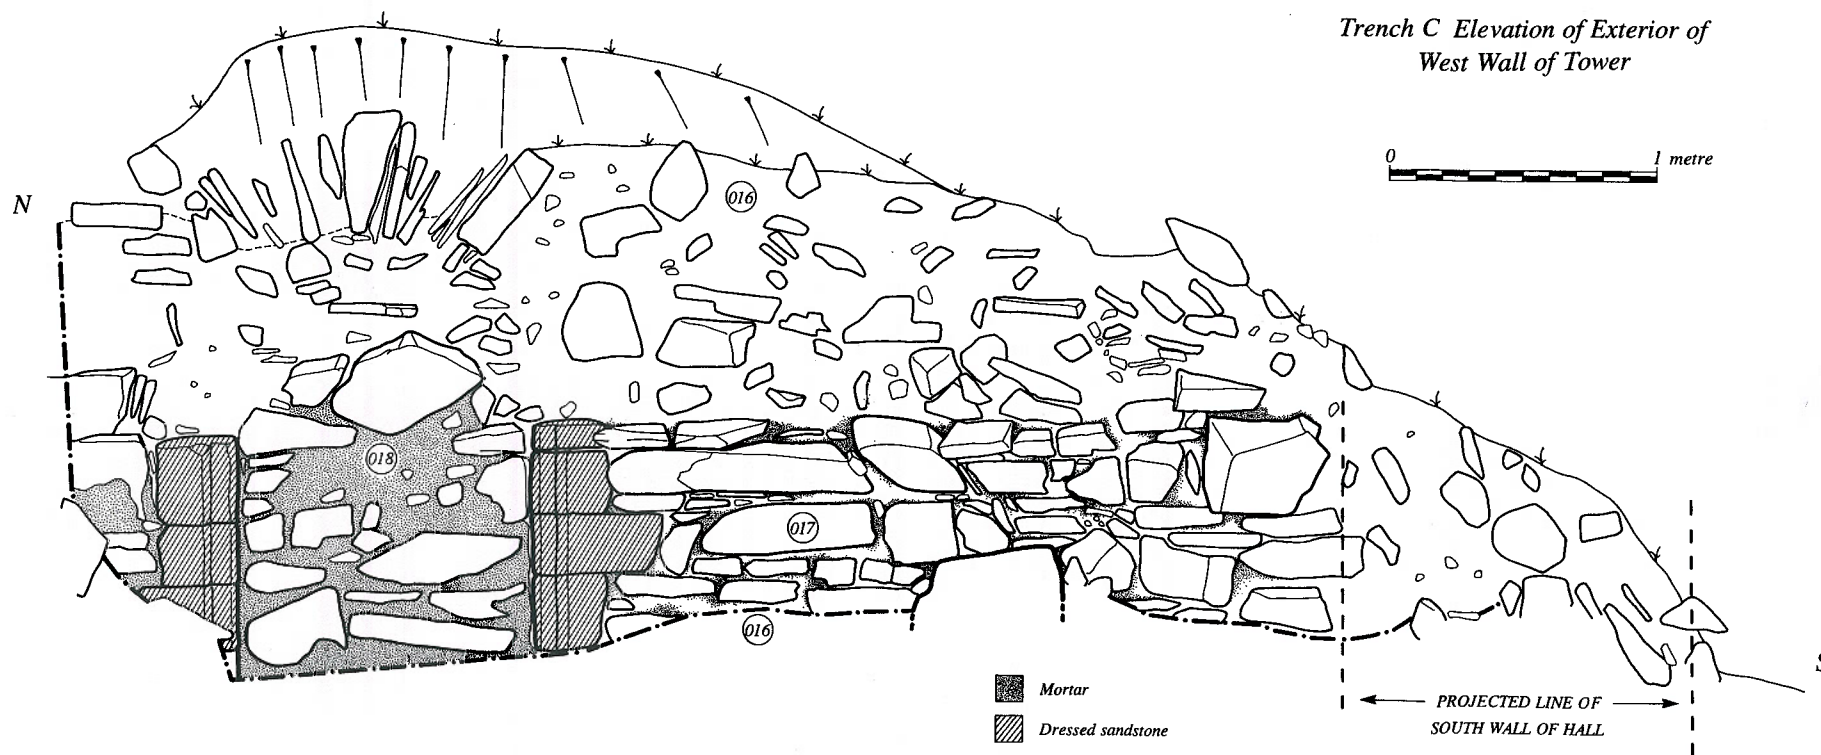
*Trench C Elevation of Exterior of  
West Wall of Tower*

*Figure 11 (facing). Elevation of west wall of tower in Trench C.*

The doorway had been blocked with schist rubble set into mortar (018), which remained solid and hard, indeed the blocking was much firmer than the body of the wall. The wall (017) into which the door was built consisted of schist rubble bonded with a shell based mortar that has become very soft and crumbly. As a consequence the wall face has slumped considerably and leans outwards at an angle of approximately 10 degrees. Unfortunately it was impossible to establish the nature of the relationship with the south wall of the hall, because the tower wall became more collapsed to the south and no trace of the south

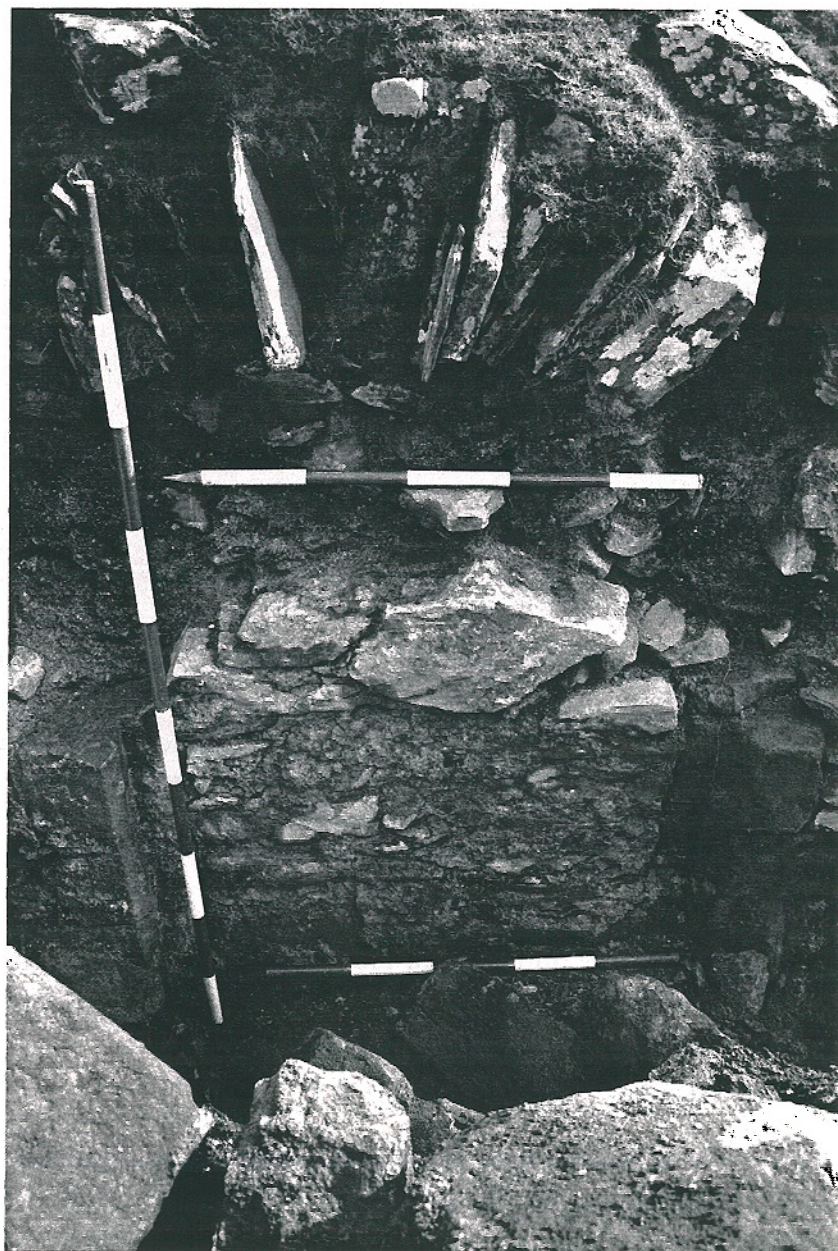
*Figure 12. Photo of blocked doorway to tower in Trench C.*

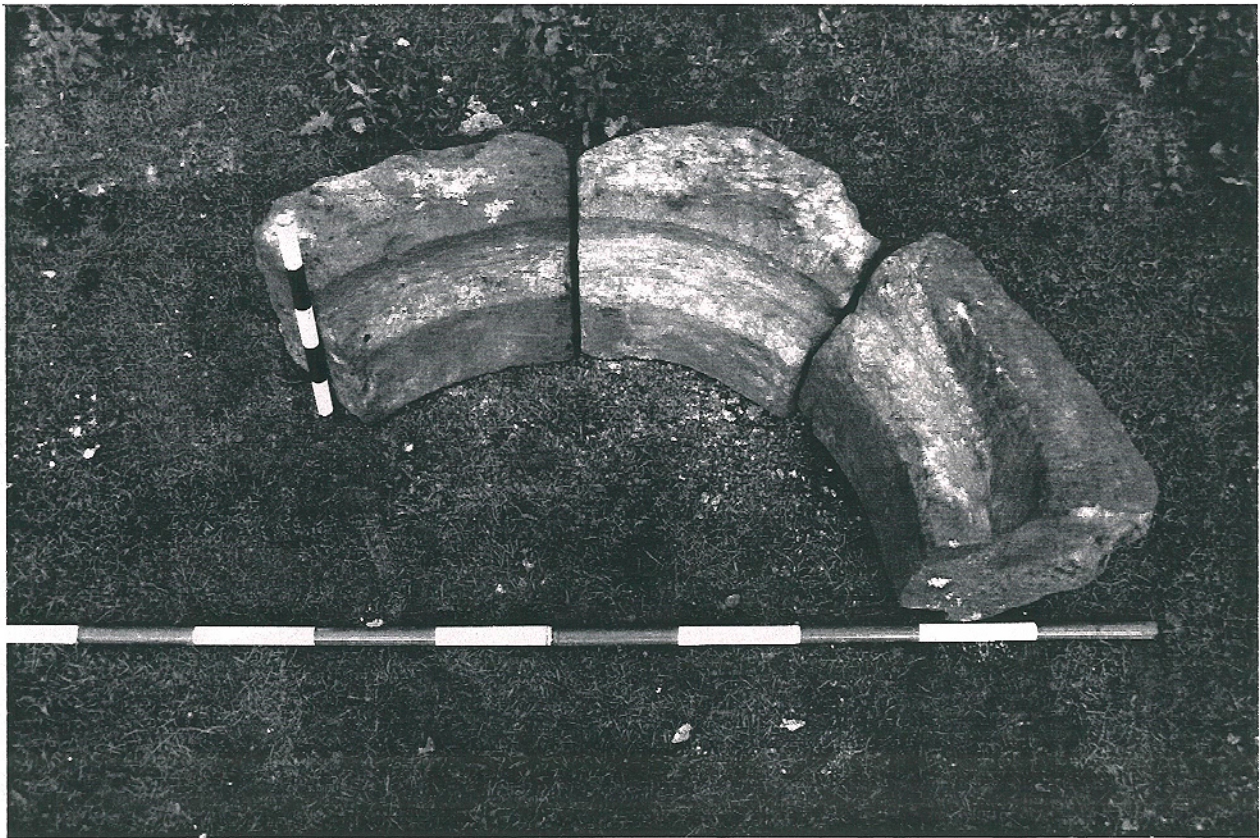
*Figure 13. Photo of back side of the tower doorway arch elements (the back finish was too irregular to allow the stones to be laid out so that the dressed face was visible).*

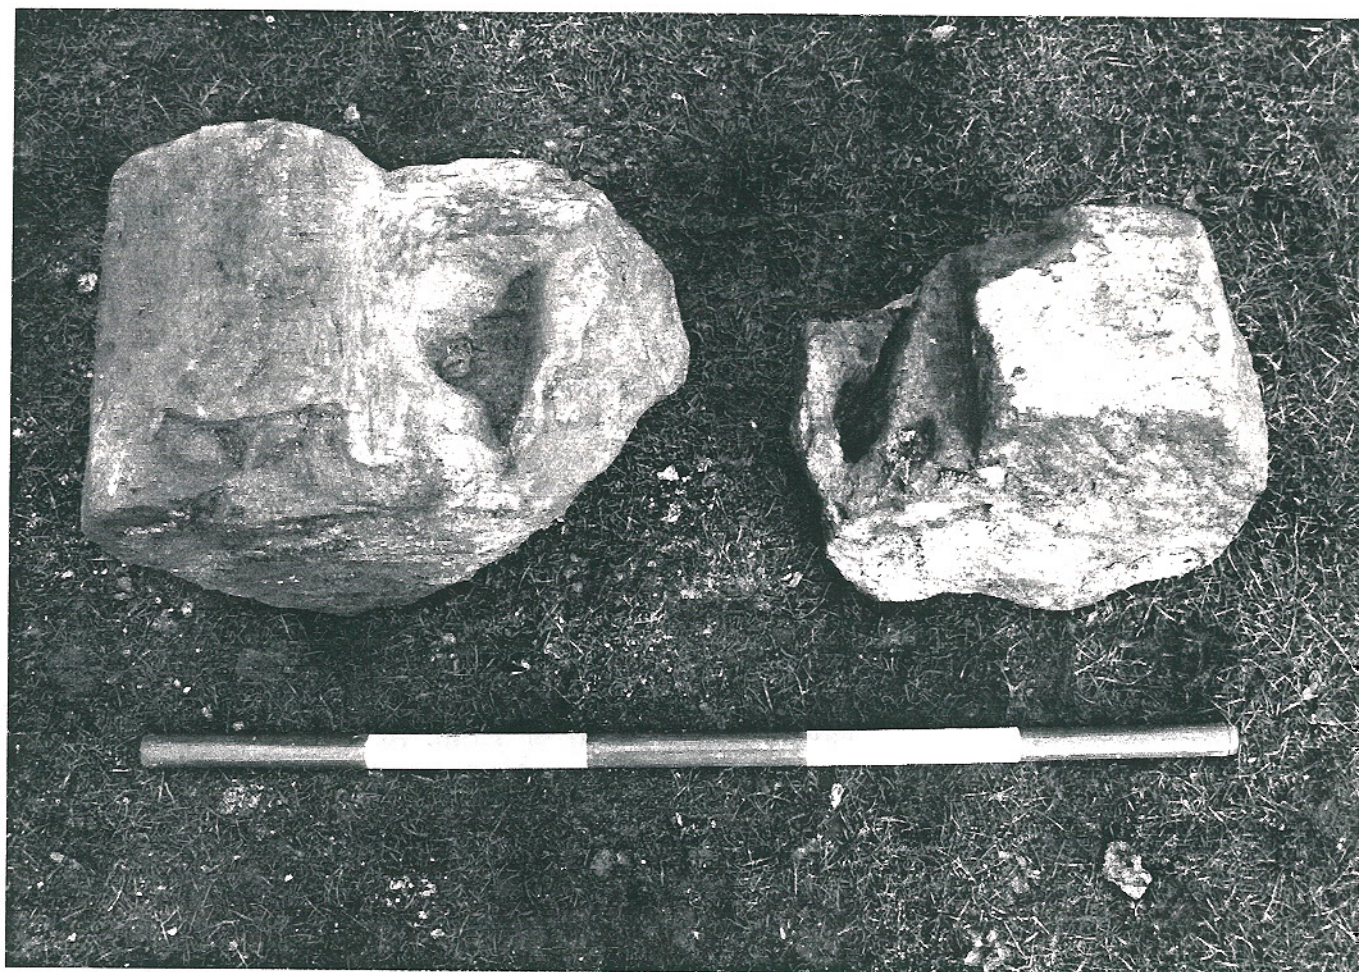
*Figure 14. Photo of window jambs from tower with sockets for iron grills.*

Two fragments of a second sandstone arch were found in the rubble, which had a tighter curve than the arch over the door and lacked the rebate for a door. They must come from a window. In addition two straight fragments of sandstone were found with sockets carved into the moulding, presumably to hold an iron grill. They may be part of the same window.

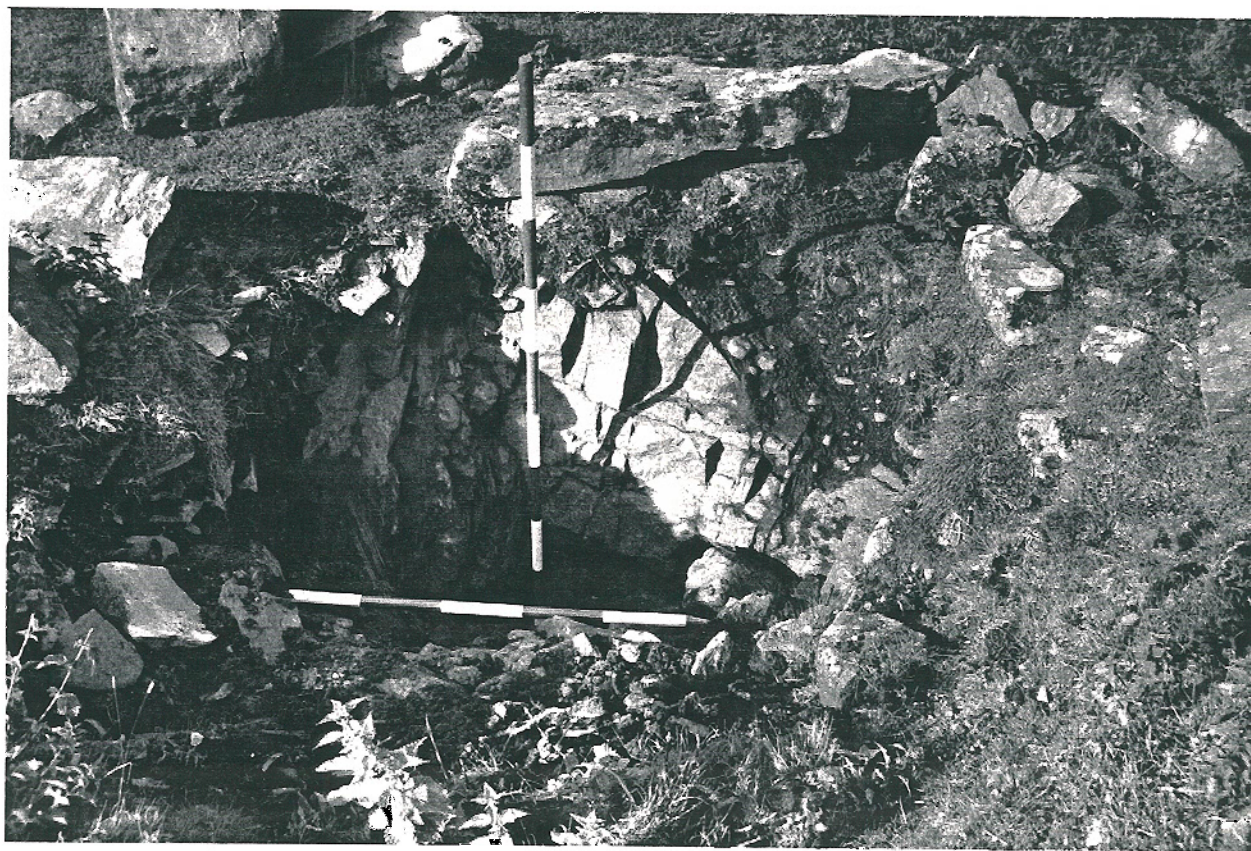
*Sections of Architectural Elements*

*Figure 15 (facing). Profiles of architectural elements from Trench C.*
