**Archaeological Assessment of the route of Power Lines
between Melvich and Armadale, and areas of refurbishment of
Power Lines between Melvich and Kinbrace, Sutherland**

Archaeological Assessment of the route of Power Lines between Melvich and Armadale, and areas of refurbishment of Power Lines between Melvich and Kinbrace, Sutherland

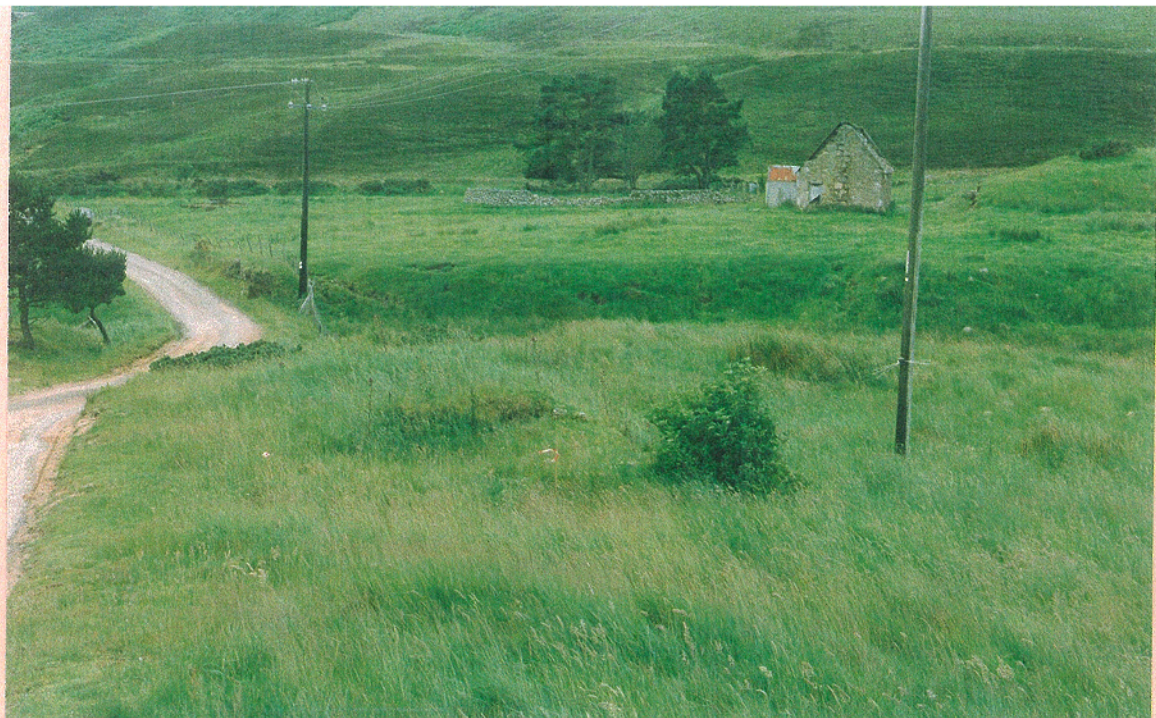
①

Pole 22, Achridigill Township at NC 8887 6292. Most of the buildings of this depopulated township are grouped on either side of the Achridigill Burn, but one building is located to the NE of the main group, beside the road. It is visible as low rubble footings, aligned NNE-SSW. It lies between Pole 22 and the road, far enough from the pole to be unaffected by stay wire changes, although any future pole change may affect associated archaeological features.

1. Pole 22: Achridigill. Footings of building between Pole 22 and the road
2. Pole 41: Cnoc Chorkael, farmstead and enclosure: Turf dyke of enclosure is visible in the foreground directly in front of Pole 41

This feature was marked with canes to prevent accidental damage from any vehicles gaining access to the pole.

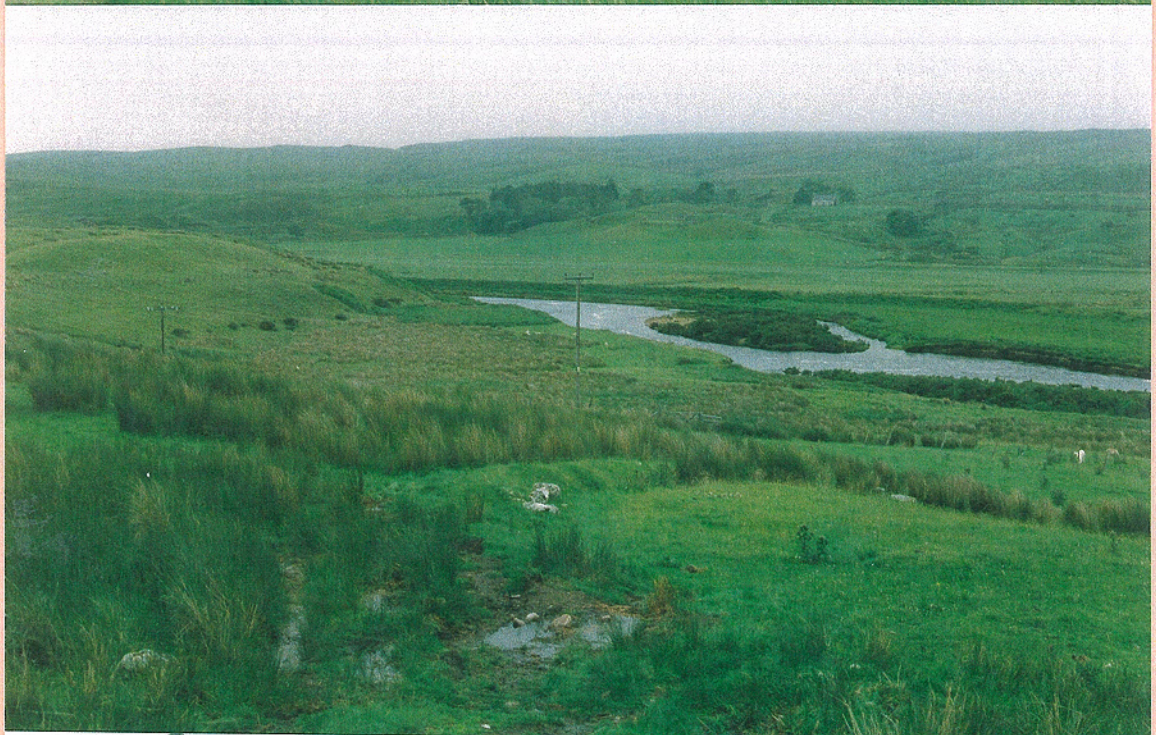
②

Pole 41, Cnoc Chorkael, Farmstead at NC 897 618, SMR no. NC86SE0045 and Golval, Enclosure at NC 8975 6200, SMR no. NC86SE0037 These two recorded archaeological features lie between Pole 41 and the road. The obvious access route from the gate on the road by the sheep fank, passes between the two features but on a recognizable track, and at the narrowest point the two are 20m apart. Both are fairly visible features, the farmstead consisting of low rubble footings and the enclosure being a substantial turf and stone dyke. It is unlikely that either feature will be affected.

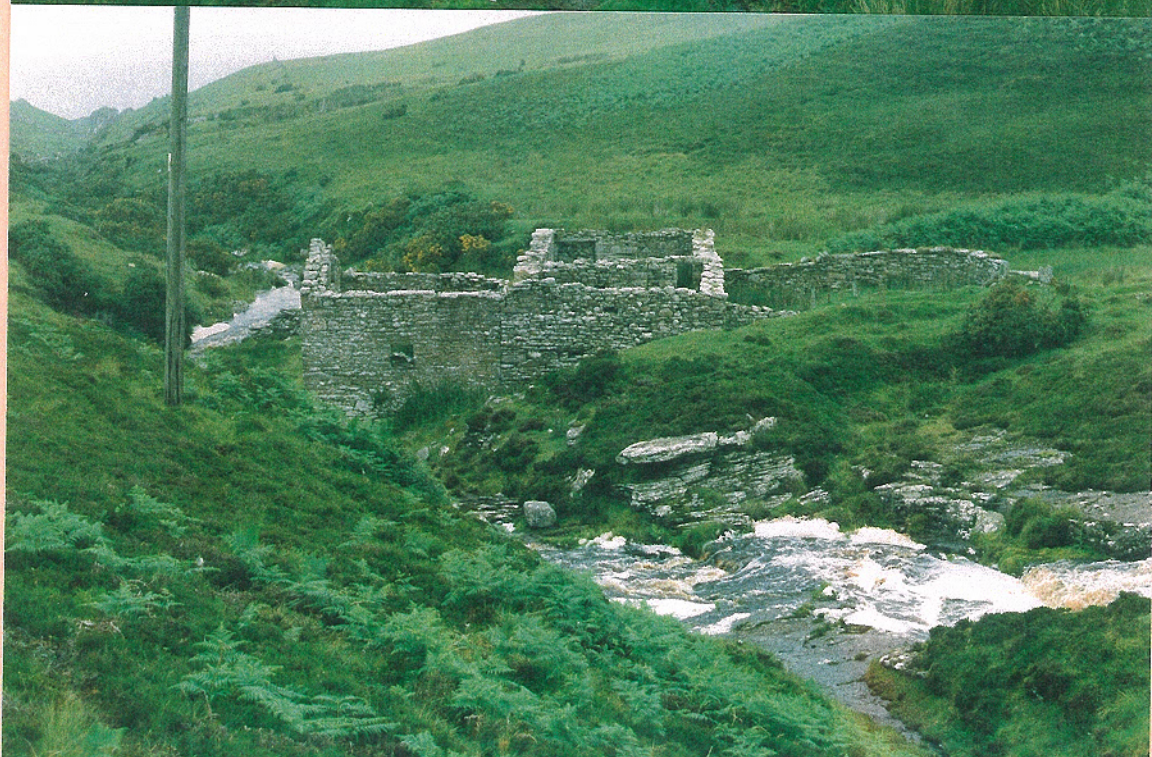
③

Poles 53-54, Baligill, 19th century Carding Mill at NC 8552 6567, SMR no. NC86NE0005, Scheduled Ancient Monument The substantial ruins of this mill are located approximately 30m north of where the power line crosses the Baligill Burn. The mill lade leaves the burn via a sluice at a point where the burn is crossable, and these are not very visible features, but the steepness of the banks make it unlikely that vehicles will attempt to take a direct route from one pole to the next. It is also unlikely that any refurbishment work will require to enter into the Scheduled area.

3. Pole 54: Baligill Mill
4. Poles 53-54: Baligill Mill, sluice and lade to the right of the stream.
5. Pole 59: Baligill, Limekiln
6. Dallangwell Pole 23: Cnoc na Leanaig Cairn.
7. Dallangwell Pole 23: Cnoc na Leanaig Cairn.
8. Dallangwell Pole 37: Dail Teine Settlement, structure is on the mound behind and to the right of the pole.
9. Poles 52-58: Armadale Burn Settlement, hut circle and cairn on one possible access route to these poles.

It is recommended that no crossings of the burn be attempted by vehicles to avoid accidental damage to the sluice and lade. The two poles should only be approached from their respective sides of the Baligill Burn

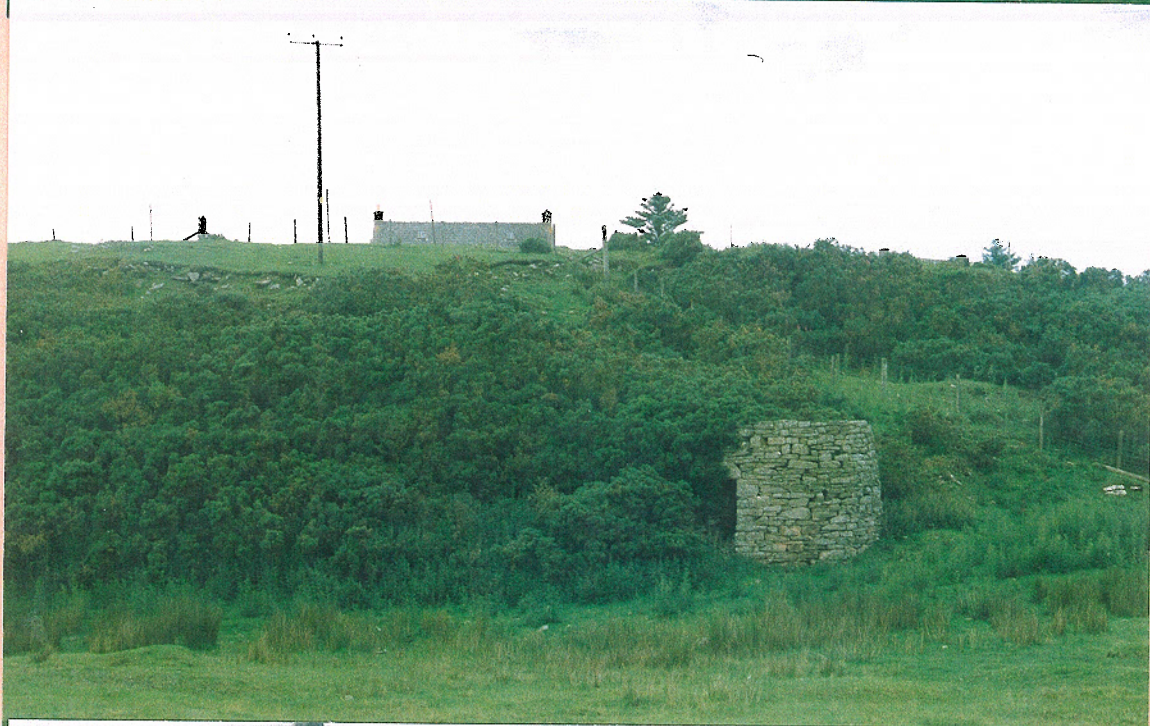
⑤

Poles 58-59, Baligill limekilns at NC 8516 6567, SMR no. NC86NE0007. The most substantial ruined limekiln is built into the steep bank below and to the east of pole 59. The steepness of this bank makes it much more practical to gain access to this pole from the west. The other kilns are located to the south of the power line and the road and should not be affected. There appear to be no associated features by Pole 58 on the other side of the road.

It is recommended that care be taken during any refurbishment work on Pole 59 to prevent material or rubble from rolling down the bank onto the kiln, thus causing accidental damage, and to prevent any damage to the bank itself which might weaken the structure of the kiln.

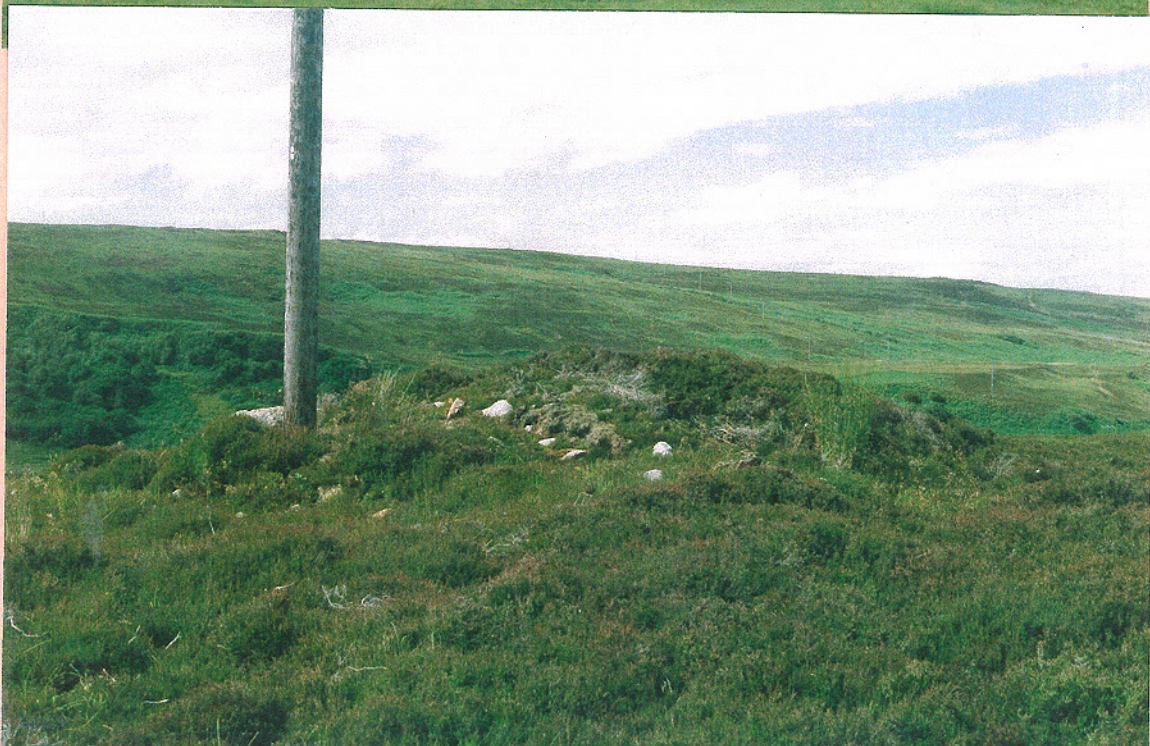
⑥

Dallangwell Branch Pole 23, Cnoc na Leanaig Gile, Cairn at NC 8371 6430, SMR no. NC86SW0007 This pole has been inserted into the edge of the cairn and it appears that material from the cairn has been removed to pack the pole upright. The cairn itself is low, a mixture of stones and peat standing on a low rise above the River Strathy. Although described as a possible Neolithic cairn, it is also possibly a large clearance cairn, as the area immediately to the north of the cairn is level and well drained and may have been a small prehistoric cultivation plot.

It is recommended that when the time comes to replace this pole, a new location is selected to the south of its present position. The existing pole should then be cut off at ground level to avoid any further damage to the cairn. No material should be removed from the cairn or from around the existing pole. It may be considered necessary for an archaeologist to be present if any excavation work is carried out in this area, in order to ascertain whether any further archaeological features are present in the vicinity.

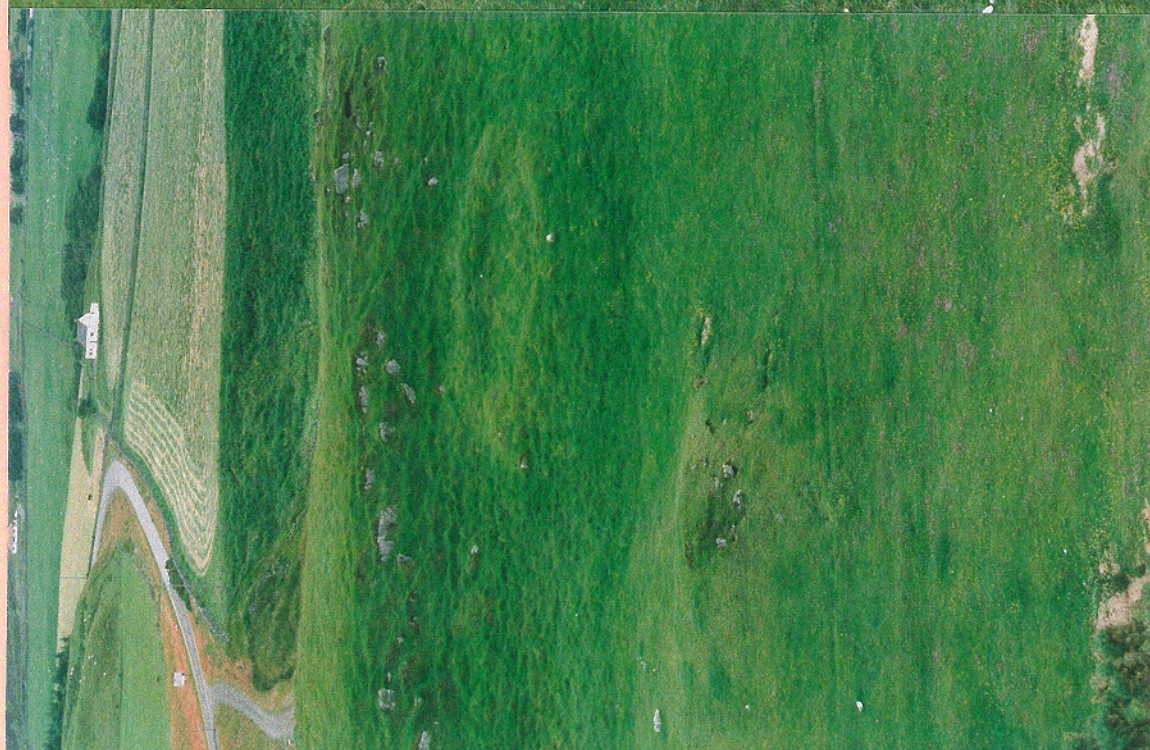
⑨

The settlement of four hut circles and associated features is located south of the power line, occupying the sheltered grassy hollows between rocky ridges. The route of the power line here is up a steep bank of rocky ridges and eroding sand, and no visible archaeological features were located. It was felt that it was unlikely that there would be any concealed prehistoric features in this steep terrain. It is possible that a direct access route from the road to the south to the power line might be considered, but this would pass through the prehistoric features. At the base of the bank, the power line crosses the Armadale Burn. There is no vehicular crossing point apart from the present road bridge, and possibly the beach to the north at low tide. If the approach were to be from the beach, it should be noted that a longhouse is located on the east bank of the burn just south of the footbridge, visible as low grass-covered footings.

It is recommended that the access route to this section be carefully considered to avoid the archaeological features to north and south. The best route from this point of view is probably following the power line down from Lednagullin. If this proves impractical because of the steepness of the slope, the route from the road or the beach would have to be investigated in more detail, and archaeological features marked to avoid damage from vehicles.
