**Archaeological Watching Brief on Landscaping and
Construction of Pathways and Laybys at East Street,
Balintore, Easter Ross
(Planning Application 03/00218/FULRC)**

Archaeological Watching Brief on Landscaping and Construction of Pathways and Laybys at East Street, Balintore, Easter Ross (Planning Application 03/00218/FULRC)

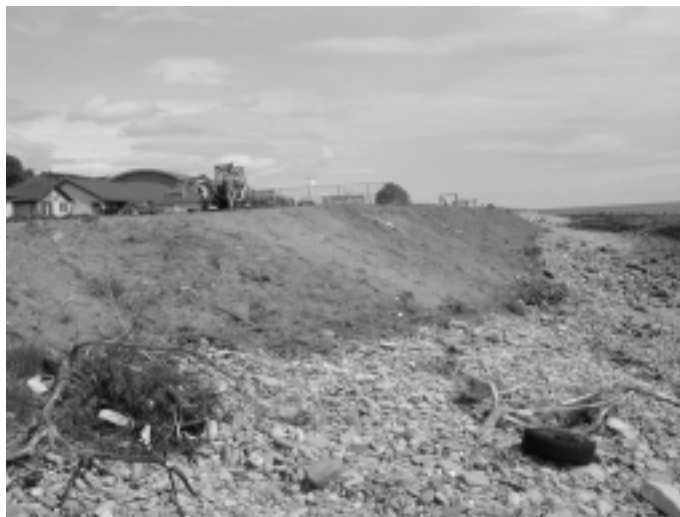
The present development covers two areas of roughly similar size (Areas A and B) separated by a bungalow, between the road and the shoreline. The building up of the shoreline with quarry spoil and rubble (see above) has resulted in the ground level on the seaward side being considerably higher than the natural **(Photo no. 1)**

1. Area A. View NE from shore showing height of bank of landfill material.

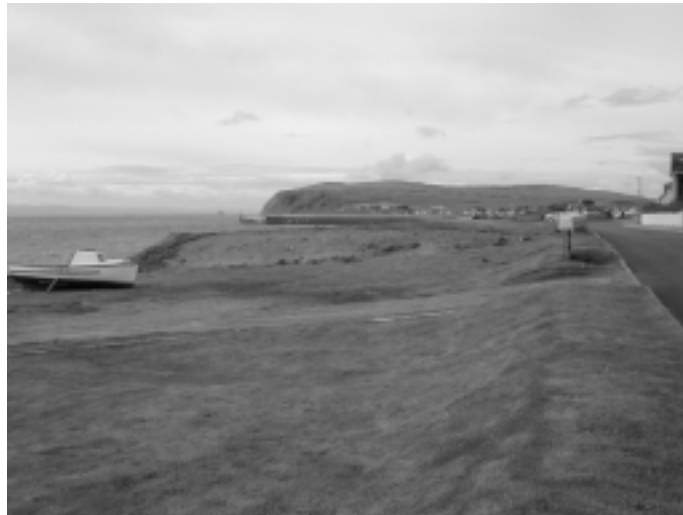
The site has recently been cleared of vegetation, leaving substantial gorse roots. The only visible features are, in Area B, the concrete foundations of a modern building associated with the builder's yard, and indications of sewage pipes and other underground services running parallel to the road.

2. Area B: level, built up, area behind the grassy foreground, view from NE.

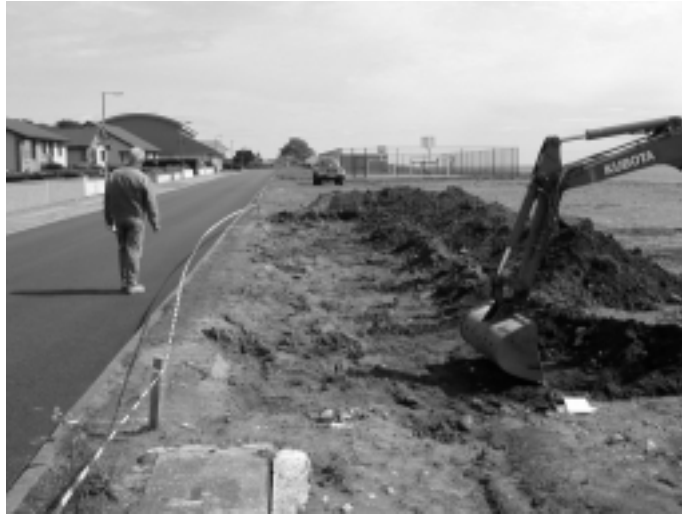
The removal of 30cm of material from the area of the layby in Area A possibly revealed the top of a layer of natural sand shelving down from the road edge (Photos no. 3 and 4) visible as a line of clean, pale sand approximately 1.6-1.9m from the kerb. This was not observed at the layby in Area B and the footpath work did not go deep enough to touch a lower layer.

3. Layby, Area A. Stripping of topsoil to a depth of 0.3m, view from SW

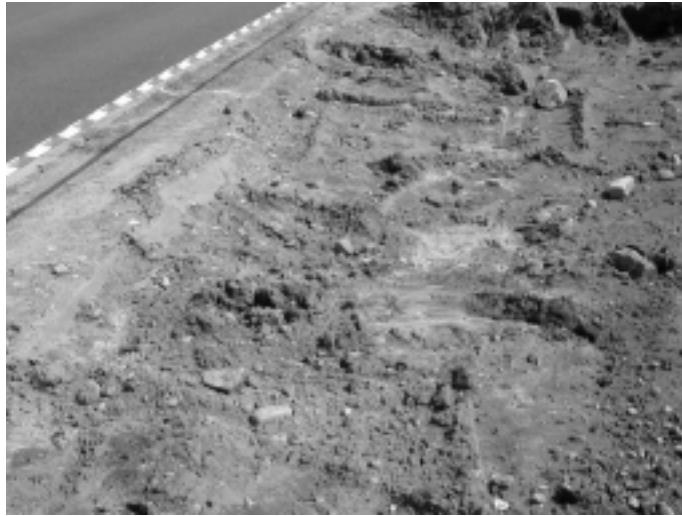
4. Layby, Area A. Lighter sand indicating the possible natural surface at a depth of 0.3m

It is recommended that, while archaeological monitoring would be advisable where any excavation is likely to extend deeper than 0.3m on the road side and possibly 2m at the sea side, it would not be necessary or useful to monitor shallow work such as further laybys or footpaths, where it is obvious that the ground is similarly made up of landfill material.

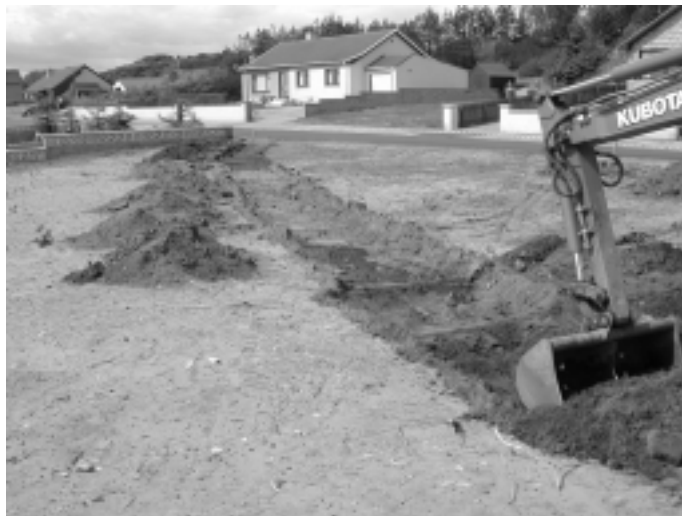
5. Area A. Footpath, topsoil stripping to a depth of 10-15cm, view from east.
