**Report of Archaeological Watching Brief  
August 7<sup>th</sup> – 29<sup>th</sup> 2003  
Tullich Water Supply Project.**

Client: Halcrow Group Ltd on behalf of Scottish Water

**By  
Stuart Farrell  
B.A A.I.F.A F.S.A.Scot.  
September 2003**

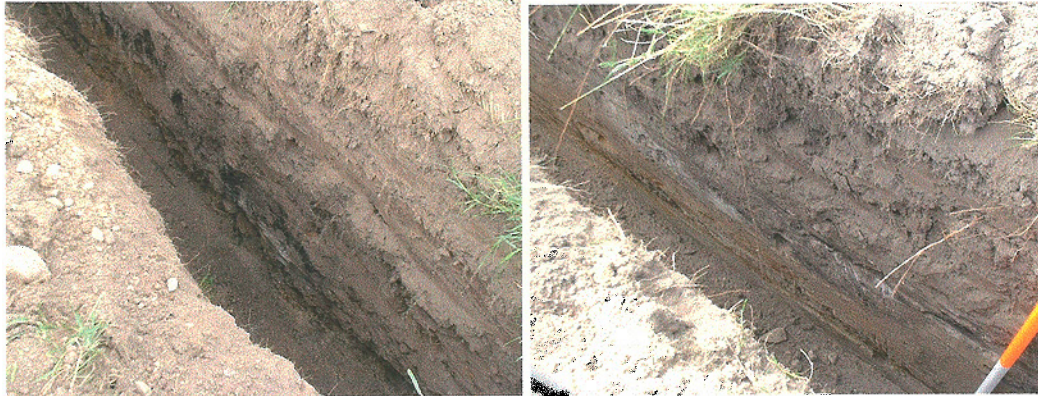
1<sup>st</sup> at NH 74138/72707 on south facing section at a depth of 600mm 20.5m w from turn of corner. (Trench not wide enough for access) Partial cleaning revealed it to be a possible dumped deposit of charcoal or possibly the edge of a hearth as burnt sand below. Deposit 200mm in depth and 350mm wide and concave in section. Not visible on north facing section of trench.

2<sup>nd</sup> at NH 74134/72682 of possible shallow scooped pit at a depth of 600mm of 1.3m wide and 200mm depth composed of lenses of white sand, charcoal and

subsoil. Looks possibly like an in-filled natural depression (Trench not wide enough for access). Not visible on west facing side of trench.

Left: View of possible feature no.1.

Right: View of possible feature no.2 – scale 1m.

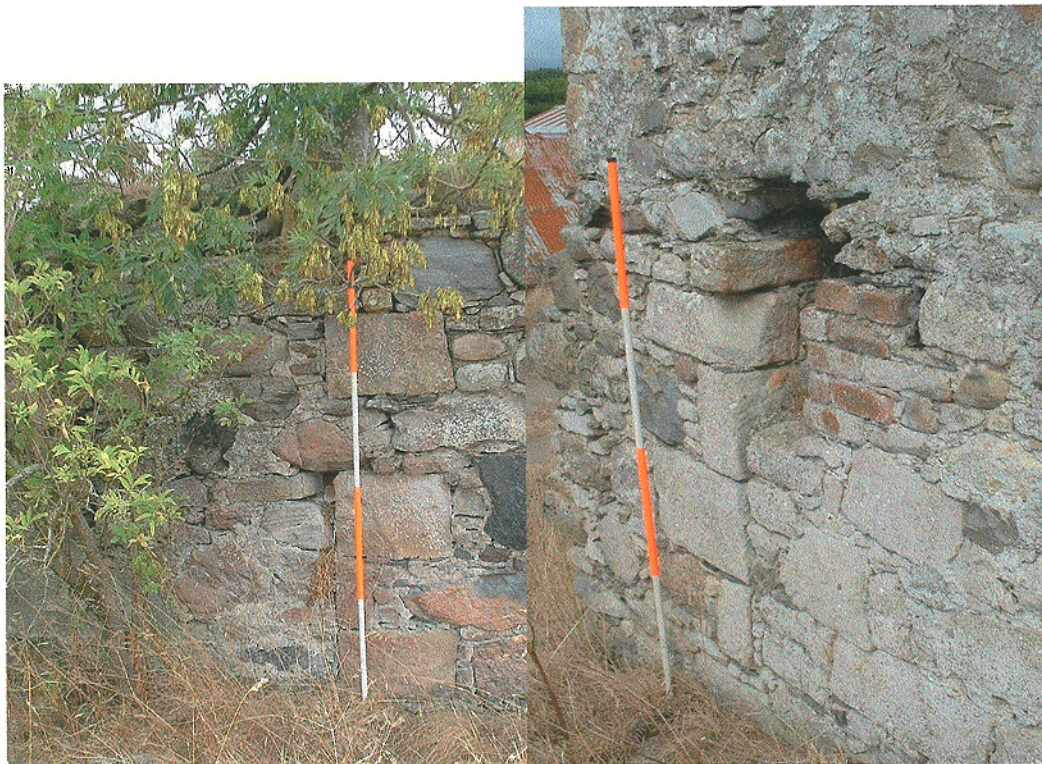
Work revealed no archaeological deposits or features of interest, a small dump of early 20<sup>th</sup> century glass and pottery was revealed at NH 73511/7266, probably relating to the occupation of Delny Cottages though road level here was raised when adjacent silage pit was constructed as former road level was visible in section. One feature of interest was noted at NH 73531/72230 - centred (to the south edge of the work) of a partly walled enclosure (?) though it was difficult to ascertain if it was originally a walled garden as it sits higher than the farm. It had 2 blocked up doorways one to the N and the other to the NW to its NW corner that has traces of an arch. In the west facing section of the trench to the entrance to Delny House was revealed a small of stretch of medium to large stones at a depth of 400mm possibly the remains of a wall footing, though it was not very level and was only revealed for a length of about 5m.

Left: View of N facing blocked up doorway – scale 2m

Right: View of NW facing blocked up doorway – scale 2m.

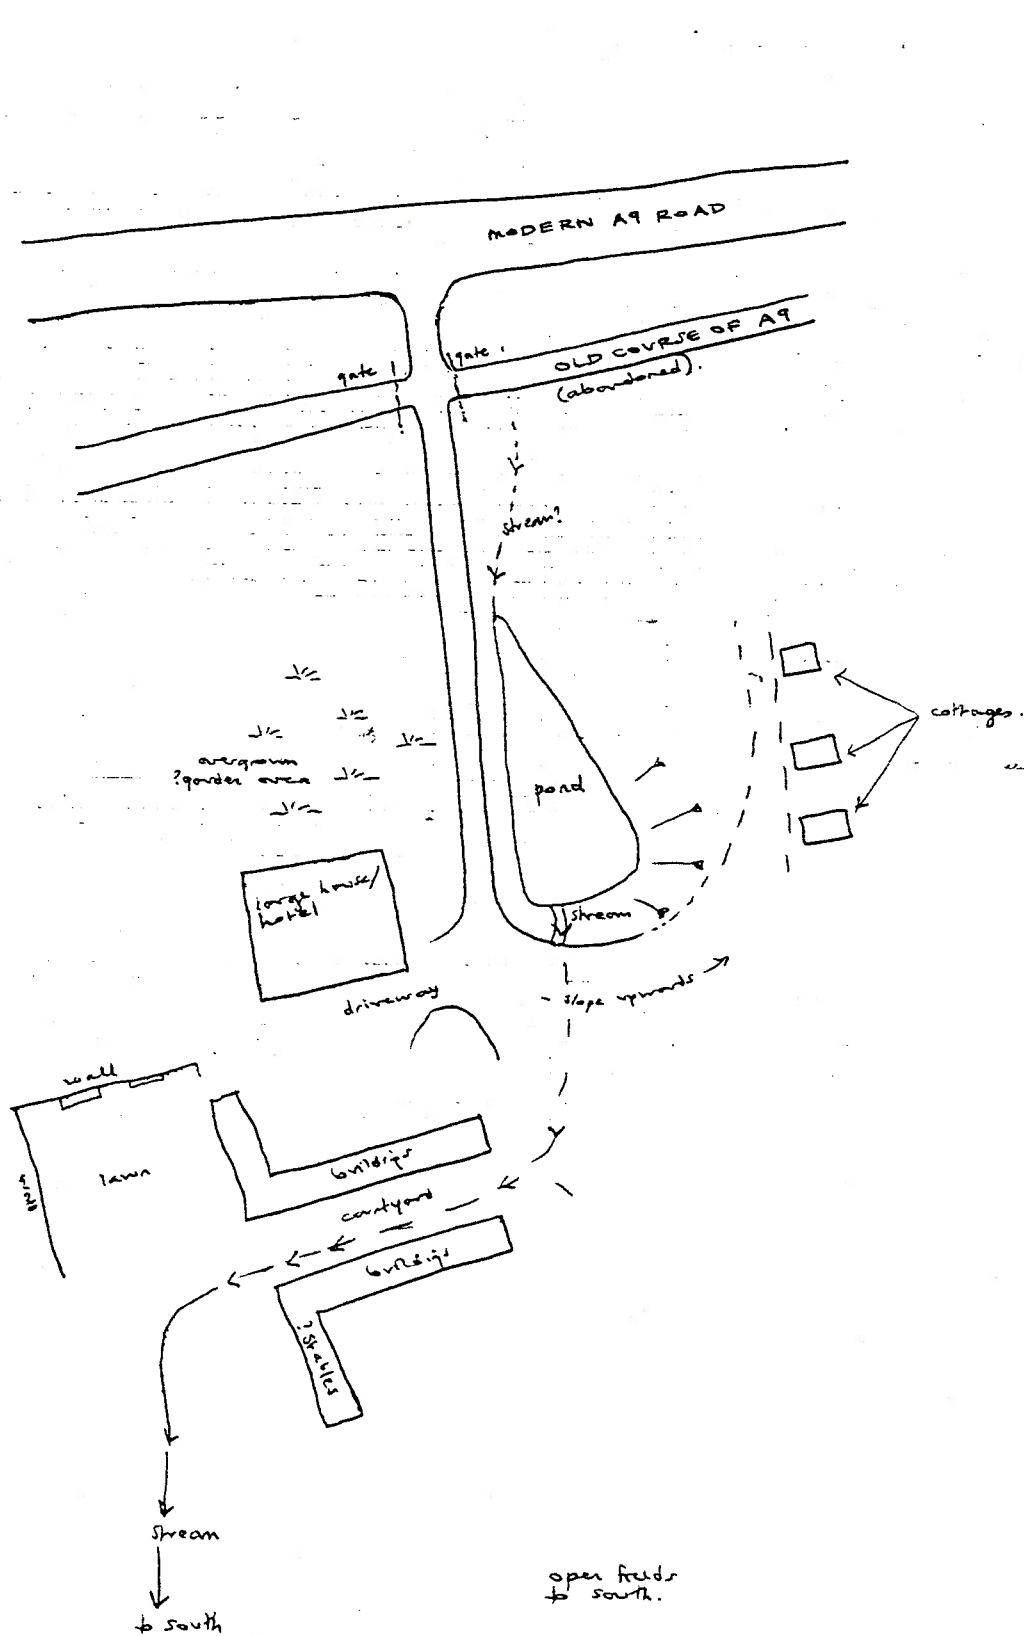
Rough sketch plan

The house itself occupies an area of raised ground and is surrounded by gardens. The gardens or open ground to the north of the house are overgrown and neglected. To the south of the house is a driveway leading to the road, and to the west of this is a partially walled area of lawn (in better condition than the ground to the north but also slightly neglected). Across the road, to the east of the house, the ground is lower and there is a pond, from which a stream runs southwards, turning westwards and running underneath the road and under a courtyard surrounded by semi-derelict farm buildings. The stream re-emerges at the other side of this courtyard and then turns sharply southwards again, running out into open fields to the south.

The layout of the buildings and watercourses here tentatively suggests a previously moated arrangement. The house occupies a slightly raised area, partly encircled by watercourses, now draining towards the south. Possibly apart from the shallow pond to the east of the house, there is no actual evidence of a moat.
