THE CLYNEKIRKTON PROJECT:

Regeneration of a Local Disused Graveyard

The Clynekirkton Project; Regeneration of a Local Disused Graveyard.

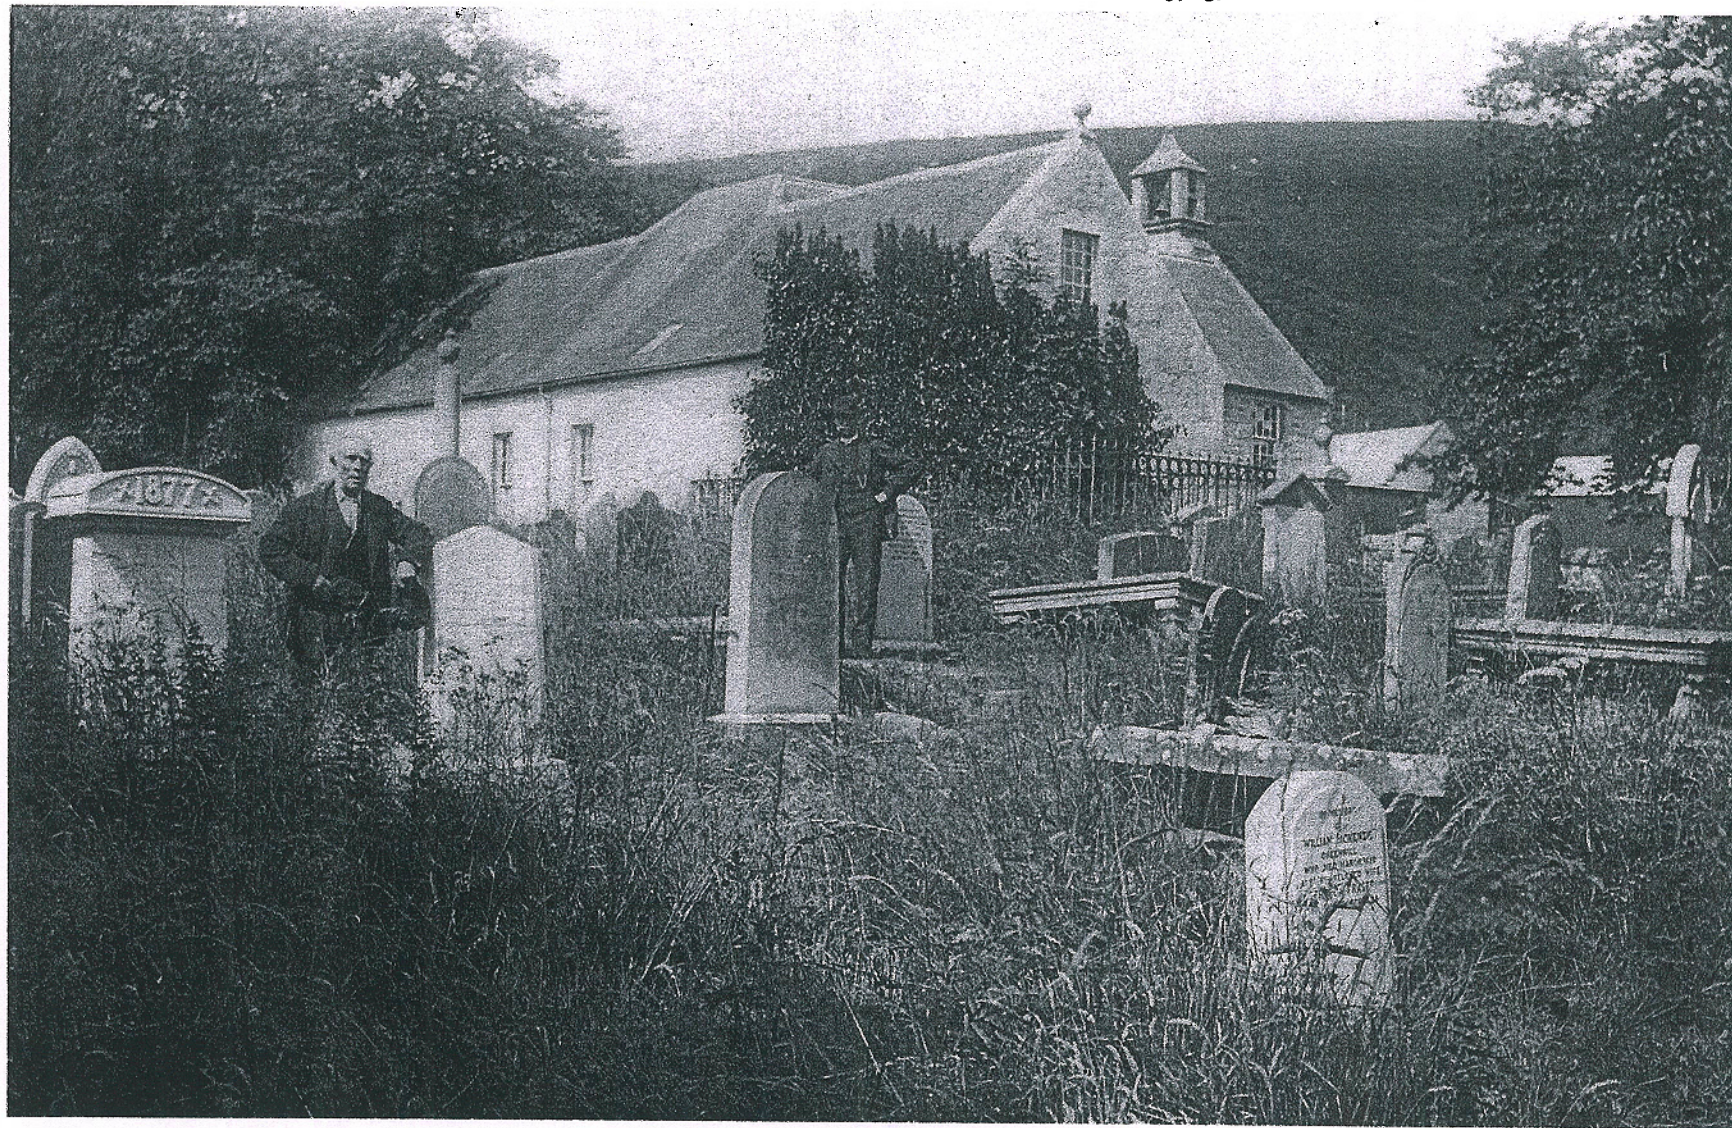
clynekirkton cemetery early 1900 a. (2310x1478x24b jpeg)

A rare insight into the past condition of the graveyard, prior to Highland Council ownership, was indicated in a photograph taken at the beginning of the last century, which came to light during the project. It showed that the graveyard was completely overgrown with vegetation, such as wild grasses and hogweed, which was left to grow wild, as high as the headstones, and filled the entire graveyard. It was also observed that the no ivy or ash was present. This reflection, on the past lack of maintenance in the graveyard, demonstrates how its appearance has changed over the last century. The implementation of the Highland Council's more structured maintenance methods over the last 80 years, has given the graveyard a more landscaped look. Latterly, this maintenance level has reduced substantially as budgets have inevitably been tightened and disused graveyards like Clynekirkton, become less of a priority, and this had culminated in the graveyard's appearance prior to the current clearance work.
