**Report of Archaeological Watching Brief
March – May 2004
Fortrose Area Water Mains
Replacement Project, Fortrose, Highland.**

Client: Halcrow Group Ltd on behalf of Scottish Water

**By
Stuart Farrell
BA, AIFA, FSAScot
&
Charles Murray
BA, DPA, MIFA, FSAScot, FMA
(Murray Archaeological Services)
May 2004**

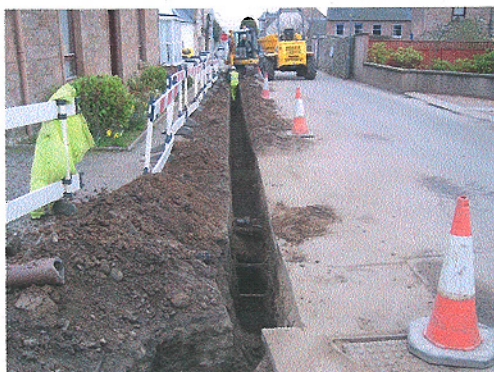
Photograph 1: Looking SE

The total length of the new water mains trench observed was c.106m long and varied slightly in depth from 1m to 1.2m. A top layer of tar c.100mm thick overlay a gravel and granite dust sub-surface c.200mm deep. This in turn overlay a light brown sandy and slightly silty natural. The trench ran the length of the N side of

the street and was much disturbed by services for water, sewerage and electricity supply [see photograph 1, below].

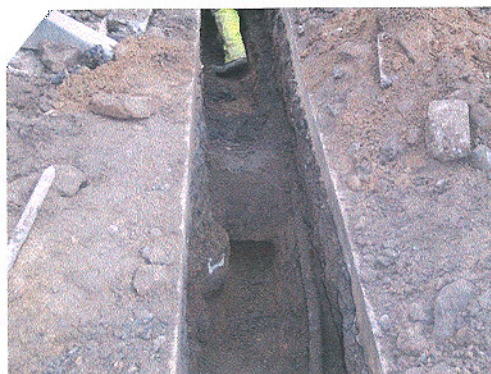
Photograph 2: Looking SE

In an area, comparatively undisturbed, opposite the pathway between No's 4 and 6 Church Street, some large boulders were encountered. Further excavation by hand showed that, while these were not structural, they represented a significant anomaly in the otherwise sandy natural [see photograph 2, below].

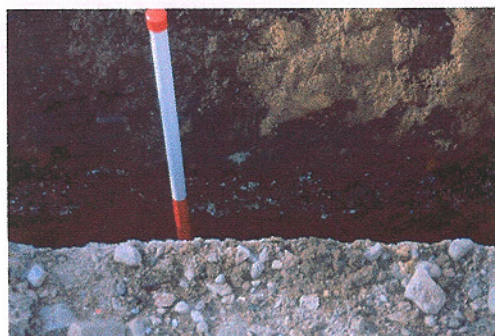
Photograph 3: Looking S – scale 1m.

Further to the NW, opposite the gateway to No.14 Church Street the trench cut through a layer or pit consisting almost entirely of shell mixed with some animal bone. The layer extended for c.1.2m and was c.200mm thick at its centre, tapering to c. 100mm at the sides. It was sealed by a black silty soil, which lay below the tarred pavement and sub-base [see Photograph 3, below]. Given the narrow confines of the trench, it was impossible to determine the extent of the feature or to tell if the shell and black sealing layer was a pit or more general spread. No pottery or other datable material was found in the shell layer.

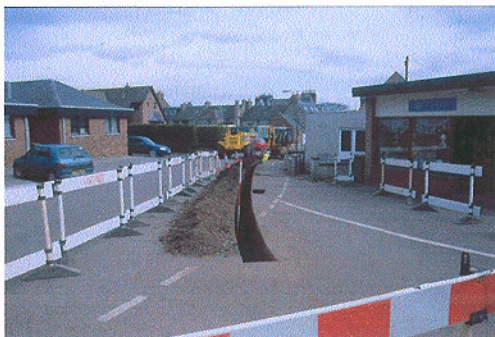
Photograph 4: NW end, looking E.

The trench observed in Station Road extended for c.79m and ran along the S side of the road; beginning at the NW end and running SE [see photographs 4 and 5, over]. The depth of the trench varied from 1m to 1.1m and was 370mm wide. The tarmac layer was c.120mm thick with a c.200mm sub-base of hard pink granite chips. At the NW end of the road, and extending SE for c.30m,

the sub-base overlay a homogeneous dark grey to black garden soil which produced fragments of 19th century pottery and some small pieces of clay tobacco pipe.

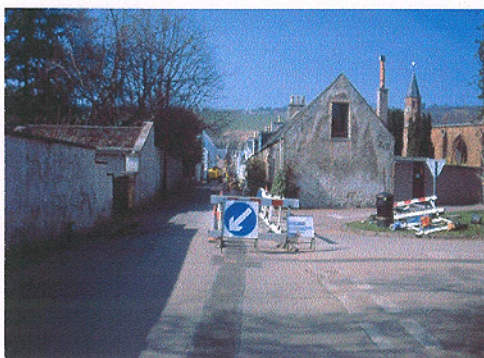
Photograph 6: Looking NW

The section of trench observed in Academy Street began at its junction with Cathedral Square and continued NW for 92m towards the High Street. The trench was excavated along the N side of the street and passed along the western precincts of Fortrose Cathedral [see Photograph 6, below]. The entire length of the trench observed showed the levels to be very heavily disturbed by services such as power cables and sewerage pipes. At 0.9m below the road surface a 3" cast iron water supply pipe was found to run along the line of the trench for its entire length [see Photograph 7, below]

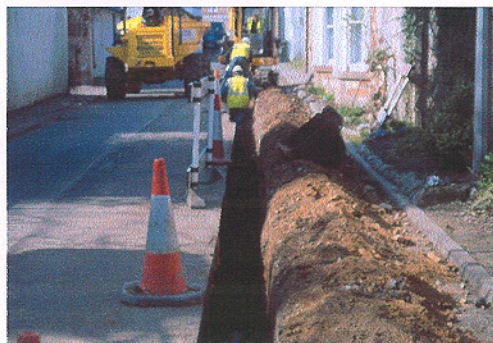
Photograph 7: Looking NW

The cast-iron pipe was broken up and removed in order to achieve the required depth of c.1m in the trench. Clearly, all evidence of earlier levels was totally destroyed by this cast iron pipe and the other services, finds in the soil included concrete and brick. Only to the north end of this trench was the natural observed

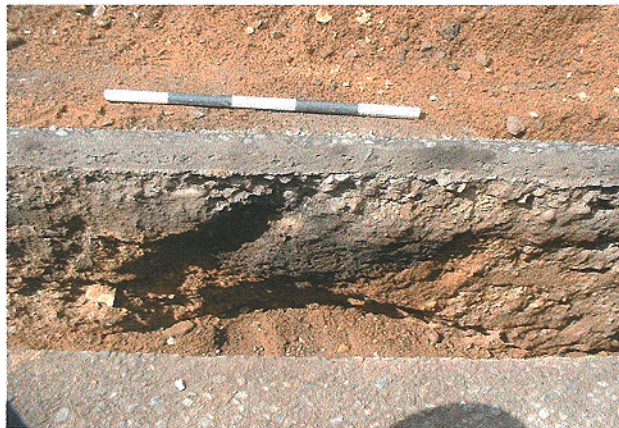
One small feature was noted at NH 73558/57565 of a small pit 220mm below road surface to a depth of 290mm and 400mm wide of a dark grey black fill with specks of charcoal but no finds. Date unknown.

Photograph 8 : Detail of pit in section – scale 0.5m.

Work in Rosemarkie was again limited due to only a small section of trench being excavated to the rear of the village. It is probable that any archaeological deposits lie closer to the High Street, though the find of the small pit atop the hill does indicate some previous use in this area to what it may have been is unknown.

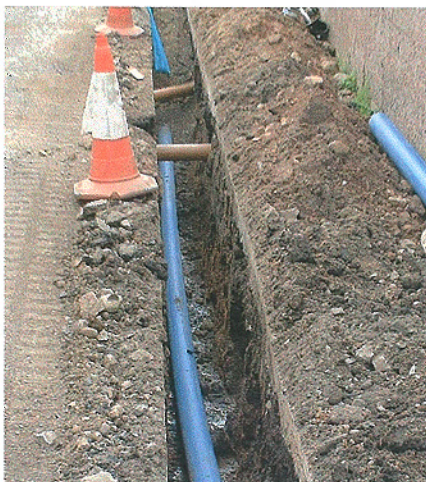
To the end of Courthill Road (towards the Plough Inn) area to west of village hall topsoil was to a depth of 1m whilst below hall road was directly onto natural of orange-brown sandy gravel with area again heavily cut by services. No indication of any features in road possibly due to the steepness of the slope.

Photograph 9 View up Courthill Road

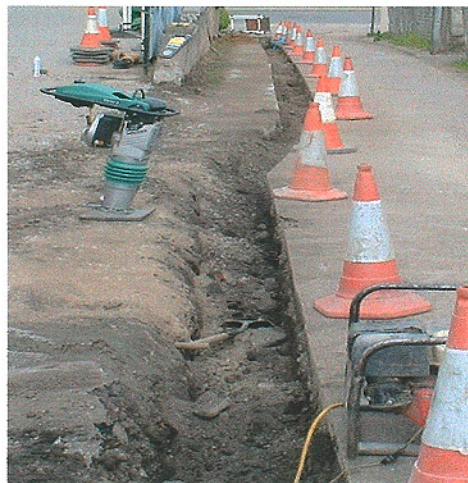
Photograph 10 View down road.
