438/SKL

An Archaeological Watching Brief at Torvaig, Skye

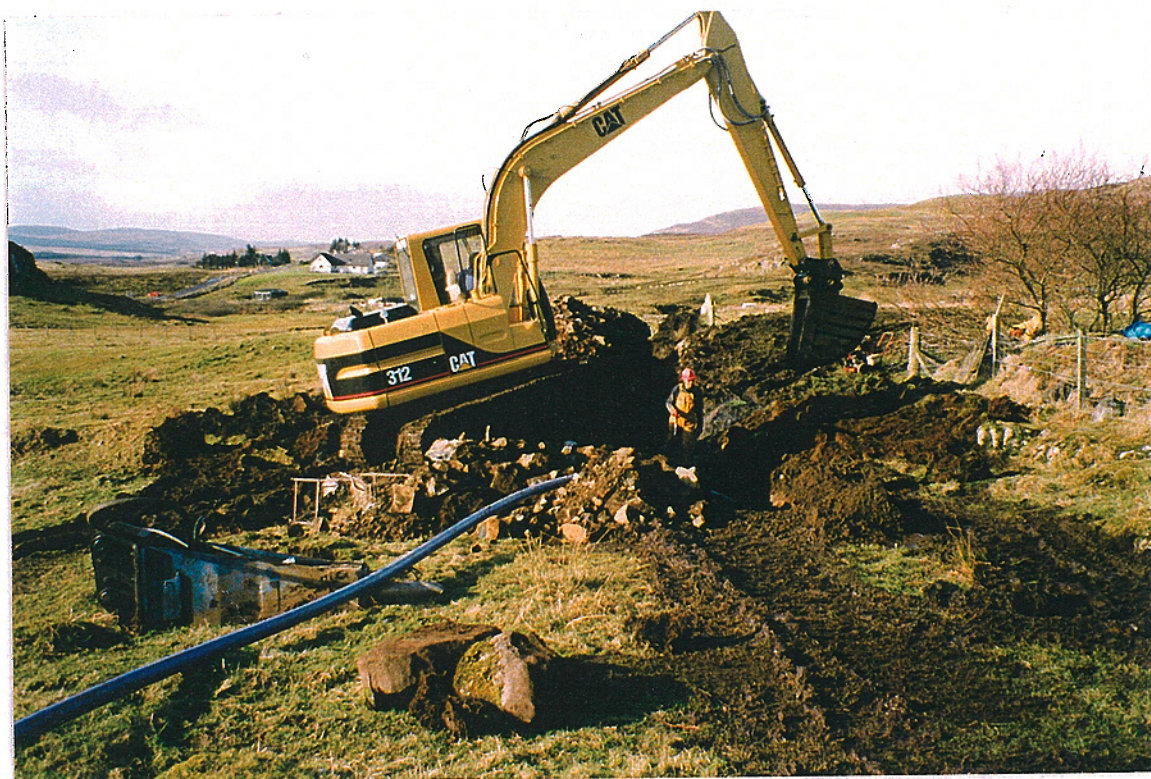
As can be seen from the frontispiece, the necessity to break rock to create a sufficient bedding trench for the pipe caused a very messy edge to the trench. As described above it was decided that the visible features should be examined by hand.
