Camster Windfarm, Near Wick, Caithness Archaeological Photographic Survey, **Desk Based Assessment** and Walkover Survey

Report No. 1797

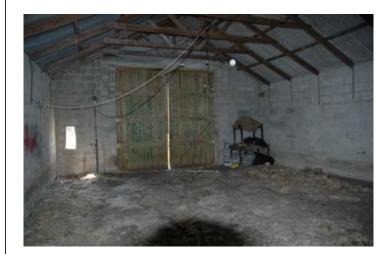
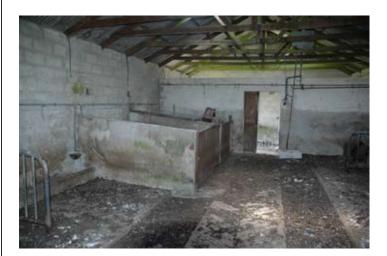
- 3.1.3 The outbuildings are of L-shaped plan and lie to the south-east of the house. They are of drystone build and are in semi-derelict to derelict condition.
