Photographs and Observations

Survey carried out 12th October 2015

Photographic Survey:

Inchnadamph Lodge & Outbuildings

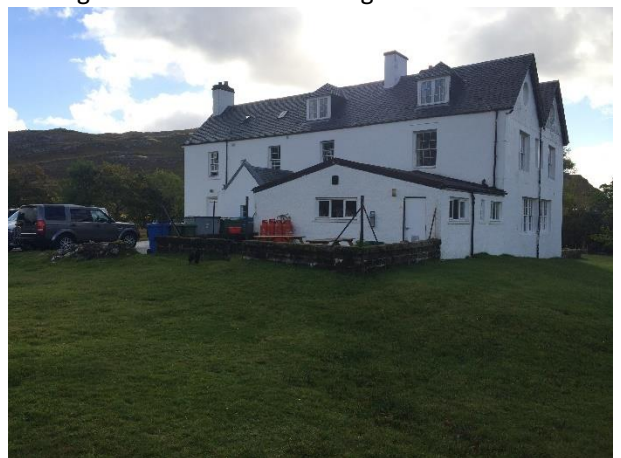
Lodge – North Elevation existing extension

Photographs showing the existing extension to the north elevation. This is a garage which has been retained to serve as kitchens, however in spite of continual maintenance the building fabric is not up to current building regulations and the core materials are of a poor standard.

The extension originally a garage is construction from concrete block with roughcast. Internally minimum insulation and plasterboard lining. The roof is 3-ply roofing felt on chipboard and timber rafters with an internal plasterboard lining.

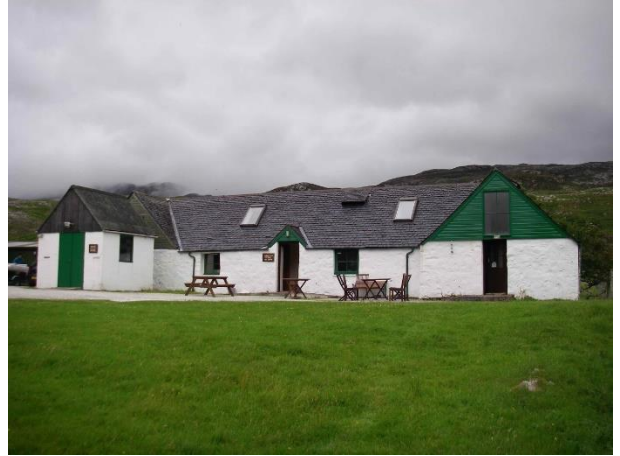
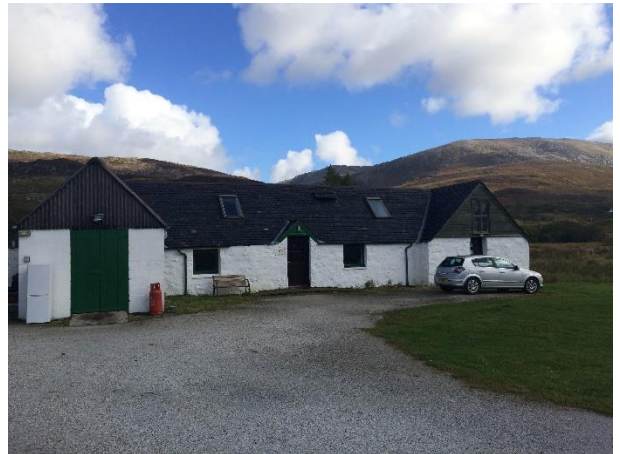
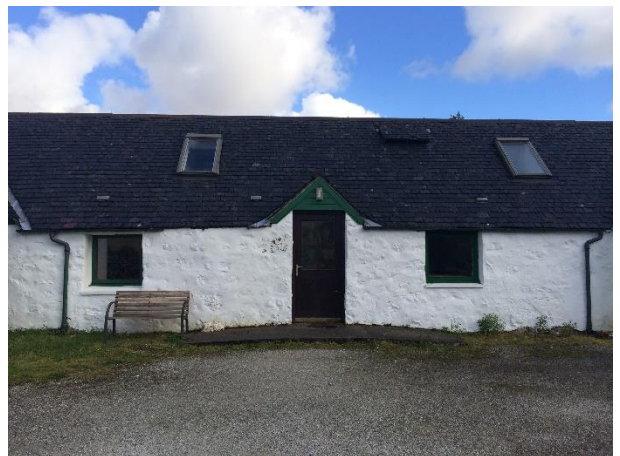
Views showing the Annex from the main approach from the south west.

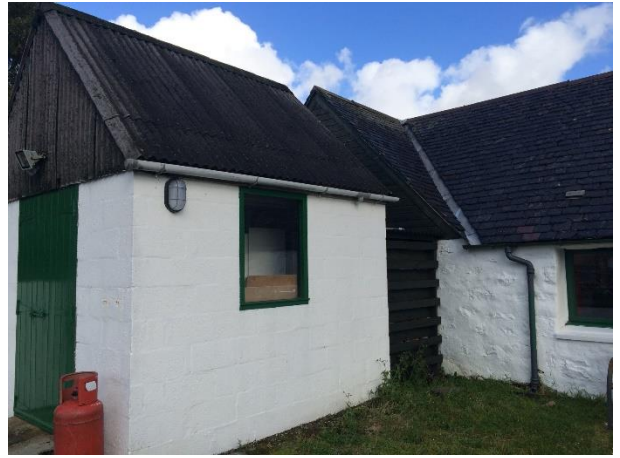
Store - corrugated roof and painted block work walls

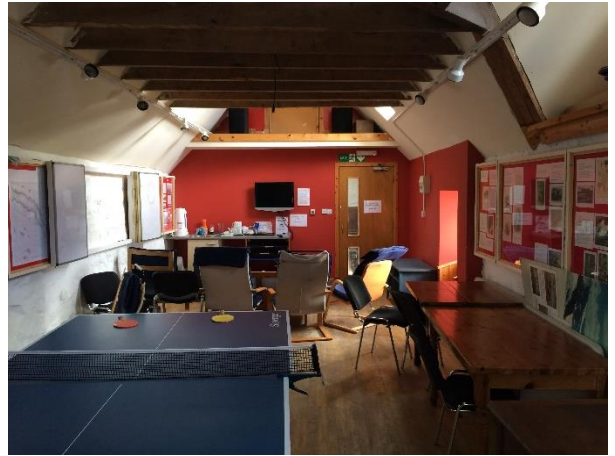
Lecture Room

Internal views of the Annex building.
The building is divided into 4 rooms, a lecture space, games room, common room and WC with entrance vestibule.
The existing roof rafters have been lined so as to maintain a full height to roof.
The tie beams have been left exposed in most of the rooms.
