Doire-
chlaigionn

Centred on NG
82575 54783

Doire-chlaigionn centred on NG 82575 54783

This settlement is situated on an E facing slope leading down to Ob Mheallaidh on Upper Loch Torridon and to the NE of the village of Shieldaig.

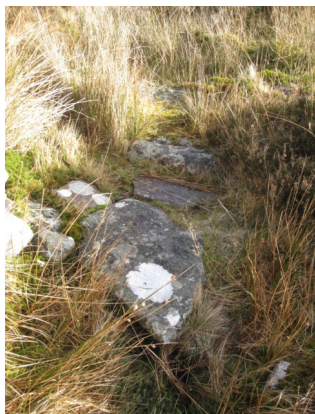
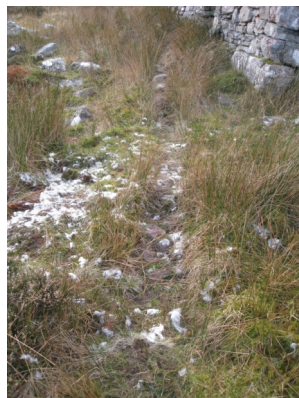
19. cont

In front of the house the drain containing the runoff from the adjacent well at 18 has a stone slab bridge over it and this drain continues on down slope towards the sea. There is a stone path in front of the building.

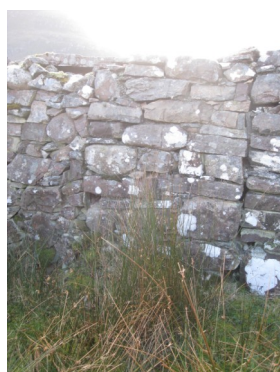
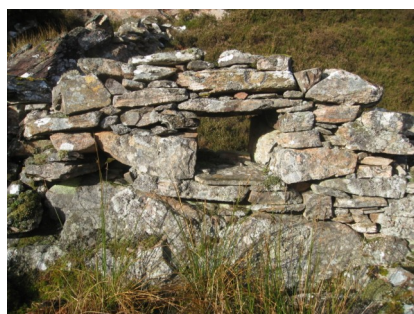
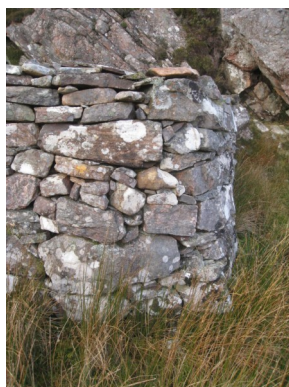
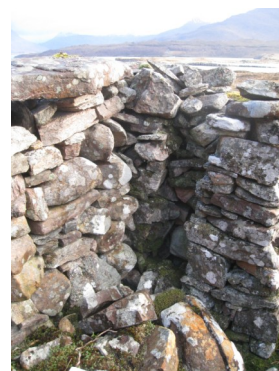
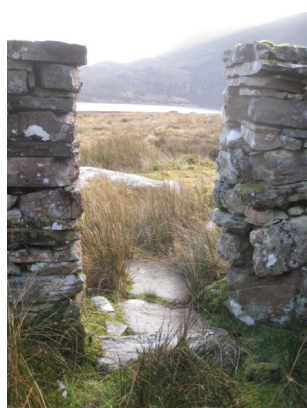
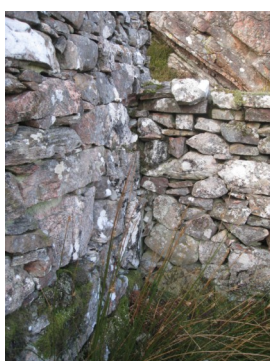
The building is well made with chosen and dressed stone that is layered. It has rounded corners and no evidence of a chimney, but a door and two windows. The main building has an added dividing wall which had a doorway that has been closed up. There is a cruck slot in one wall. A later byre with drain has been attached to the building and beyond this there is a terraced area.

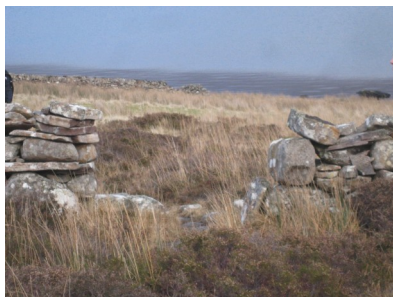
20. To the NW of these are the substantial walls of two enclosures which are accessed by a gateway NG 82616 54991 elevation 8m.

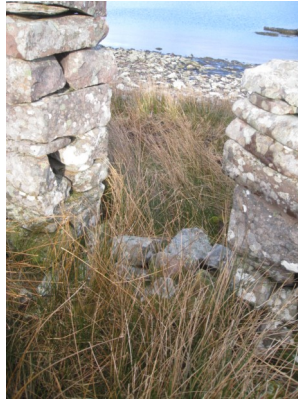
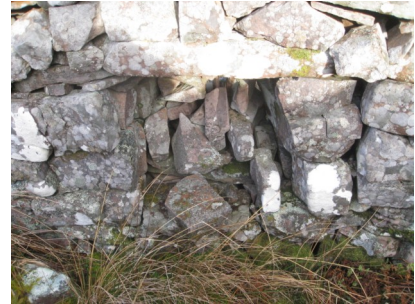
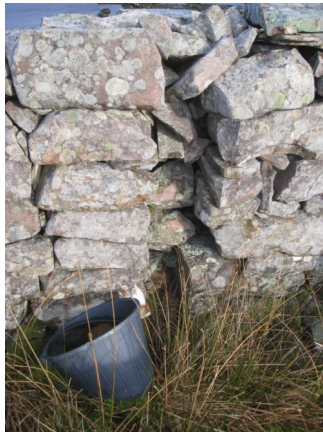
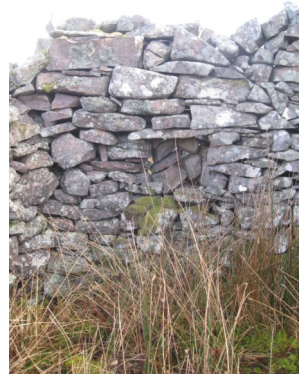
22. NG 82749 54983 elevation 2m. This bothy is very narrow in width 2m. There is a lot of tumble in the ruin but a door, blocked windows facing the shore, and a small window in the gable end can be seen. There is a buttress against the external facing of this wall for support. The walls are of rough construction made with stones from the shoreline which naturally break in layers. A cruck slot is visible in one wall.
