Dalmore Distillery Watching Brief

DSR and Recommendations

HAS Report No.	DMD22-004
Site Code	DMD22
Client	Blyth & Blyth Ltd
Planning Reference	22/02146/FUL
OS Grid Reference	NH 66710 68747
Date	11/09/2024
Author(s)	Karen Kennedy
Approved by	Lachlan McKeggie

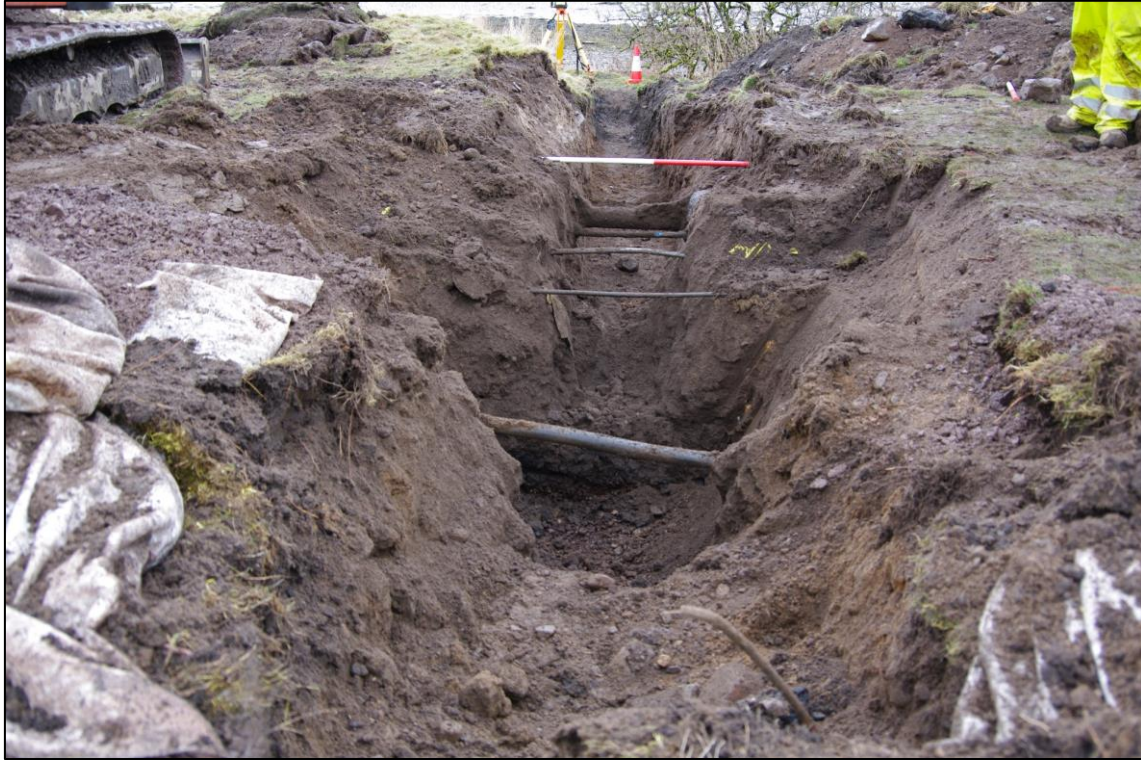
The suds area to the south of the road was 22sqm in size and was a narrow, roughly rectangular trench running north west to south east towards the shore. The topsoil (40) in this area was largely a mid brown black sandy loam with patches of hardcore and sand. To the east and the west side of the trench an additional patch of tar, which was likely to be remains of an old road surface, was noted. The topsoil excavated was between 0.4 and 1.7m in depth sloping up northwards away from the shore. Even at this depth it was not possible to see the natural subsoil (Figure 47). This demonstrates that the area south of the road was likely to be made up ground. The area also had many services running through it.

Figure 47: Photo 6693, post-ex of suds area to the south of road

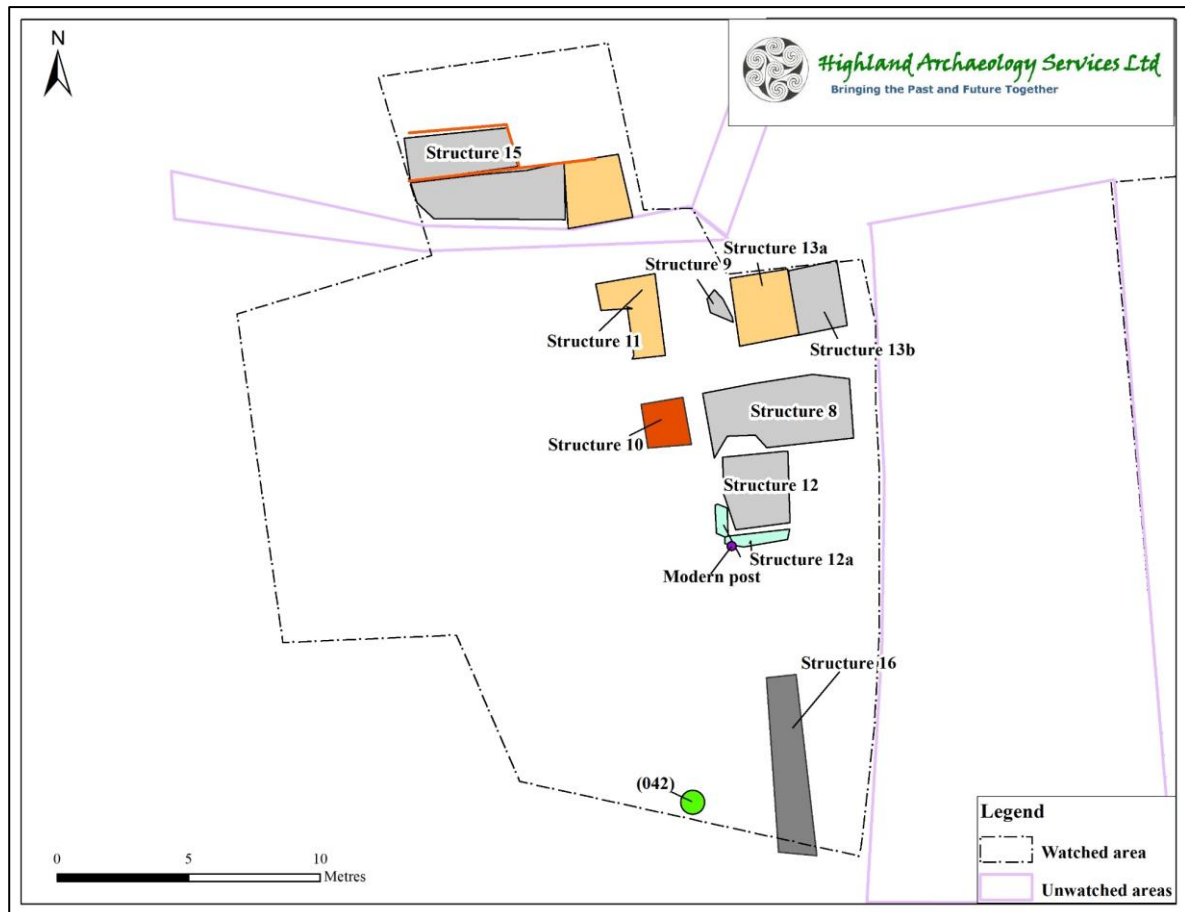
Figure 48: Watched area Boilerhouse Area

There were 3 areas not watched as they had live electricity cables running along them and were excavated by a vacuum excavator for safety. These were to the east of the boilerhouse area, a strip running east-west, south of structure 15 and another running south west to north east towards the north edge of the study area. These are marked in pink in Figure 48 below.

Within the boilerhouse area were seven structures and the remains of a garden wall. There was also a very thin spread of a coaly deposit (42) to the south of the area. (Figure 48)

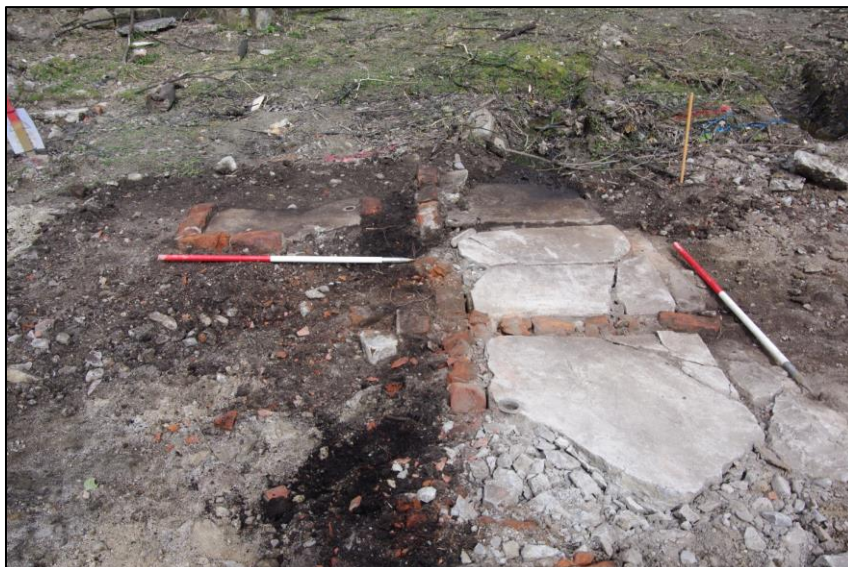
Figure 49: Photo 6719, Structure 11, facing north, 1m scales

This structure measured 3m in length by 2m at its widest point (Figure 49). It ran north south with a dogleg to the north west. It was very degraded and comprises four remaining precast concrete slabs [44] in very poor condition. It is likely that the structure would have been larger at some point and was possibly related to other similar structures in the vicinity. The slabs were surrounded by orange bricks [77] which were very degraded or missing in some parts. There were metal rings on the inner sides of each of the slabs. There was also the remains of flat grey stone to the east of the structure and it is likely that the structure continued to the north but this was within an area a high voltage cable and was not watched. It seems likely this had been disturbed by the installation of this cable.

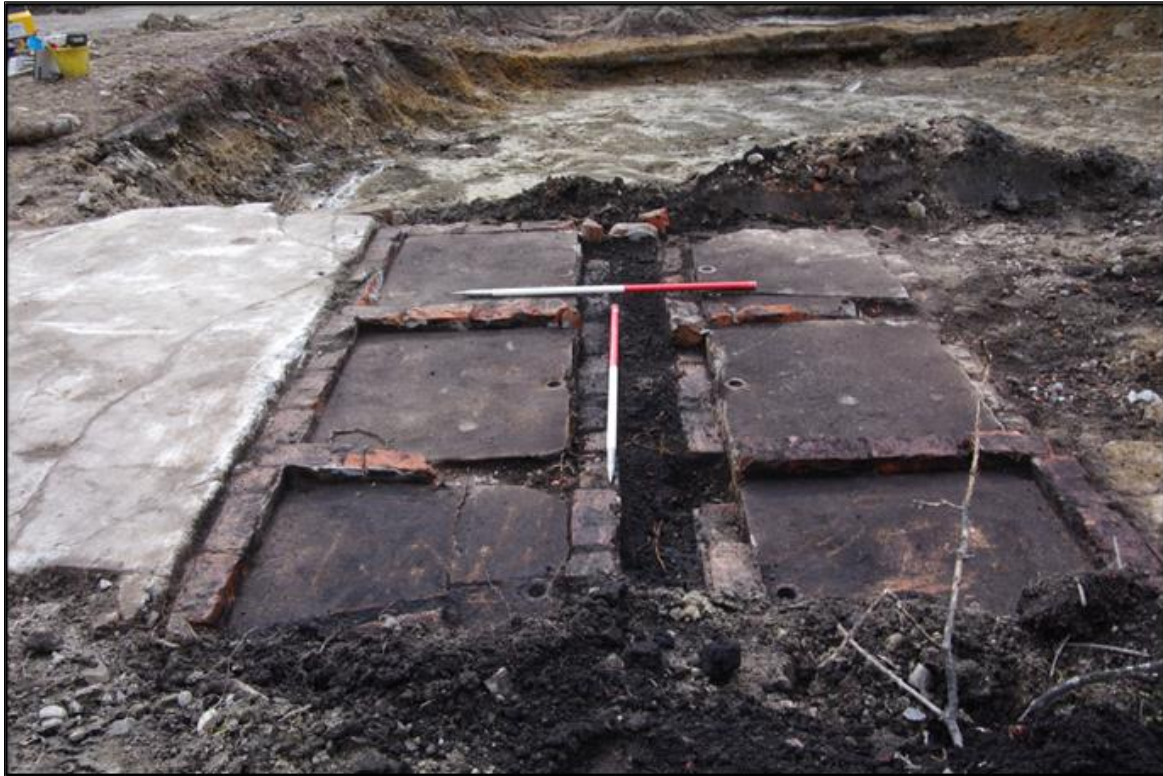
Figure 51: Photo 6742, Structure 13a, facing south, 1m scales

Structure 13a measures 2.15m by 2.47m and is similar in nature to structure 11 although more complete. It ran west to east and was rectangular in shape. It comprised 6 dark grey brown precast slabs [50] each surrounded by red bricks [96] with a metal ring in the centre of the interior edge (Figure 51). There was also a gap which ran between the two rows of slabs. The soil in this gap and on top of structure structure 13a was a very dark brown black humic soil (80) which was very wet. Structures 13a and 13b appeared to be one structure. Structure 13b was a smooth grey concrete pad [50] measuring 2.5m by 1.97m which overlay [93]. [93] consisted of 5 courses of brick work and was bonded with a creamy coloured mortar. The mortar remains in patches on the southern extent of the structure. These bricks underlie both structures 13a and 13b. Towards the eastern side of structure 13b the concrete continues over the front of the structure for a 0.8m, this section had no bricks underlying it. This may have been a step into the structure. Underlying the bricks was a layer of pale grey concrete [94] which was 0.18m in depth and ran under both structures and sat directly onto the natural (Figure 52).

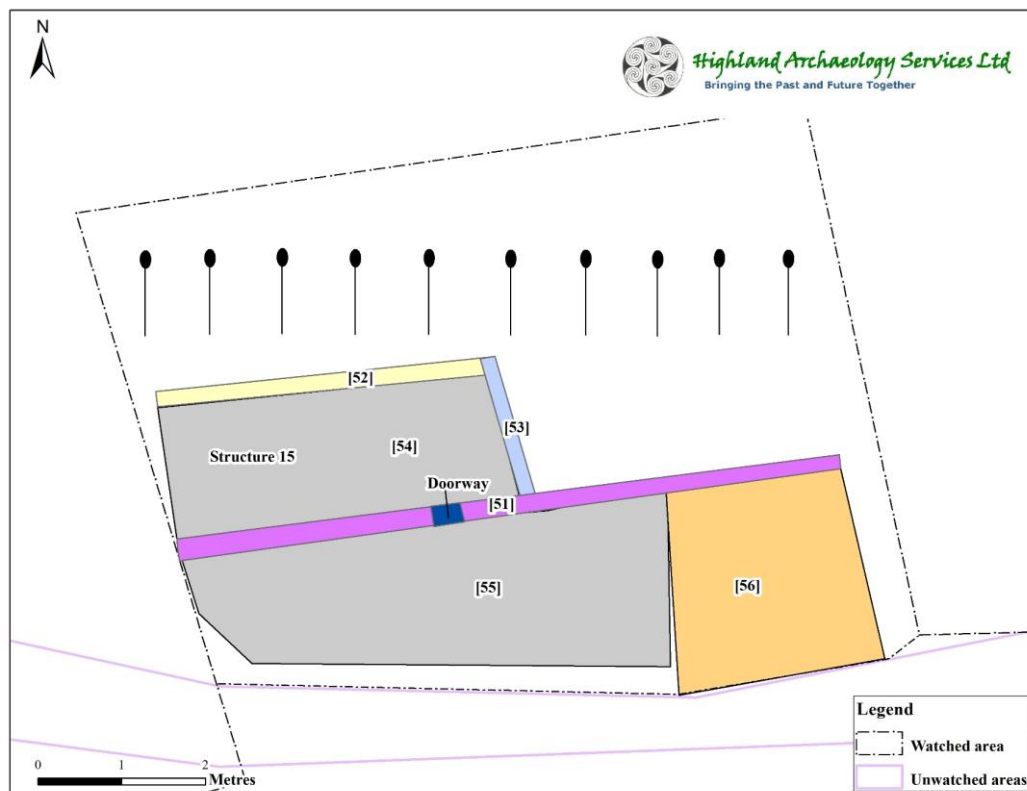
Figure 53: Plan of Structure 15

This structure was located to the north of the boiler house area at the base of a steep slope from the B817. The north wall of structure 15 [52] ran west to east and was a double skinned drystone construction comprising worked rectangular stones which were tightly packed and infilled with smaller flat stones (Figure 54). It survived to a height of 1.3m and was topped with coping stones which were bonded with mortar. There were also two gaps of unknown function.

The eastern extent of structure 15 [53] ran north to south joining the parallel walls [51] and [52]. Like [51] it was constructed of rectangular worked stones with some large rounded stones and infilled with smaller stones. It abutted the northern wall [52] and appeared to be keyed into the southern wall [51] although it was difficult to say definitively as the remains of these walls were in such poor condition and the stones were very loose and tumbled. The entrance to structure 15 is towards the east of the southern wall [51], a stake hole was noted to the west of the entrance.

Between these three walls ([51], [52] and [53]) was a concrete floor [54], this abutted these walls and measured 4m in length by 1.9m wide. The western end of this concrete slab was very degraded and from the amount of loose large stones in this location it is likely that at some point a wall stood here enclosing the structure (Figure 55)..

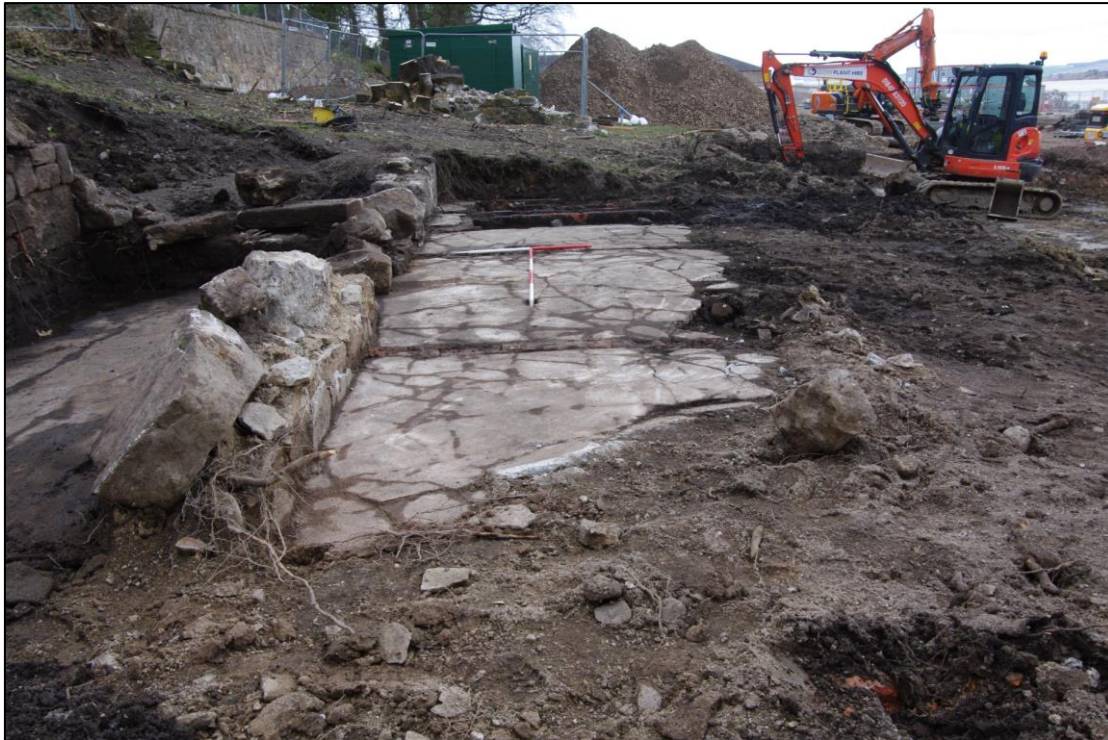
Probably associated with Structure 15 was another smooth grey concrete slab [55] located to the south west of structure 15, it was somewhat degraded particularly to the west and south (Figure 56). The remains of this structure measured 5.6m in length by 1.9m wide. There were two single strips of Brora bricks [82] (Figure 56) running north to south, 1.8m and 4.5m from the western edge of the concrete pad. To the east of [55] and to the south east of structure 15 (Figure 57) was what appeared to be the base for machinery [56] which measured 2.5m to the limit of excavation by 2.6m wide. The concrete slabs were very similar in nature to that of structures 11 and 14 and like those structures the slabs are surrounded by bricks. The bricks to the north were sealed by a layer of concrete/mortar [95] and this continued around the northern part of the eastern edge of the structure. The bricks to the east of structure [15] were two rows wide. The concrete slab [55] was slightly higher than structure 15 resulting in a small step down through the doorway into the structure 15 (Figure 58**Error! Reference source not found.**). The southern wall of structure 15[51] was built on top of this concrete slab which would suggest that the walls and concrete slabs were all part of the same phase of building. The southern extent of the concrete slab/machine base were not fully exposed as a live electricity cable ran east to west of the structure and this was to be vacuum excavated at a later date.

Figure 56: Photo 6784, structures 15d and 15e facing east, 2m and 1m

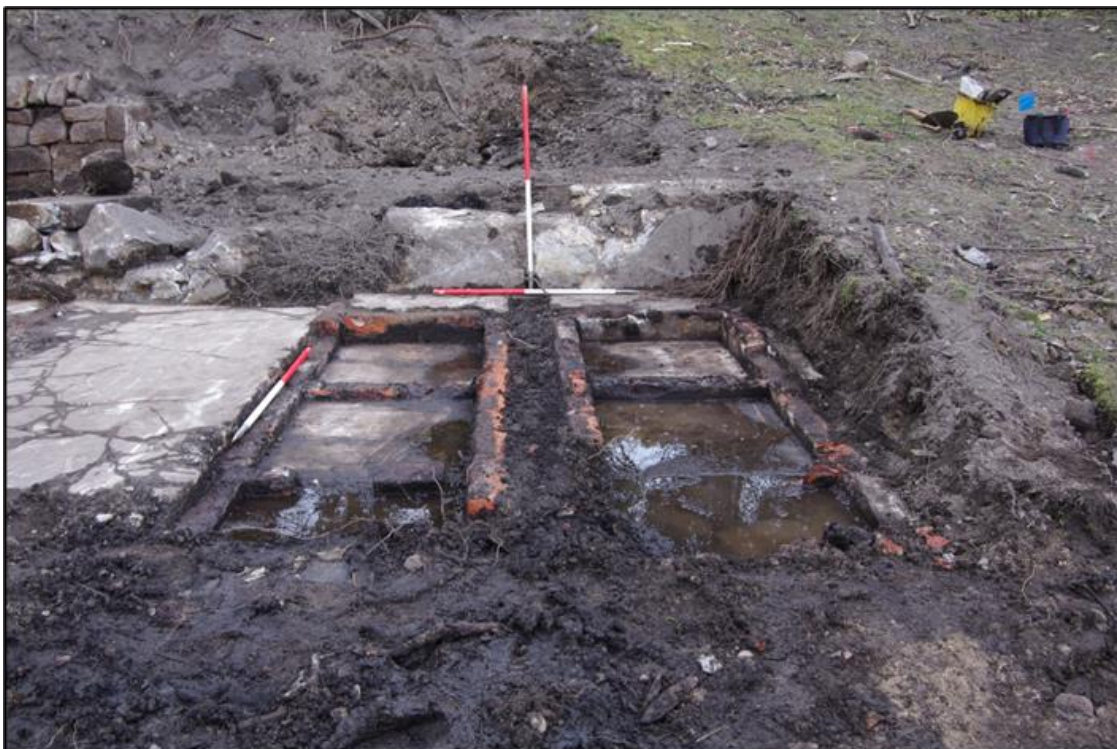
Figure 57: Photo 6785, Structure 15e, facing north, 1m scales

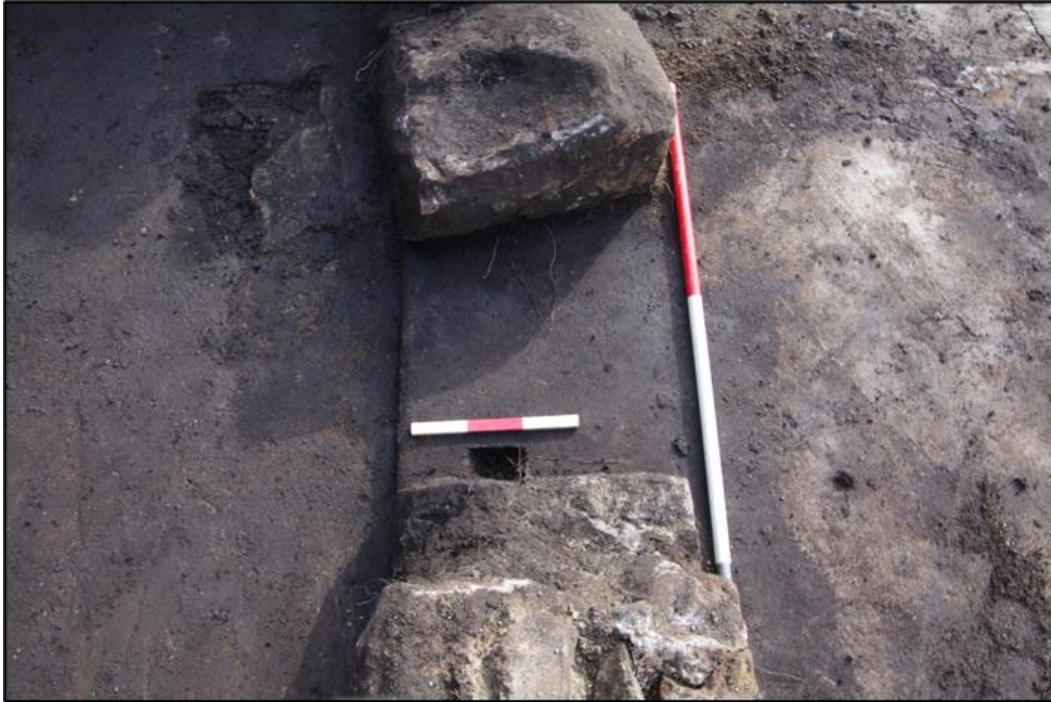
Figure 58: Doorway in structure 15c, facing east, 1m and 0.3m scales

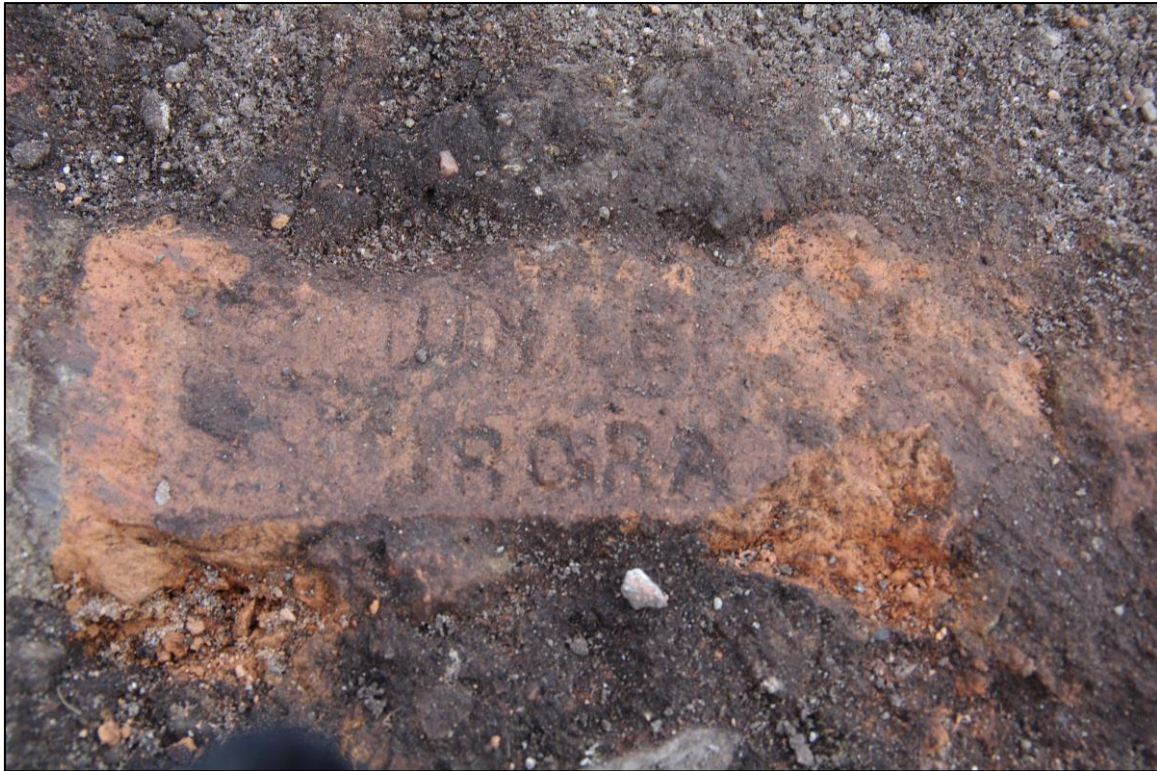
To the east of Structure 10 was structure 8, a smooth grey concrete pad [41] measuring 5.5m by 2.72m (Figure 60). The south west corner of which was quite degraded. To the north and west of the structure a single row of bricks [47], some of which were identified as Hunter Brora bricks (Figure 61) were noted. Hunter Brora bricks were being produced between 1914 and 1949⁹. These bricks ran along the western edge adjoining the northern part of the western edge of Structure 12 (Figure 62) which was also a concrete pad [45] measuring 2.5m by 2.76m. The concrete appears to be quite degraded around the edges particularly in the southern edge.

Figure 61: Hunter Brora Brick

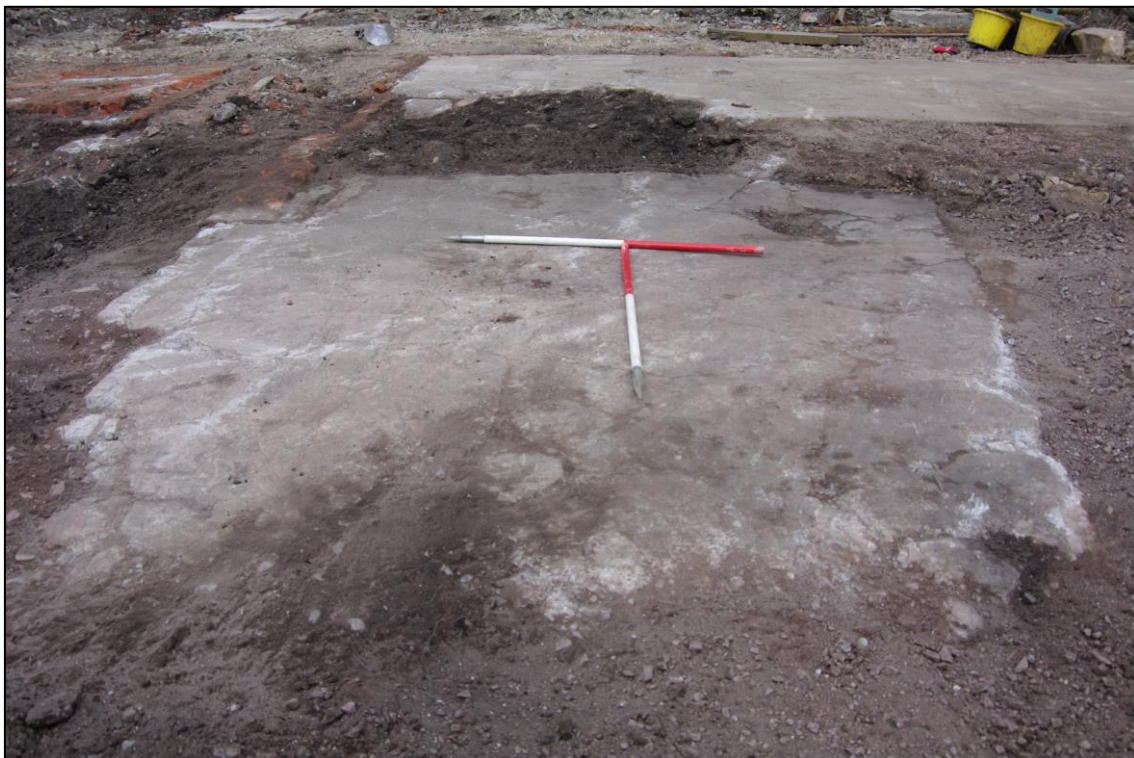
Figure 62: Photo 6724, Structure 12 and Structures 8 and 10 in background, facing north, 1m scales

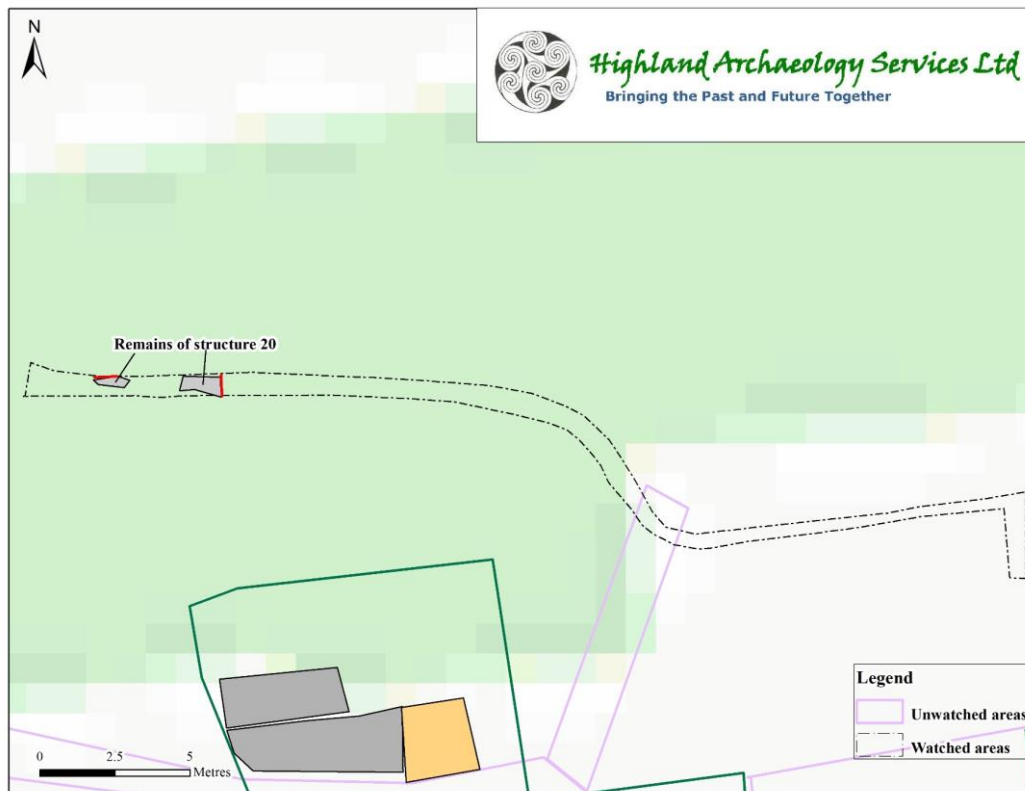
Figure 65: Watched area for drain, behind boilerhouse area

A narrow trench 38 metres in length by 1.1 metres wide at its widest point was watched to a depth of 0.8m (Figure 65). The trench ran approximately west to east on the slope below the B817 to the north west of the site. This was as deep as the client was excavating and the subsoil was not visible at this depth. The topsoil (68) was a dark brown loam with few stones and many roots. At the eastern most end structure 20 was uncovered. Structure 20 comprised two short sections of wall to the north and east of the structure (73) and (74). These were built of stone, were bonded with mortar and also had a facing of mortar on the interior. The floor visible within the structure only survived in patches (Figure 67) and comprised a thin layer of smooth pale grey cement (71) which overlay a

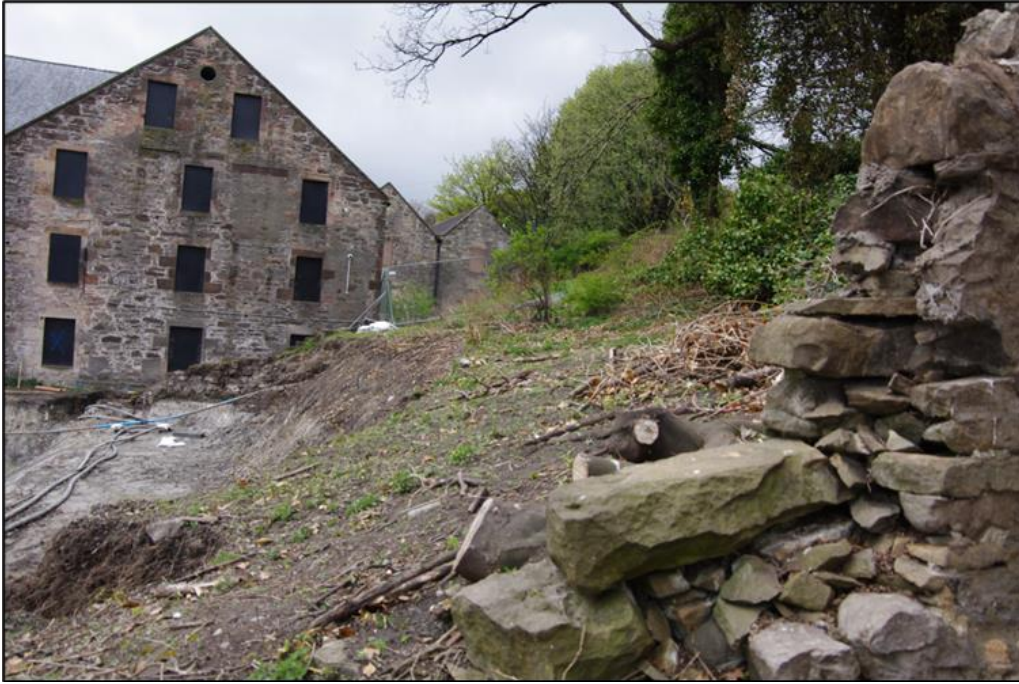
Figure 66: Photo 6861, Pre-excavation shot behind boilerhouse area, facing north west

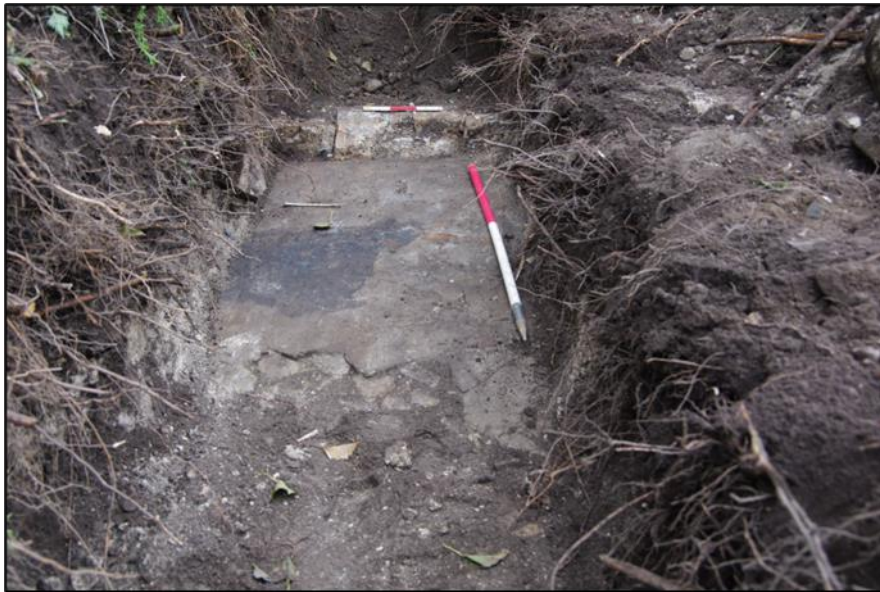
Figure 67: Photo 6867, facing east showing cobbles beneath concrete layer and walls to north and east of structure 20, 1m and 0.3m scales

layer of tightly packed rounded cobbles which varied in size but were largely between 0.10m-0.30m (72).

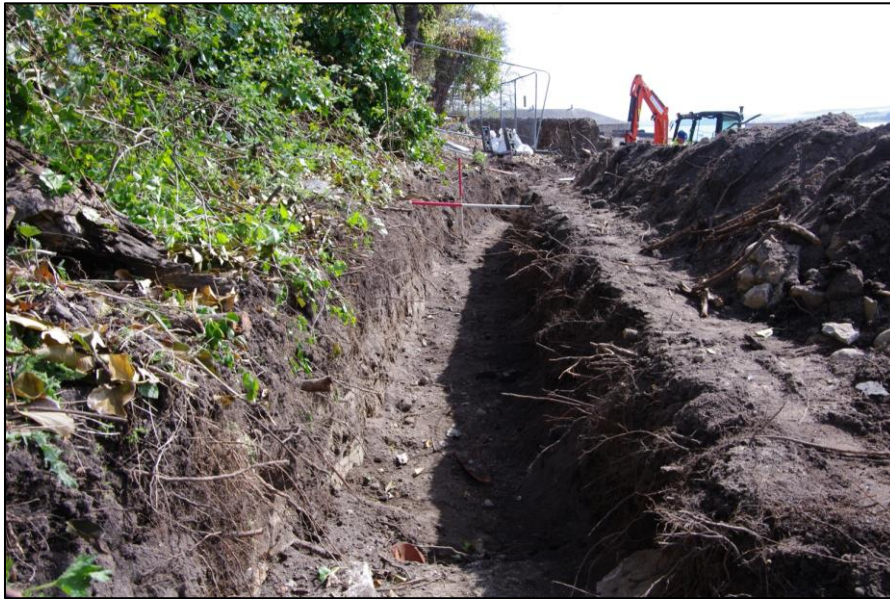
Figure 68: Photo 6874, Post-excitation shot behind boilerhouse area facing east, 1m scales

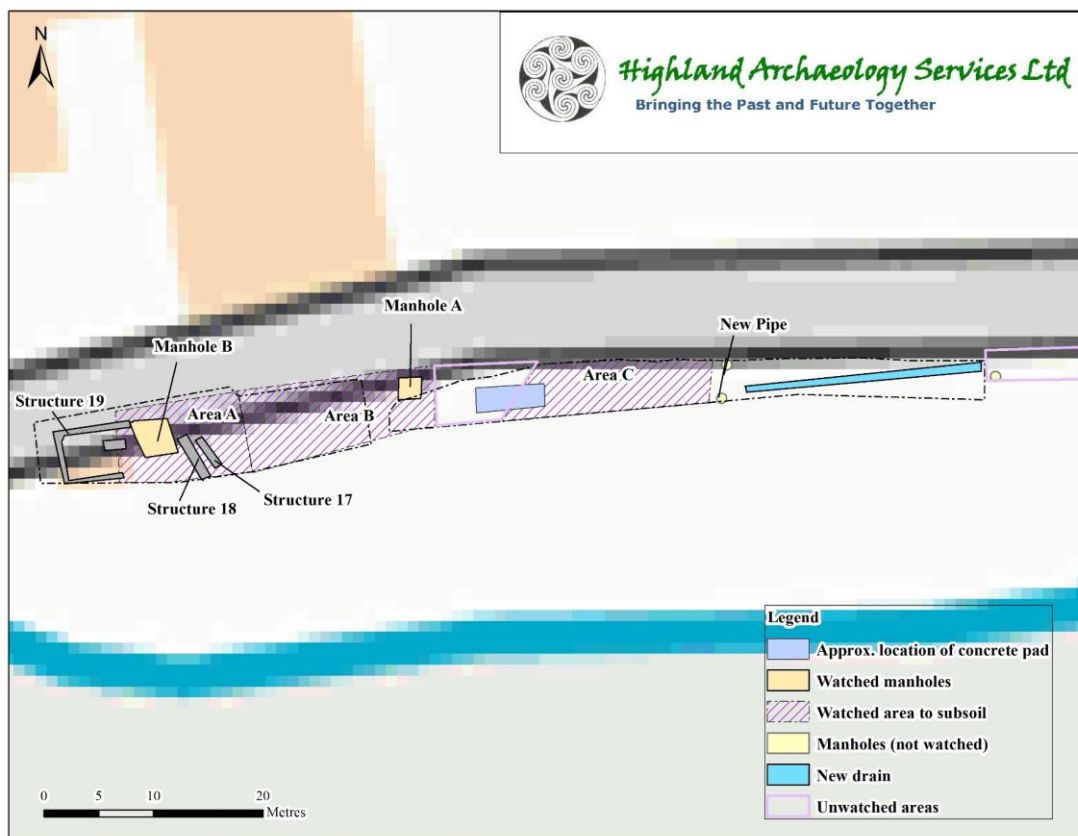
Figure 69: Watched area of Shore Road re-route

The total area watched south of the Shore Road was 431sqm. The excavated area ran east to west along the southern edge of the Shore road at the southernmost edge of the development site and was roughly rectangular in shape.

Two areas were not watched during excavation. The first was to the east of the trench which was excavated whilst the archaeologist was on different part of the site. This area was felt to have been made up ground where the natural subsoil was not visible and where services were prevalent and was therefore deemed to be of low potential. The second was in the approximate middle of the trench. This was also an area where there were many services and was therefore also deemed to be of low potential. A high voltage cable had also been vacuum excavated in the location of the area watched. Whilst the ground was being prepared for the vacuum excavation (turf removed) it was noticed by the archaeologist whilst watching another area on the site that a concrete slab was being removed after the client had been informed that it would need to be recorded before lifting. The approximate location is marked on the map above (Figure 69).

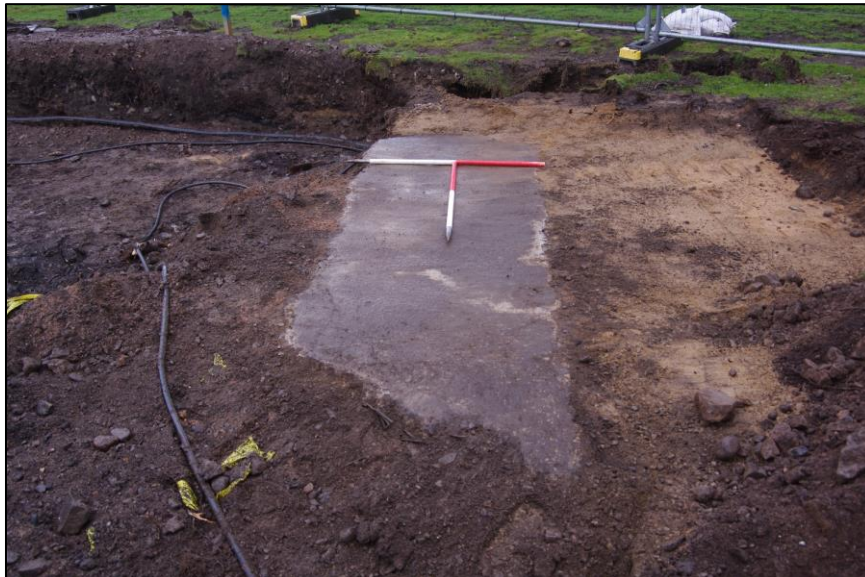
At the west end of the trench two concrete slabs were uncovered, structure 17 [058] (Figure 70) and Structure 18 [059] (Figure 71). Structure 17 was a small rectangular slab of reinforced smooth grey concrete, no clear edges were visible but what remained measured 0.20cm deep and was 3m by 0.74m. Structure 17 overlay a layer of sharp sand which in turn overlay the topsoil. Structure 18 was similar in nature but measured 4.34m by 0.89m.

Figure 70: Photo 6809, remains of structure 17 facing east, 1m scales

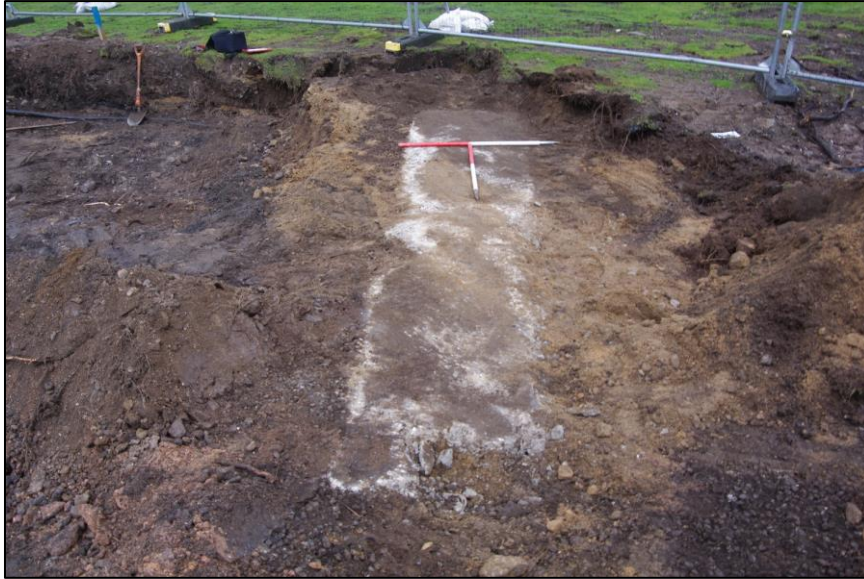
Figure 71: Photo 6817, remains of structure 18, facing south, 1m scales

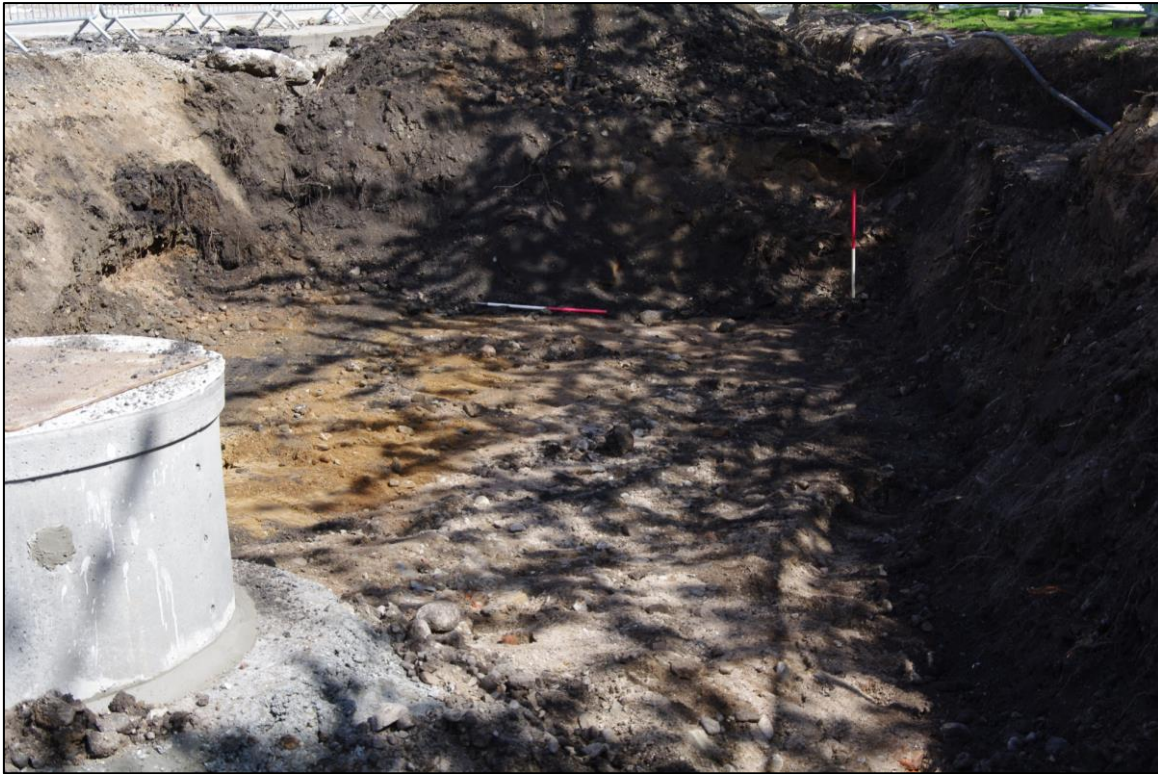
Once the manholes were installed it was decided that the road would be excavated deeper as it was felt that the topsoil was too soft for the building of the new road re-route. Stripping was thus watched to the subsoil (70) and covered an area of approximately 271sqm in total. This was watched in 3 different sections, recorded as Areas A, B and C (Figure 69 above) as each section was filled with hardcore before moving onto the next. The area watched gently sloped downwards from north to south towards the shore. The topsoil (69) was a mid brown grey silty loam with stones of various sizes and 2.5m in depth. (Figure 74). Many cables, drains, etc ran through the topsoil. There were occasional black patches and large patches of sandy silt which was similar in nature, but slightly darker than the subsoil. The subsoil (70) was pale orange sandy silt with rounded stones of various sizes, thought to be the same as (63) and (65).

Figure 74: Photo 6876, post-excavation of area A for shore road, facing east, 1m scales

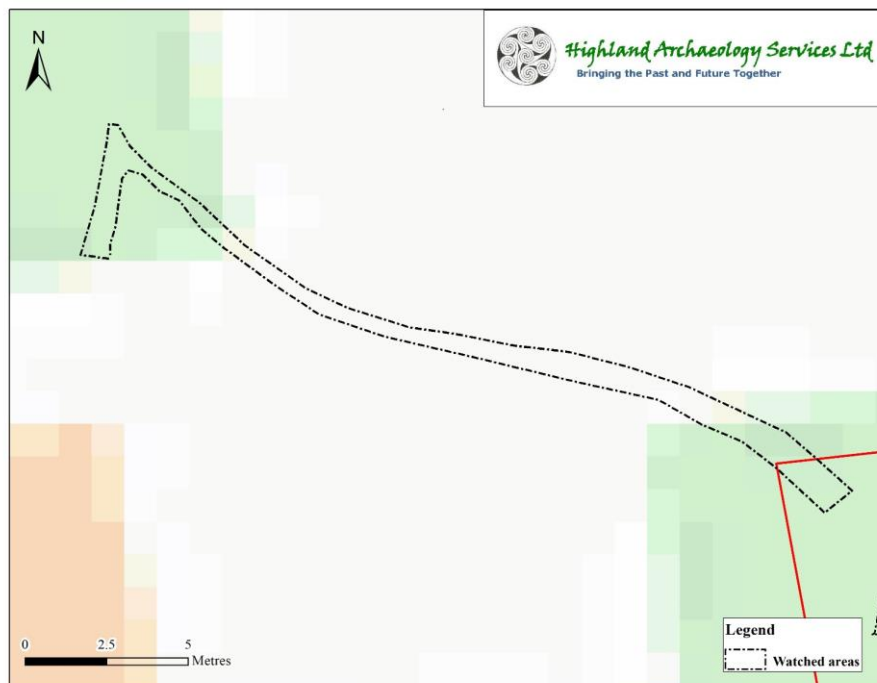
Figure 75: Electricity Cable re-route

The total area watched for the new electric cable here was 20sqm with the trench orientated approximated north west to south east. The trench was excavated below the B817 ending close to the re-routing of the drain behind the boilerhouse. The topsoil (87) was excavated to a depth of 0.8m and was a dark brown loam with few stones and many roots. The excavation did not go deep enough to see the subsoil. No archaeological artefacts or features were noted in this area.

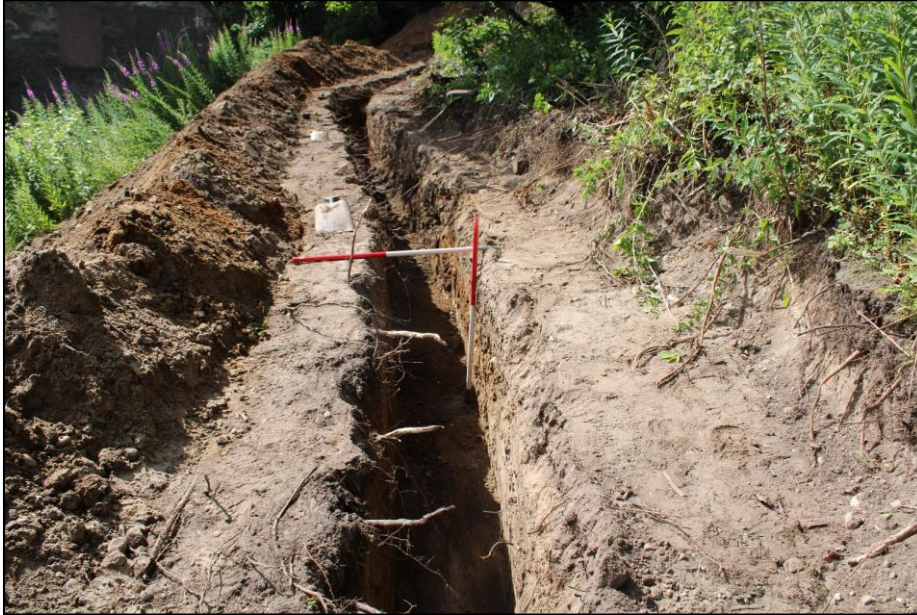
Figure 76: Photo 5891, post excavation shot of cable, facing west north west, 1m scales

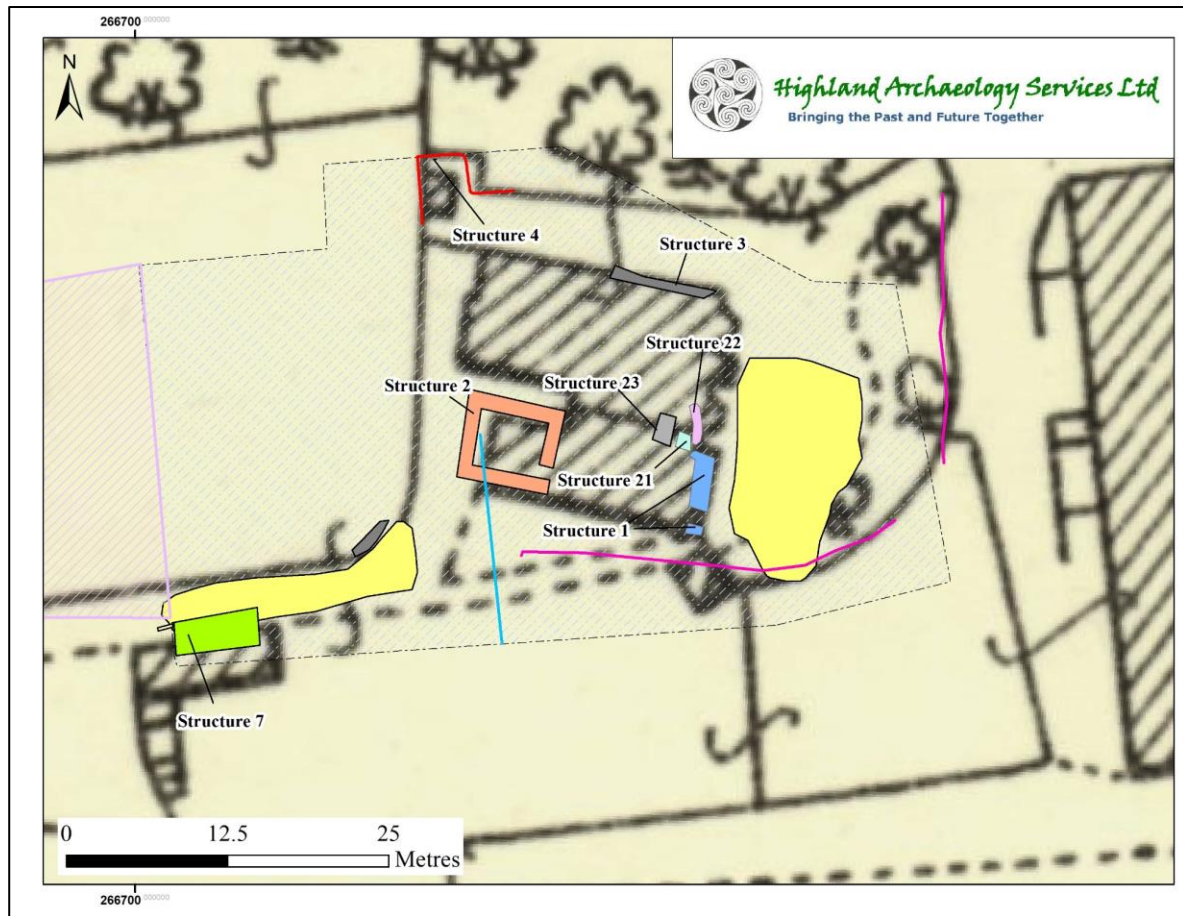
Figure 77: Garden area structures overlaid onto 2nd edition 25 inch OS Map

Some of the structures in the garden area were likely to be the remains of structures which are depicted on the second edition OS map, surveyed in 1904. In particular structure 4, to the north of the garden area, with the remains a concrete base and cobbles is thought likely to be the small, roofed structure depicted on the map (see Figure 77).

On the 1st edition OS map surveyed in 1874 'Dalmore Cottage' is depicted as one large structure surrounded by trees and with a large formal garden area to the west. But by the 2nd edition, in 1904, it has changed shape slightly and the structure now appears to be divided. This may be seen in a photograph from 1966 (Figure 78, garden area in red) in which the 'Cottage' appears to be 2 or more structures. Structure 3 corresponds well with the north wall of the cottage as does structure 1 and 21 with the east wall. Structure 2 corresponds well in size and shape of the south west corner of the cottage although is a little too far to the west but this may simply be a slight projection or plotting error. Structures 22 and 23 are more likely to be part of later activity on the site. In addition the cobbled areas (show in yellow in Figure 77) and walls also match up with the layout around the cottage in the 1904 map.

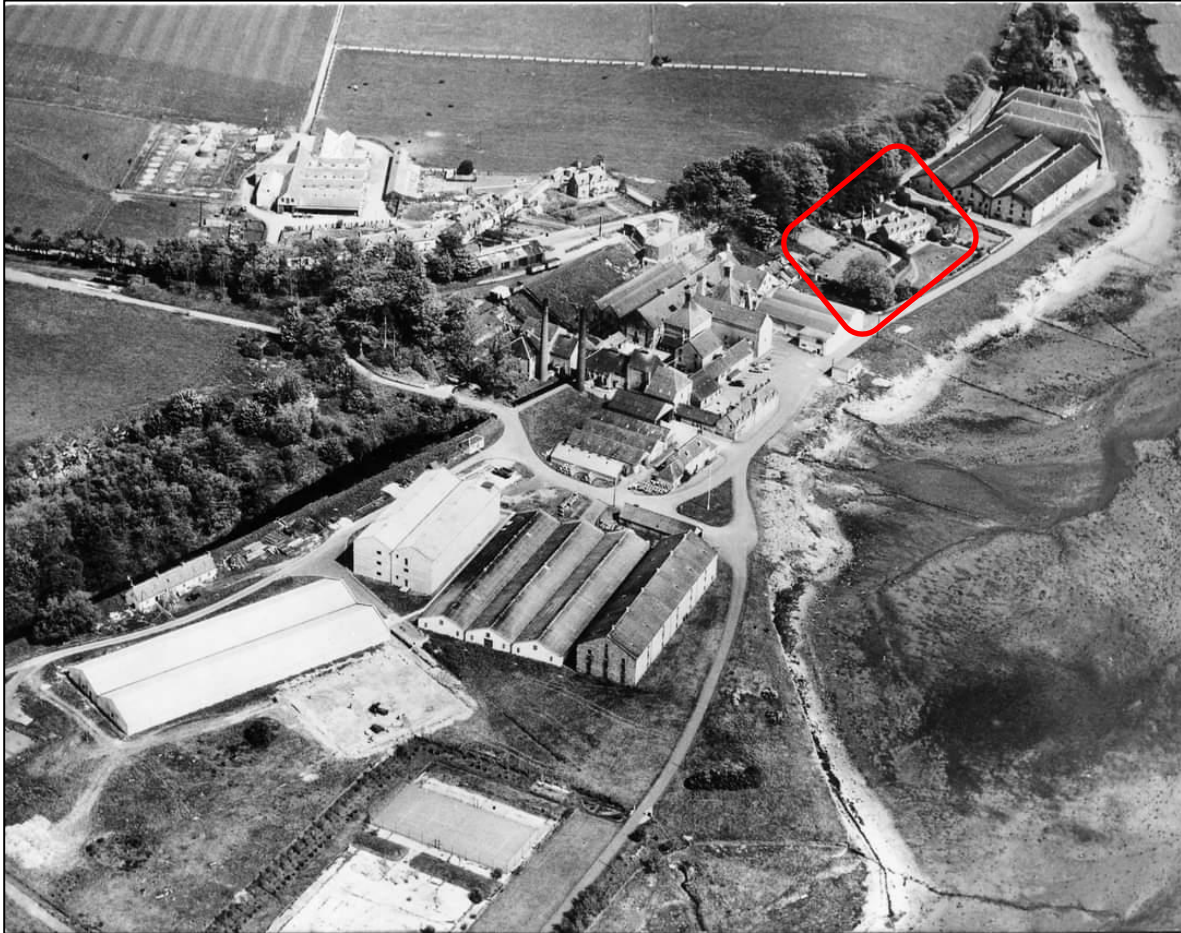
Figure 78: 1966 photo of Dalmore distillery. Garden area shown by red line

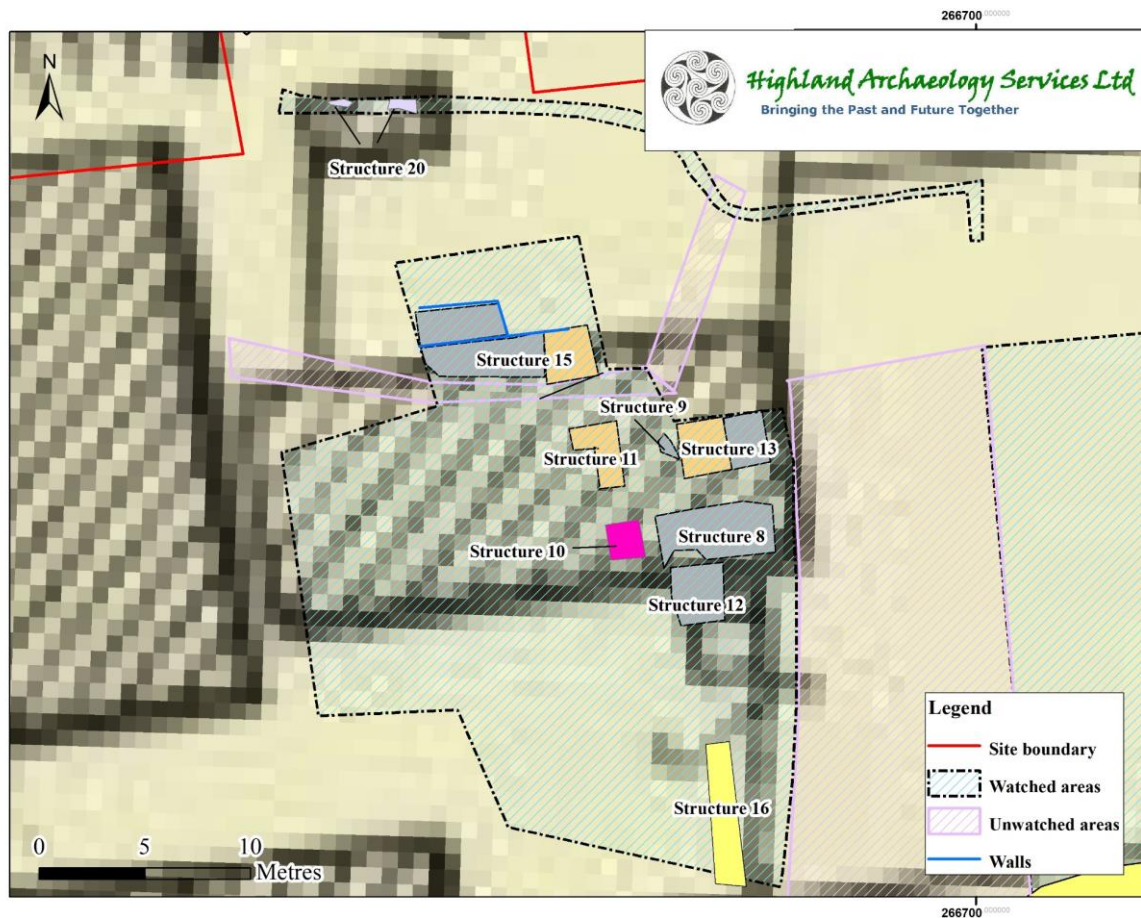
Figure 79: Boiler House Area

Again the structures in the area next to the boilerhouse sit within the footprint of a structure shown on the second edition OS map surveyed in 1904. 1904 is fairly early for precast concrete therefore seems likely these are either a later addition to the building or these structures have been located here after the structure shown on the OS map was demolished. The Brora bricks surrounding some of the structures within this area date to between 1914 and 1949 therefore later in date than the OS map survey date of 1904. This would further add to the evidence that these features are later in date than the structure depicted on the map. Similar Hunter Brora bricks have also been noted at North Sutor where wartime remains are also located. Maps provided by ARCH (see Figure 80 and Figure 81 below) show that there were two structures within this area depicted as a 'coal house' and 'tank' and used during WW1 but that during WWII they were not used for military purposes. In addition, the wall of structure 15 seems to align well with the north wall of the structure on the 1904 map. It may be that this wall was re-used by a later structure.
