Dalmore Distillery Watching Brief

DSR and Recommendations

HAS Report No.	DMD22-004
Site Code	DMD22
Client	Blyth & Blyth Ltd
Planning Reference	22/02146/FUL
OS Grid Reference	NH 66710 68747
Date	11/09/2024
Author(s)	Karen Kennedy
Approved by	Lachlan McKeggie

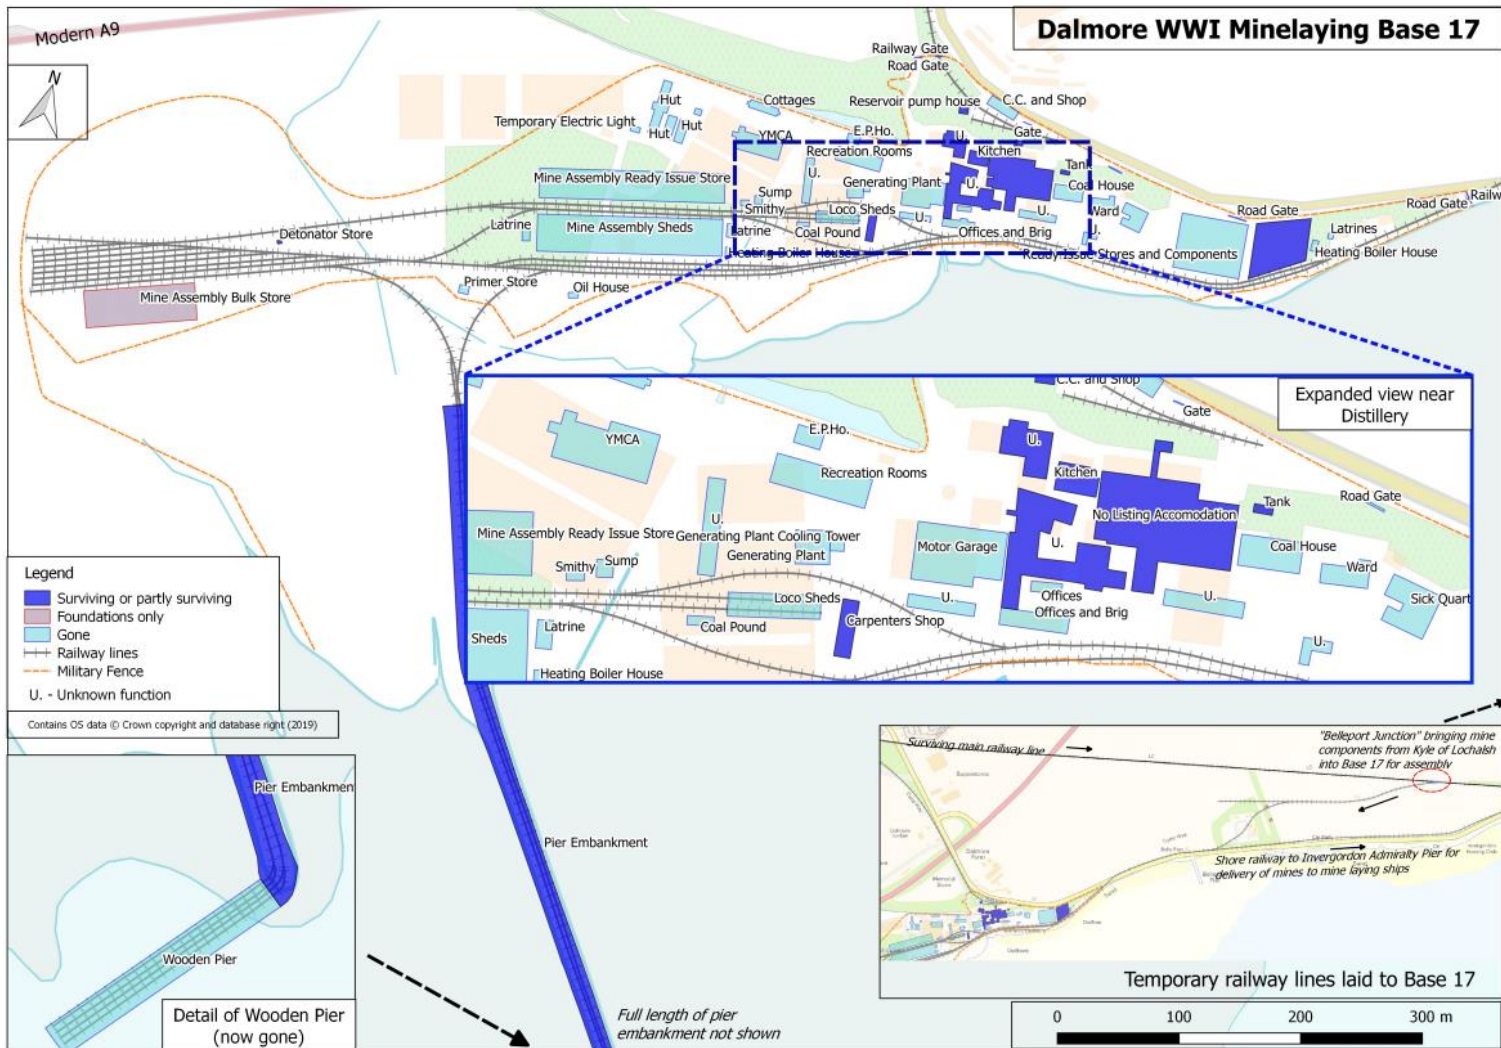
The locations of structure 20 to the north of this area also corresponds with a structure depicted on the WWI plan as a 'tank' (Figure 80). The concrete which overlies the cobbles within this structure may represent a later phase of use.

Figure 80: Dalmore WWI Minelaying Base 17 (courtesy of ARCH)
