FEARN ABBEY: CONSERVATION PLAN

For the past few months I have been carrying out research into the preparation of a conservation plan as part of the programme for repairs to the fabric of Fearn Abbey, funded by the HLF and by Historic Scotland.

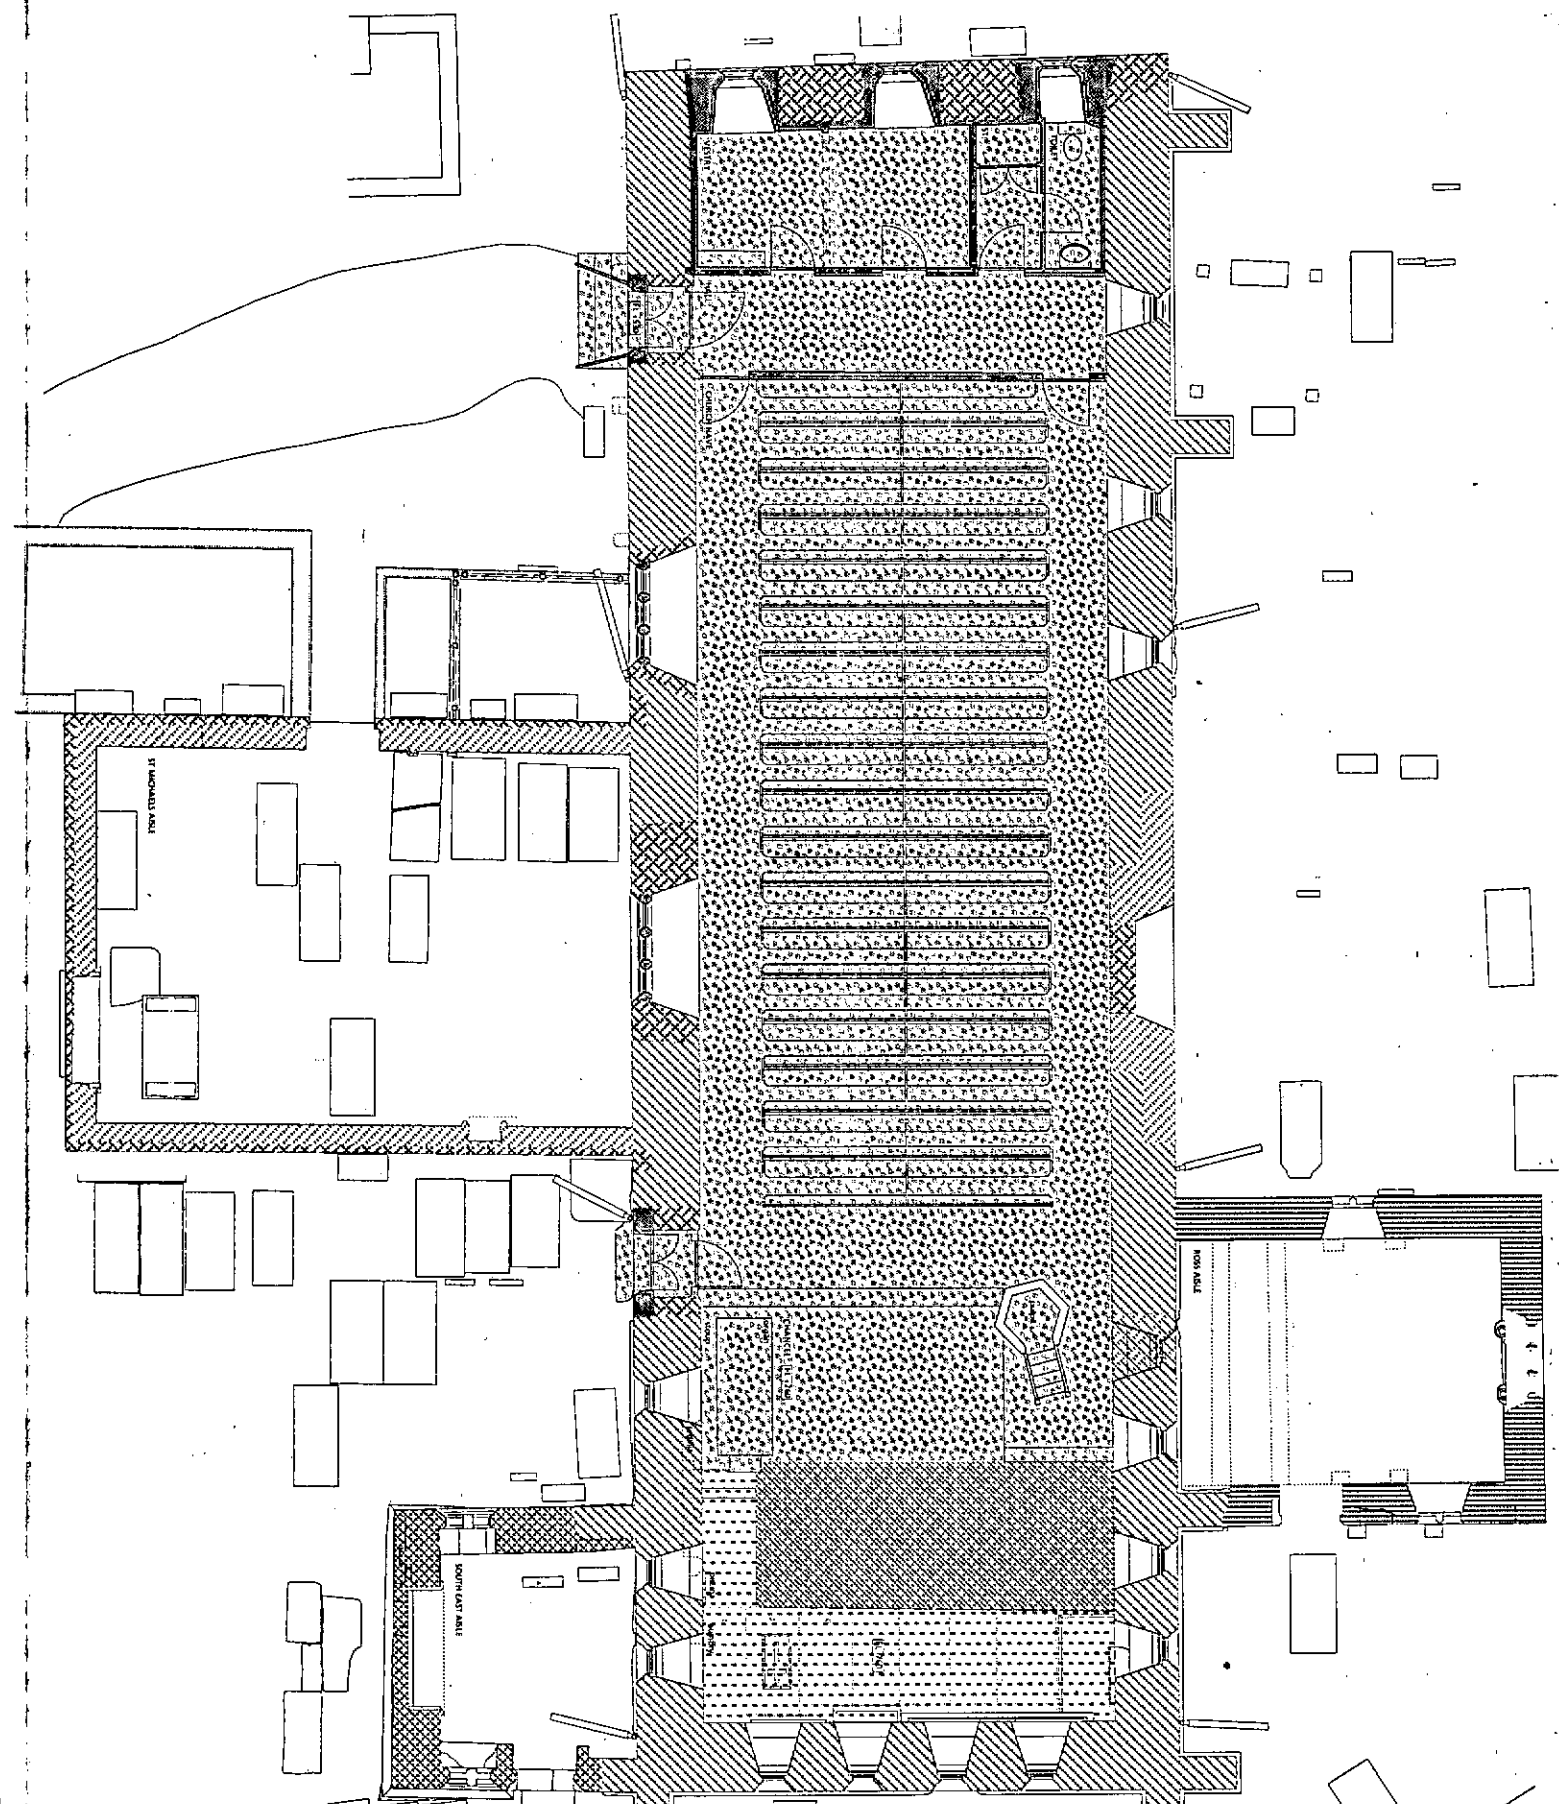
14th century
15th century
16th century
17th century
18th century
20th century

1903
1712
c.1970
