# John O'Groats Mill, Huna, Caithness

## Archaeology & Inventory of Artefacts

### Report

AOC 22376

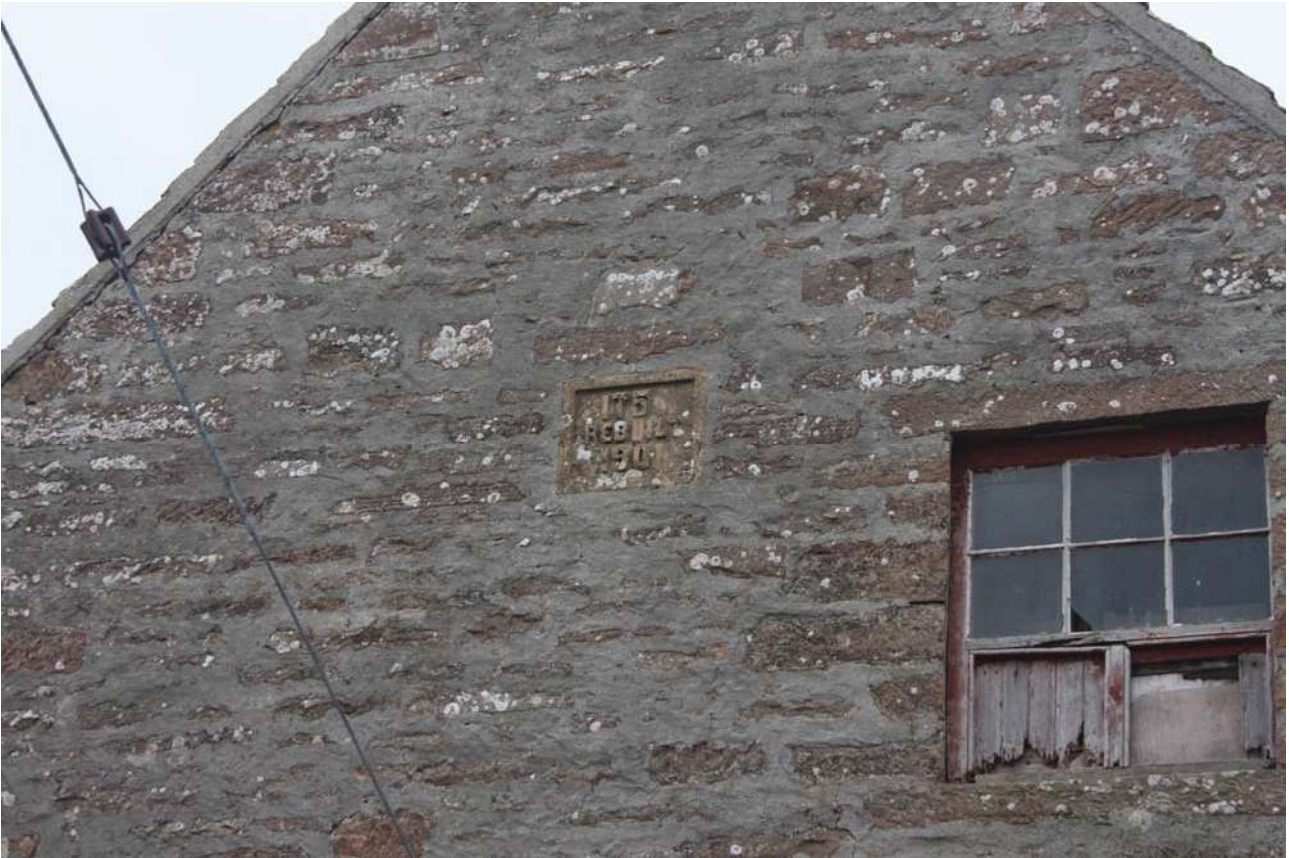
Plate 7: The mill, detail of the 1750 – 1901 datestone to the top of the south gable, from the SSE

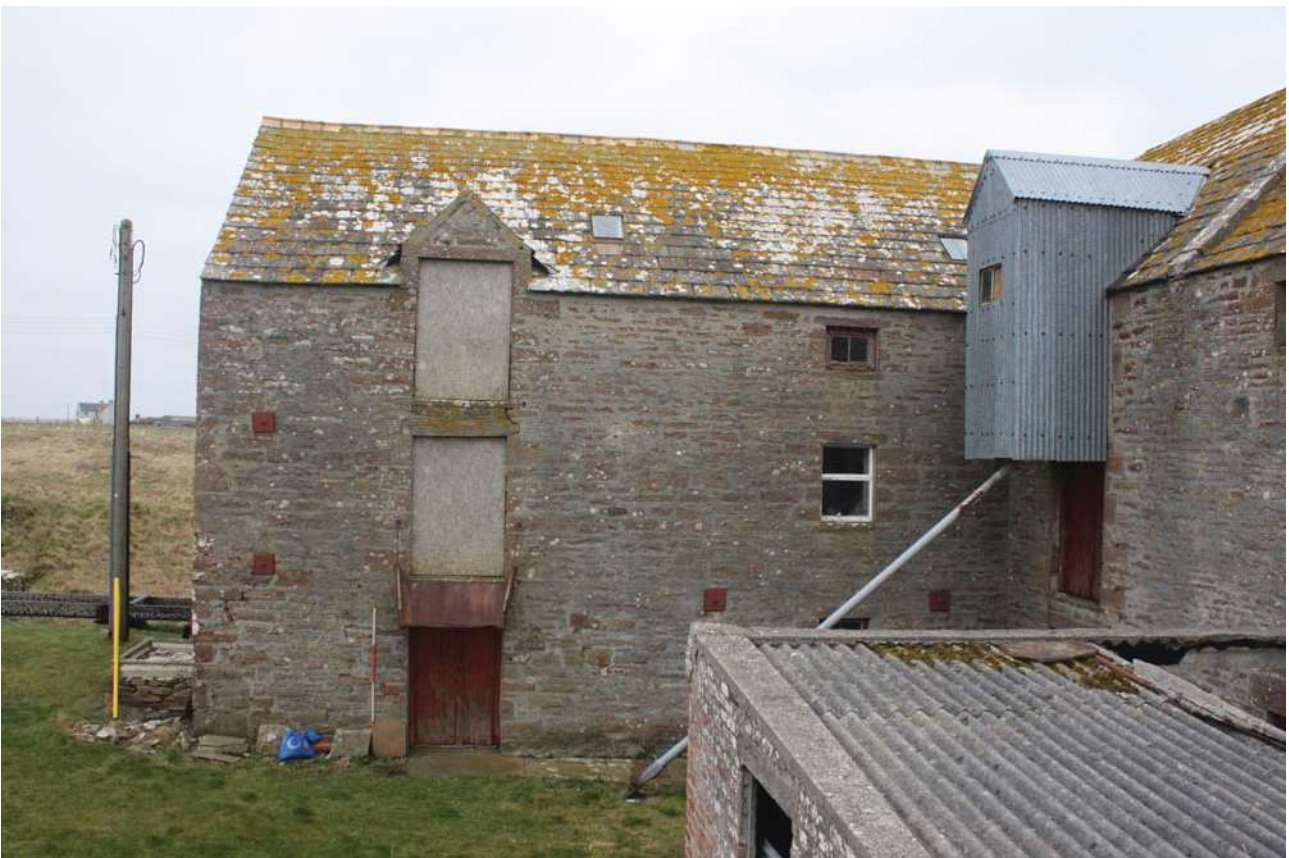
Plate 8: The mill, general view of the east elevation of the main mill to the south side, from the east

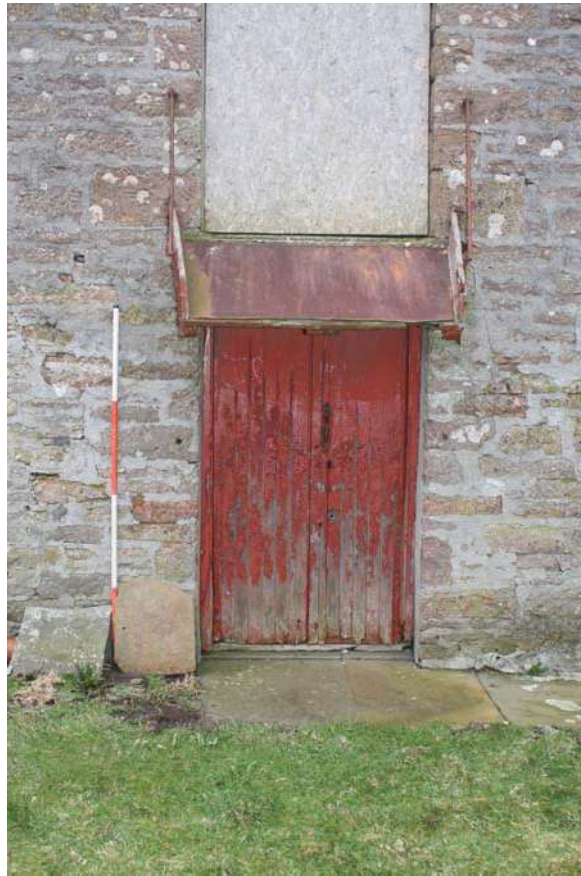
Plate 9: The mill, detail of the main entrance to the mill to the south bay of the east elevation, from the east

- 7.1.2 The main entrance is to the east elevation and, as can be seen in the archive photograph, the ground level in front of the mill has been reduced substantially (see [Figure 9](#); [Plate 109](#)). The main three bays to the north consist of (from south to north) the main double entrance door, an upper floor loading door with a triangular head raised above the roofline, and a smaller window with holes for exterior security bars ([Plate 110](#)). To the far top left (north) of the elevation is a tiny angled opening, thought to have been used for the operation of the sluice gate ([Plate 111](#)); an iron pole may have been attached to the gate over the timber lade and to the inside attached to a mechanism whereby the rod could move the gate back and forth/up and down to control the power of the water running over the wheel. Moving to the south part of the elevation, a small stone-blocked opening can be seen near ground level ([Plate 112](#)). The southernmost bay then features a ground floor window, which was once a doorway looking at the blocking below it, with a small first floor window above.

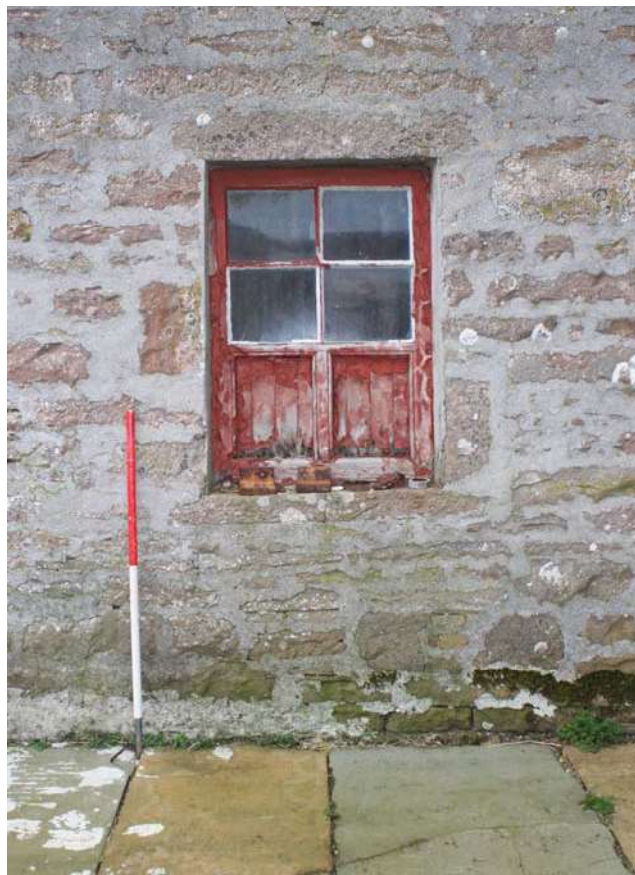
Plate 10: The mill, detail of the ground floor window in the east elevation, from the east

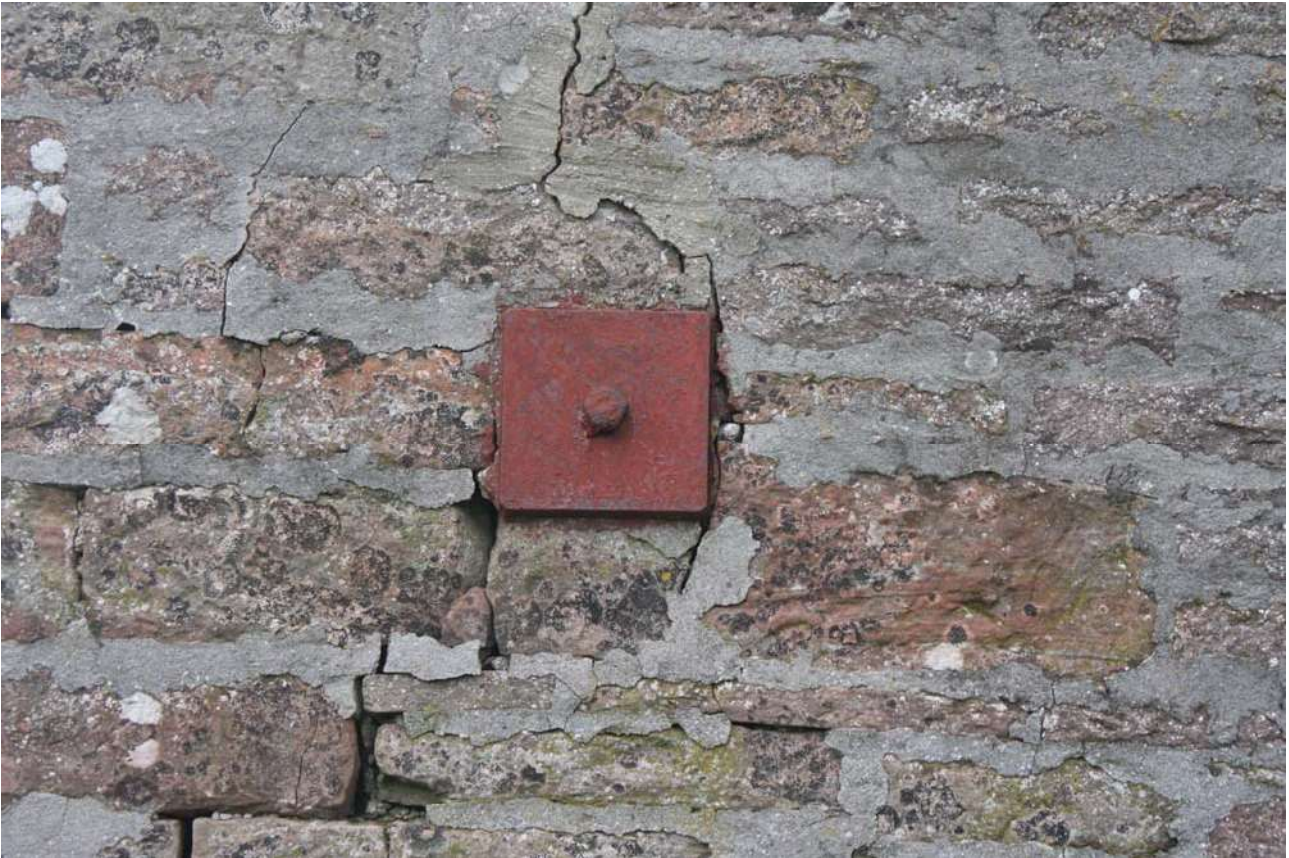
Plate 11: The mill, detail of the square building tie in the east elevation, from the east

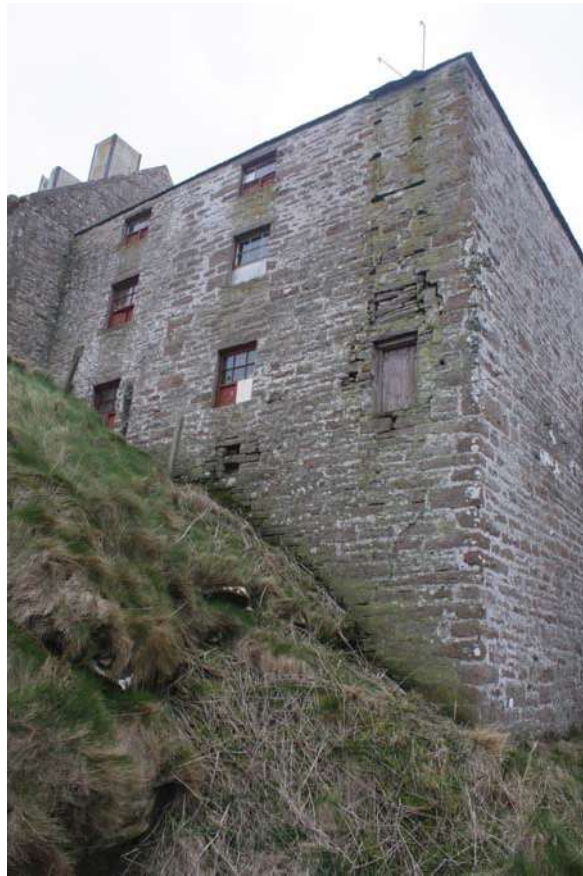
Plate 22: The mill, detail of the small door in the west bay of the north elevation of the mill, from the north-east

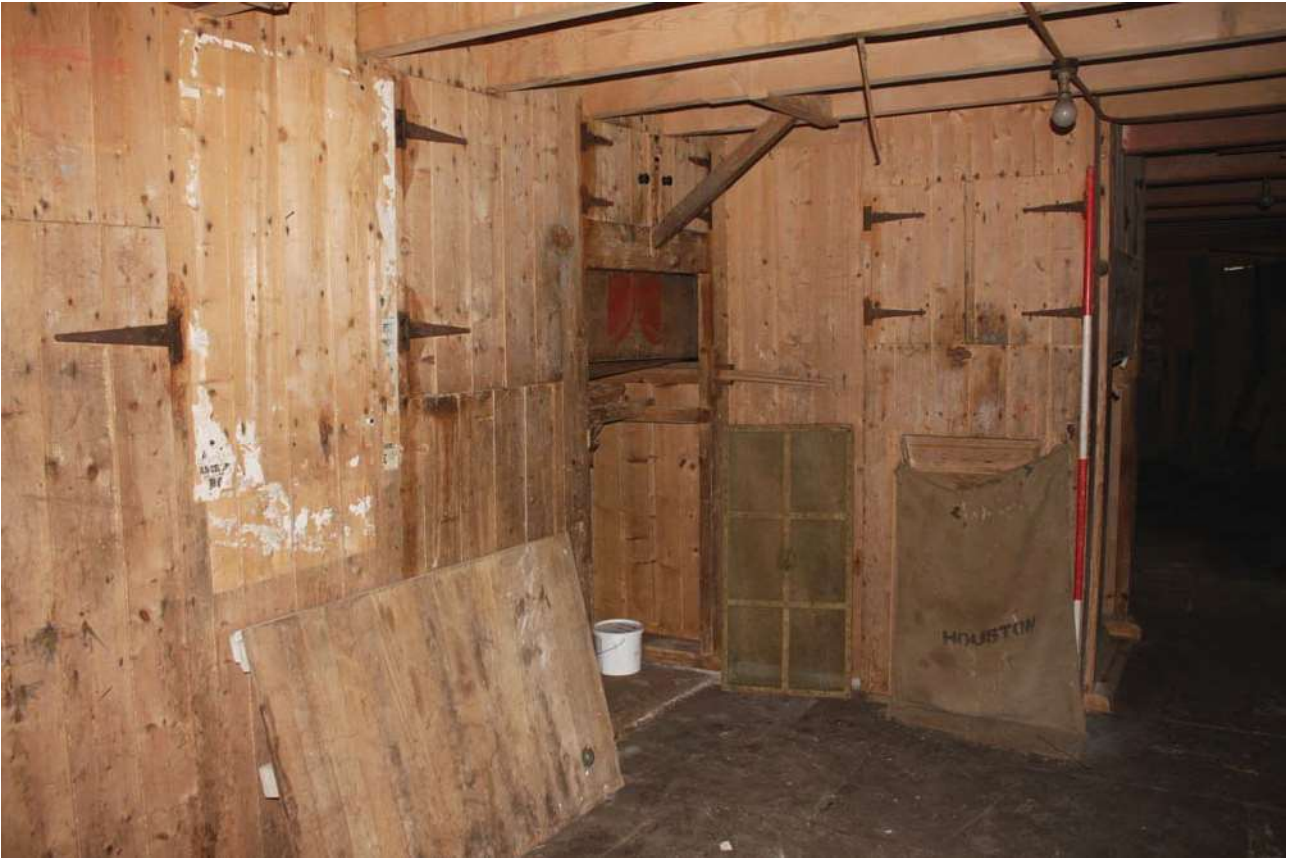
Plate 34: The mill, Room 0/1, detail of the south end of the gearing cupboard, from the east

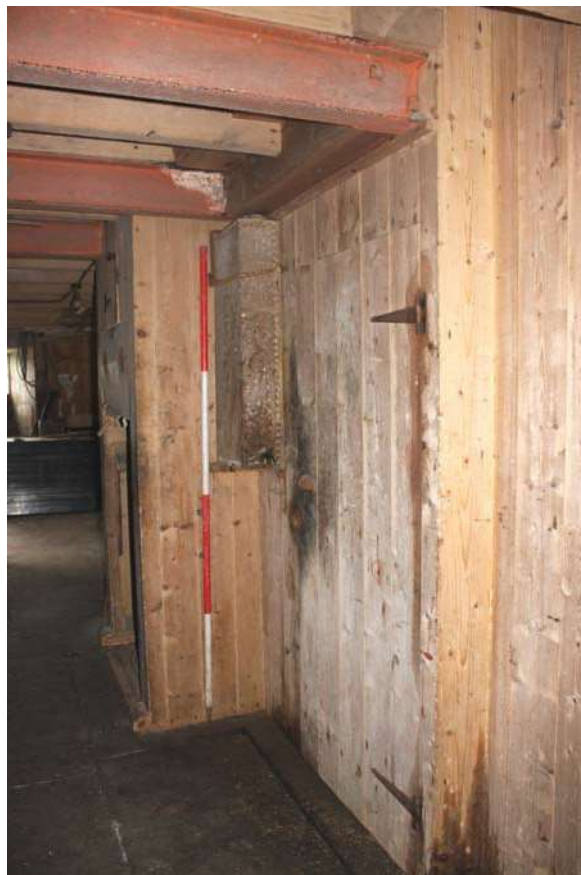
Plate 35: The mill, Room 0/1, detail of the south end of the gearing cupboard from the south-east

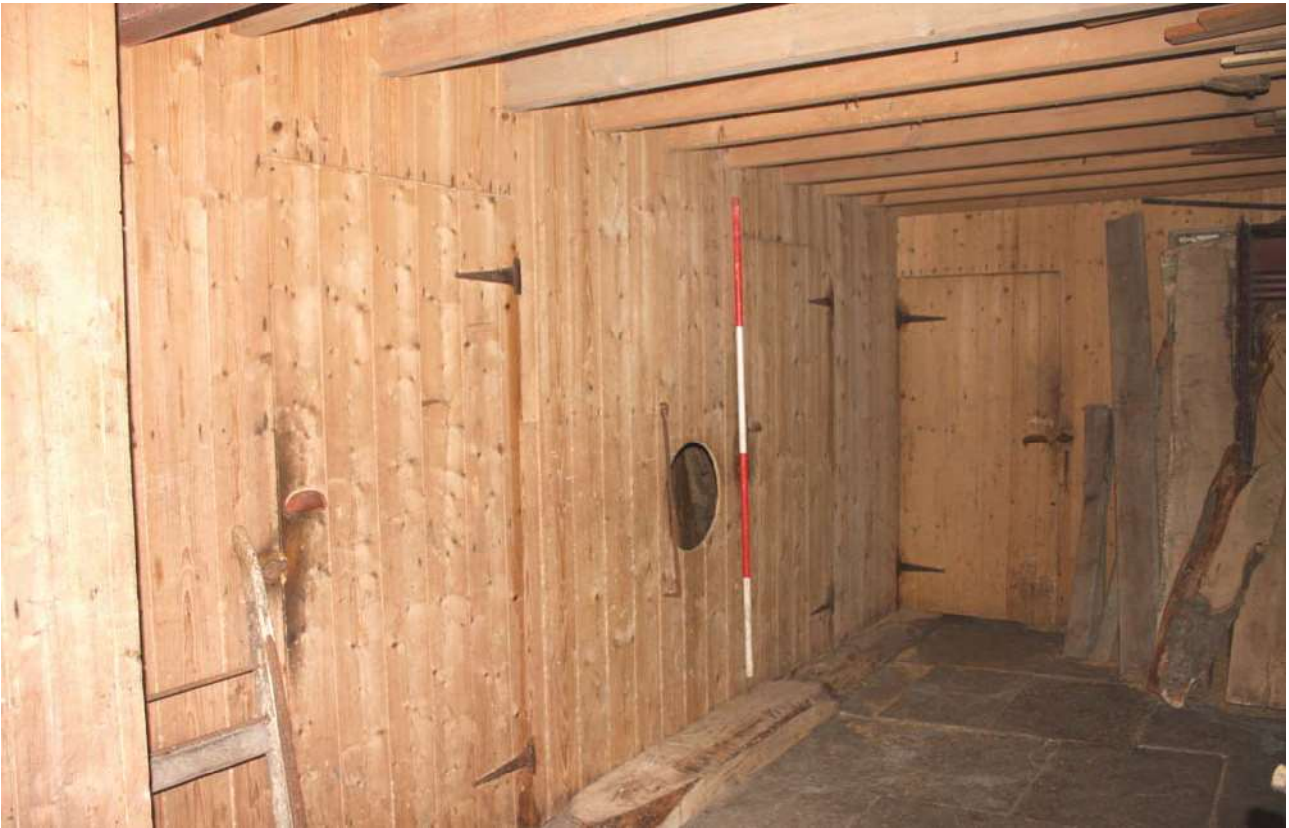
Plate 36: The mill, Room 0/1, detail of the south end of the gearing cupboard from the SSW

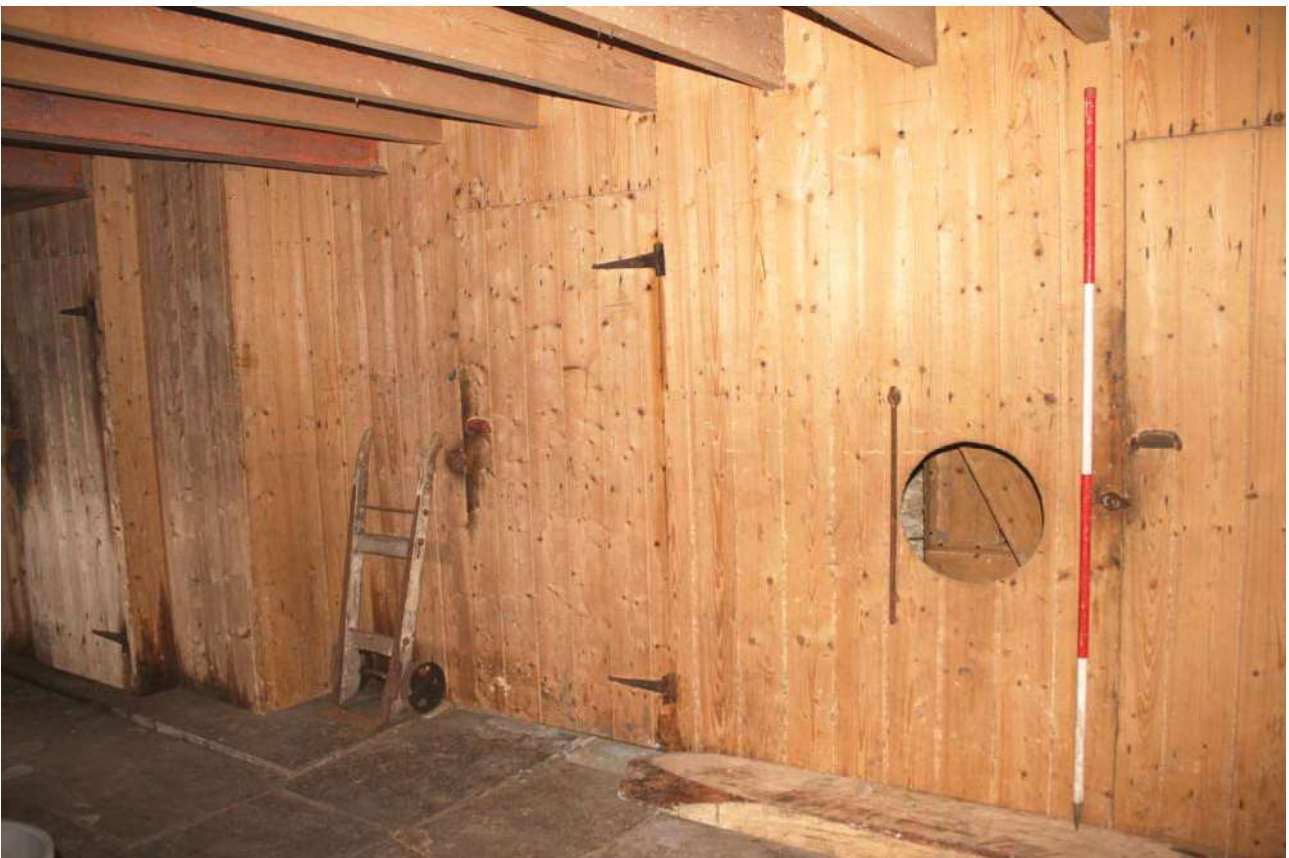
Plate 37: The mill, Room 0/1, detail of the north end of the gearing cupboard from the SSE

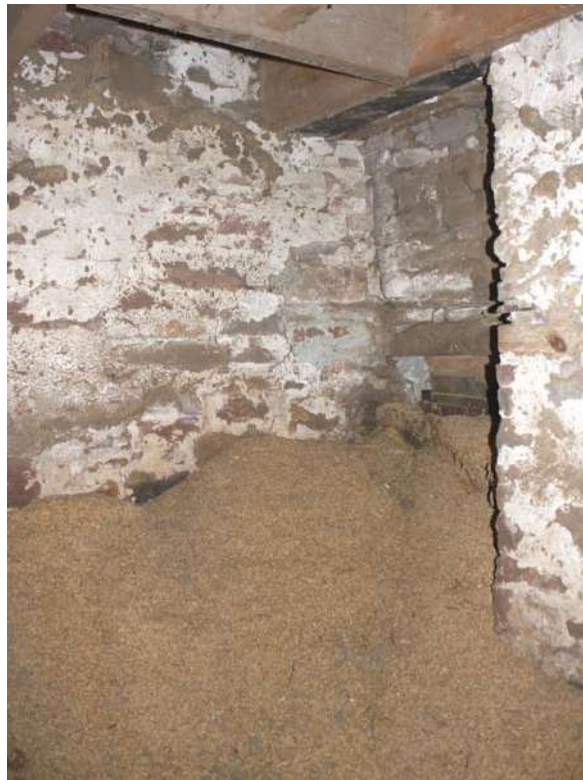
Plate 41: The mill, Room 0/1, general view of the north end of the gearing cupboard and doorway to the husk (sids) cupboard, Room 0/2, from the south

This is the husk cupboard, or 'sids' cupboard, used for storing the husks discarded from the fanner/winnowing machine which was, in this case, to the west end of the south side set within the gearing cupboard. Opposite this on the west wall is a small stone-blocked recess, equating to the small doorway seen to the exterior wall ([Plates 42 & 43](#)). A small splayed window is located adjacent to this to the far north side of the room ([Plate 44](#)).

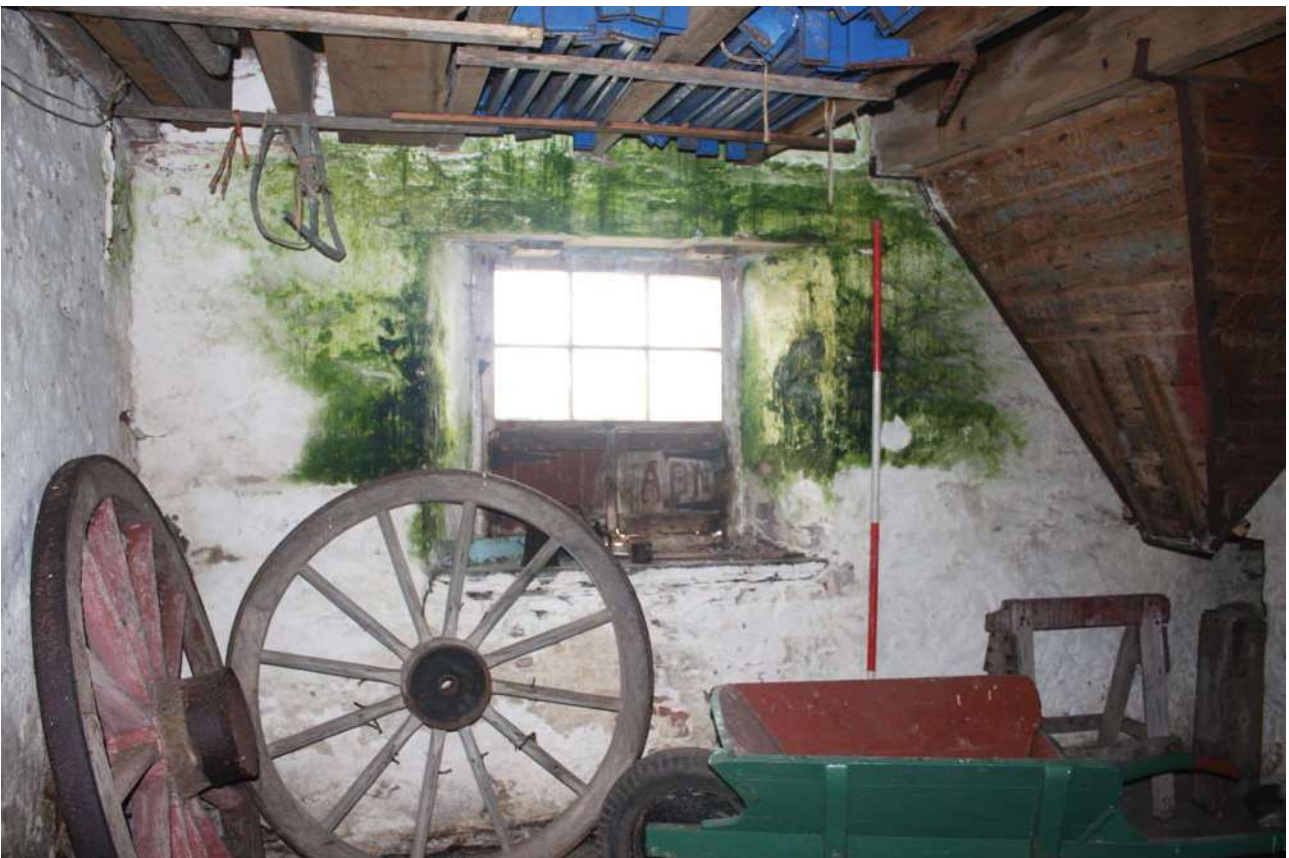
Plate 47: The mill, Room 0/3, general view of the south wall from the NNW

This small room is located between the main mill and the furnace room to the north and is accessed from Room 0/1 through a double door ([Plate 45](#)) and has a wide opening in the stone walling to the north side going down into 0/4 via two stone steps. As with 0/1 and 0/4, it has whitewashed stone rubble walls and a stone flagged floor and is dominated by the three hoppers against the north wall ([Plate 46](#)). On the south wall is the small inward opening double door (now too dilapidated to open) ([Plate 47](#)). Another splayed

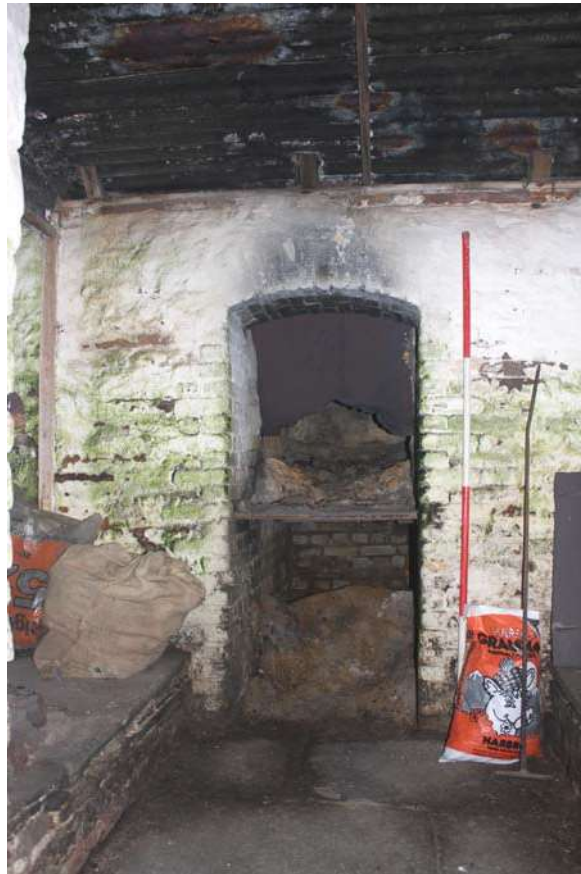
Plate 49: The mill, Room 0/4, detail of the furnace opening in the east wall from the west

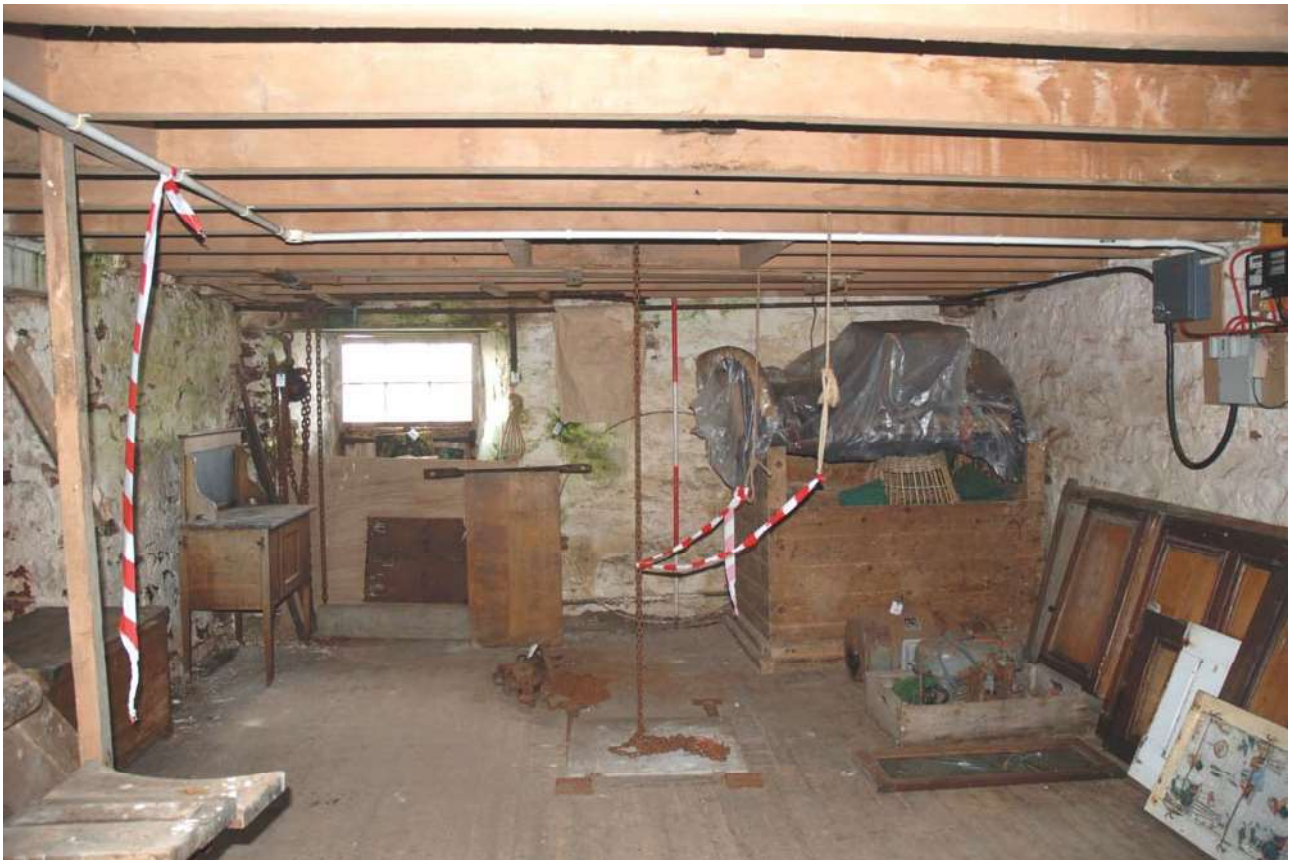
Plate 56: The mill, Room 1/1, general view of the south wall from the north

The first floor of the mill is the main working area with three large millstones along the west side with a small annexed room (Room 1/2) to the north-east into the back wall of the kiln behind (Plates 56 – 58; Figures 19 & 21). With white-washed stone rubble walls, the floor has timber floorboards with sawn timber floor beams supporting the floor above. The stair continues to the east side of the mill with the loading door behind, boarded to the exterior, a dilapidated inward-opening vertically-panelled door within (Plates 59 & 60). The splayed window in the south wall to the east side also continues from the first floor arrangement; a large chest covers the remainder of the south wall (see Plate 56).

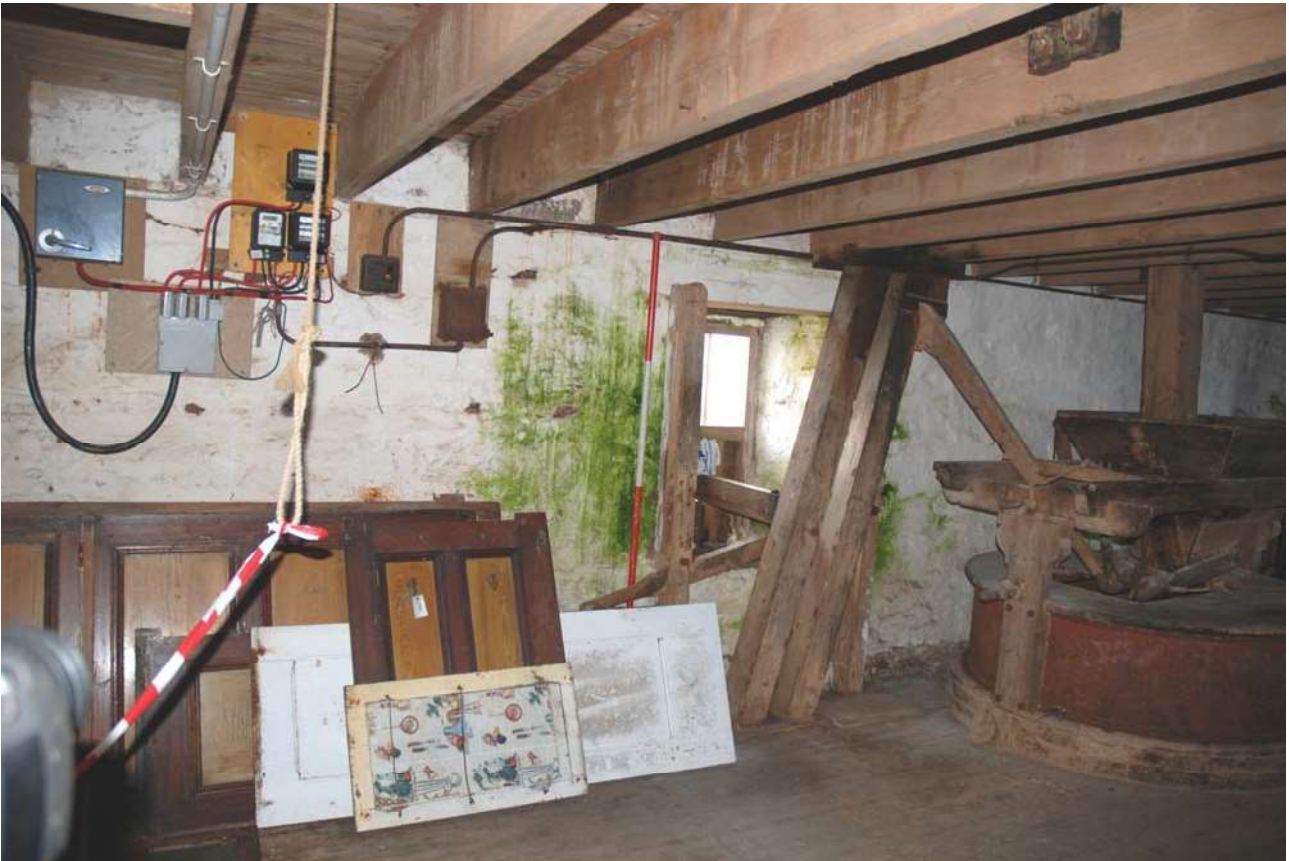
Plate 57: The mill, Room 1/1, general view from the south-east

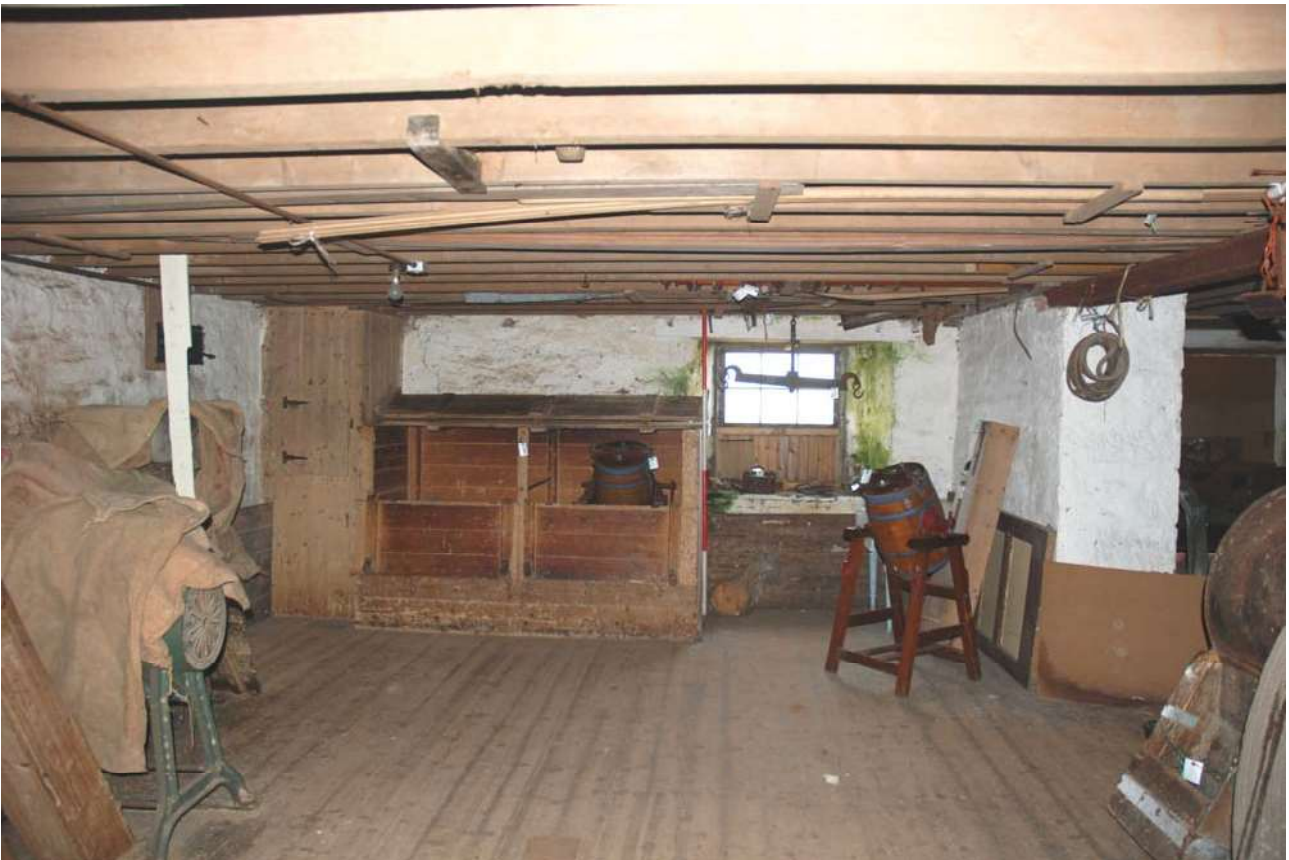
Plate 58: The mill, Room 1/1, general view of the north wall from the south

On the north wall there is another splayed window to the east side with a large timber box taking up the remainder of the wall (see Plate 58); in the north-west corner is an enclosed timber panelled area which goes up to the second floor, as noted from the first floor. To the north side of the east wall is the wide opening into Room 1/2, no doorway (Plate 66).

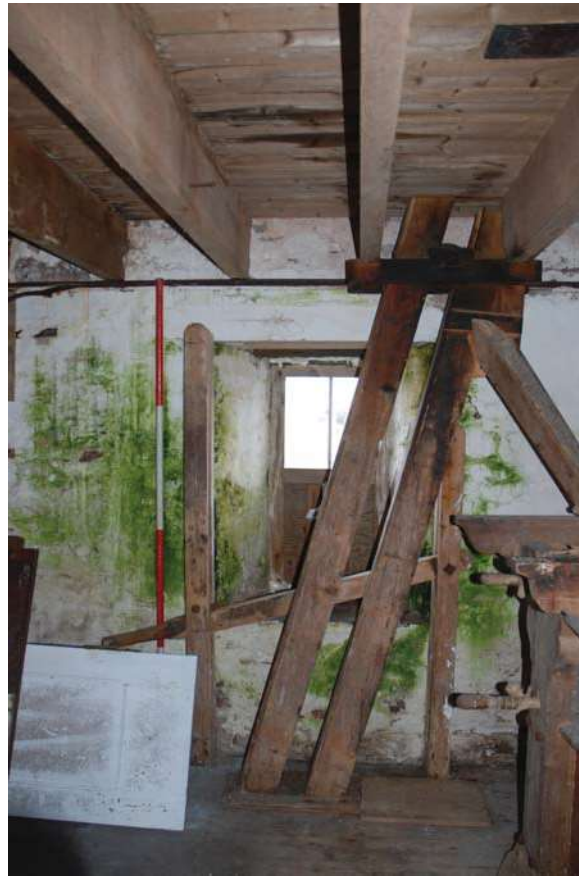
Plate 61: The mill, Room 1/1, detail of the window in the west wall from the east

To the north of the stair on the east wall is a window, square-set. Opposite this on the west wall is another window, seen from the exterior as located above the main wheelhouse. The bottom pane is boarded and contains a pulley system, protected to the interior within a wooden skin (Plate 61). The three millstones themselves are covered with steel tun covers on a timber footing, with voids in the centre with adjustable hoppers above with timber chutes coming through the floorboards to feed the hoppers (Plates 62). Bucket elevators also exist to the north side together with two bruisers fixed to the floor, one of which has a powered motor, the other hand driven (Plates 63 - 65). There is also a small square patch in the floor of the mill to the north side – there are more to the second floor – indicating earlier possible links with the ground floor.

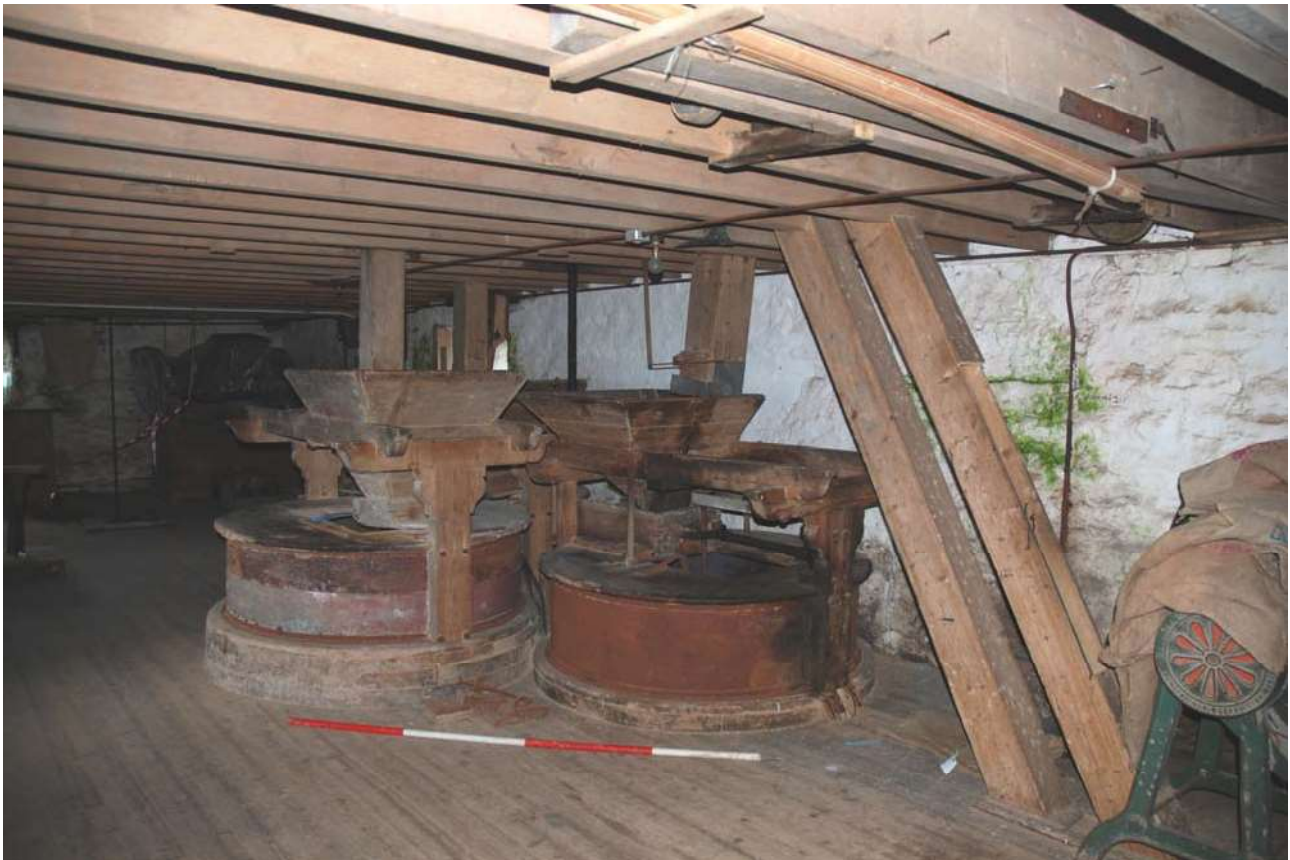
Plate 62: The mill, Room 1/1, detail of the grinding stones from the north-east

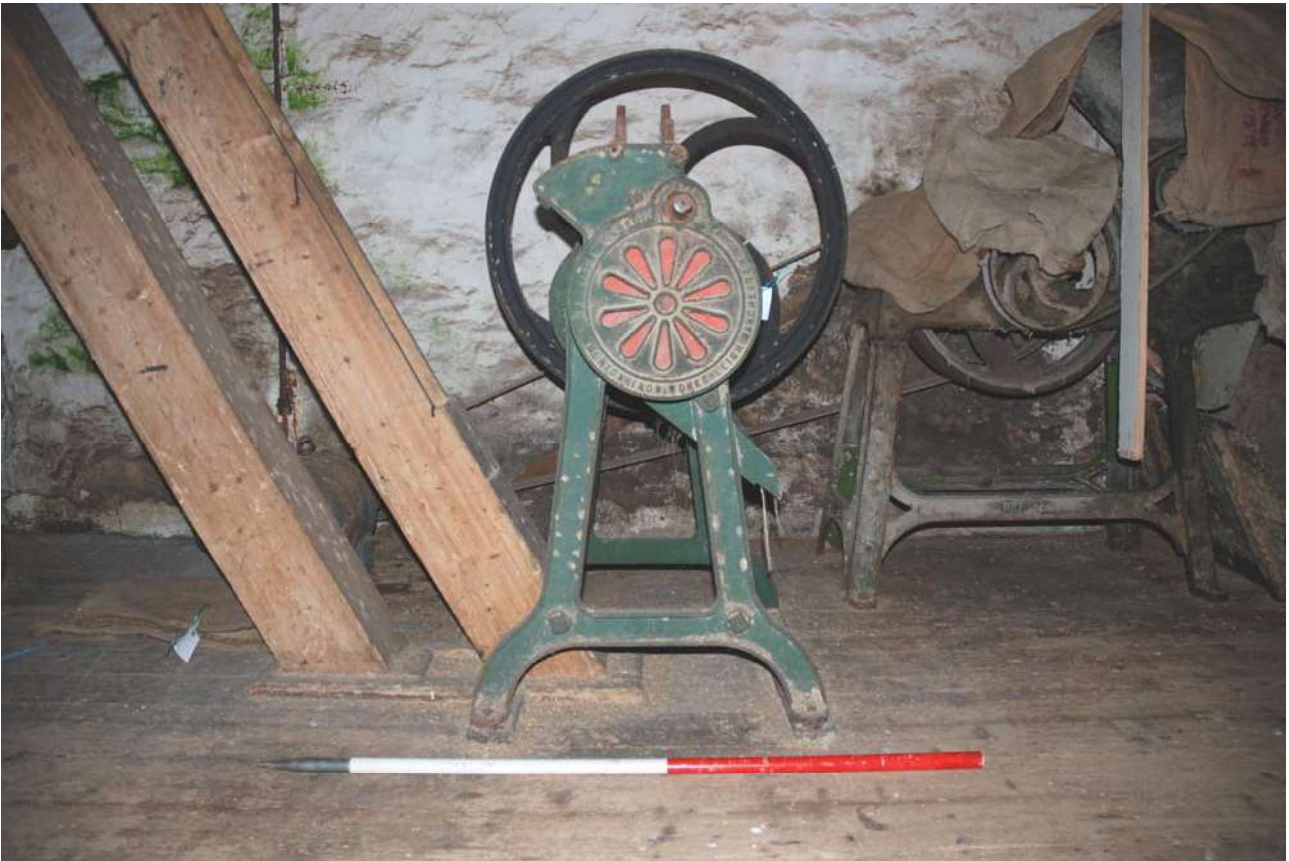
Plate 63: The mill, Room 1/1, detail of the bruiser to the north of the grinding stones from the east

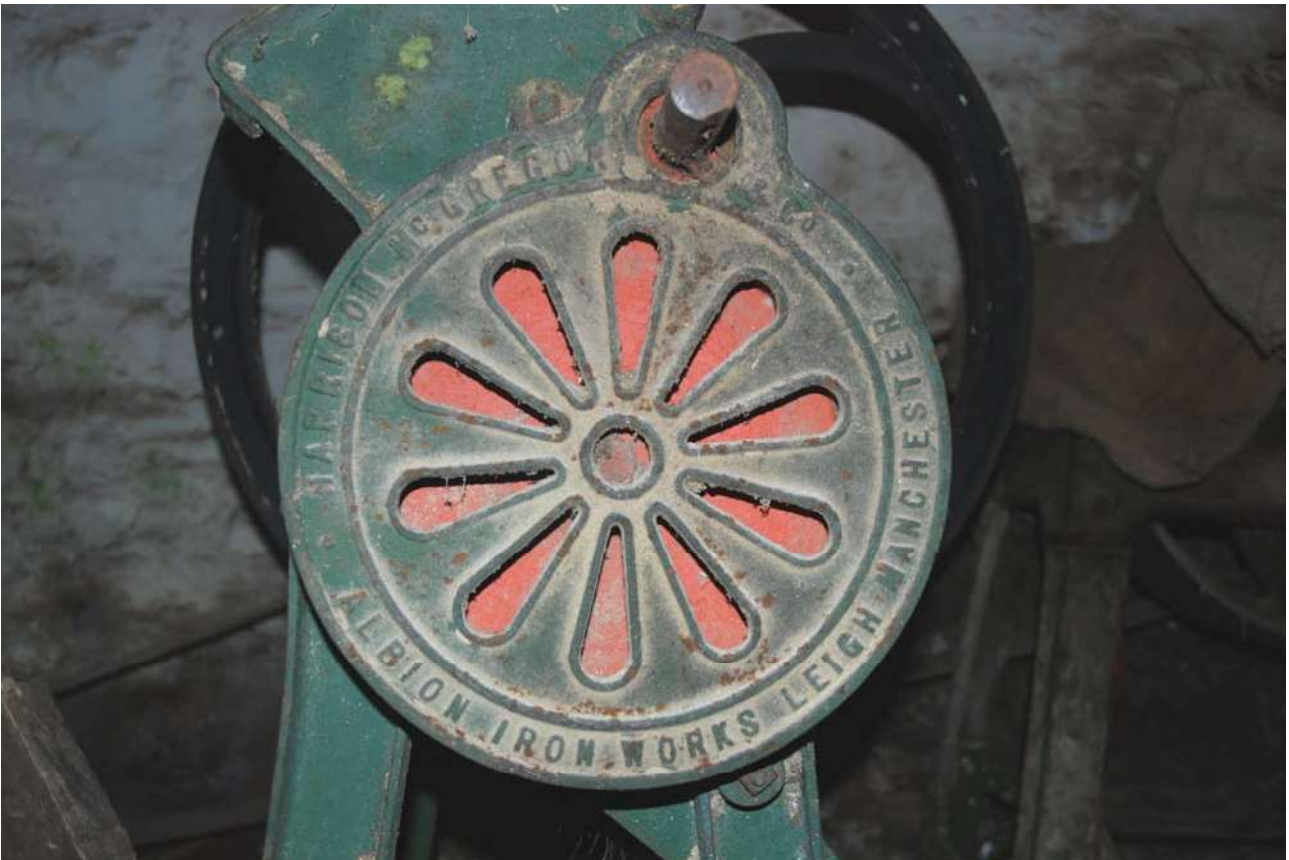
Plate 64: The mill, Room 1/1, detail of the manufacturer's mark on the wheel of the bruiser to the north of the grinding stones from the east

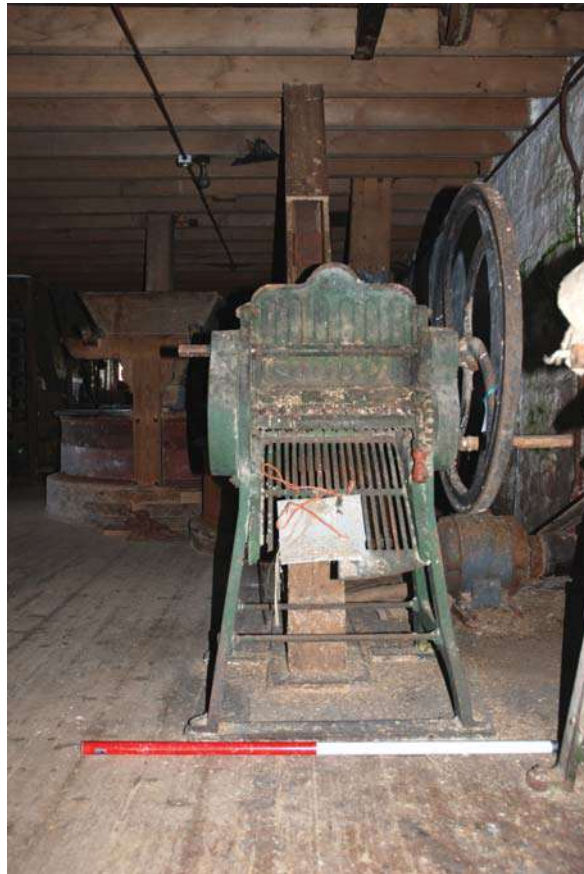
Plate 65: The mill, Room 1/1, detail of the second bruiser to the north, from the north

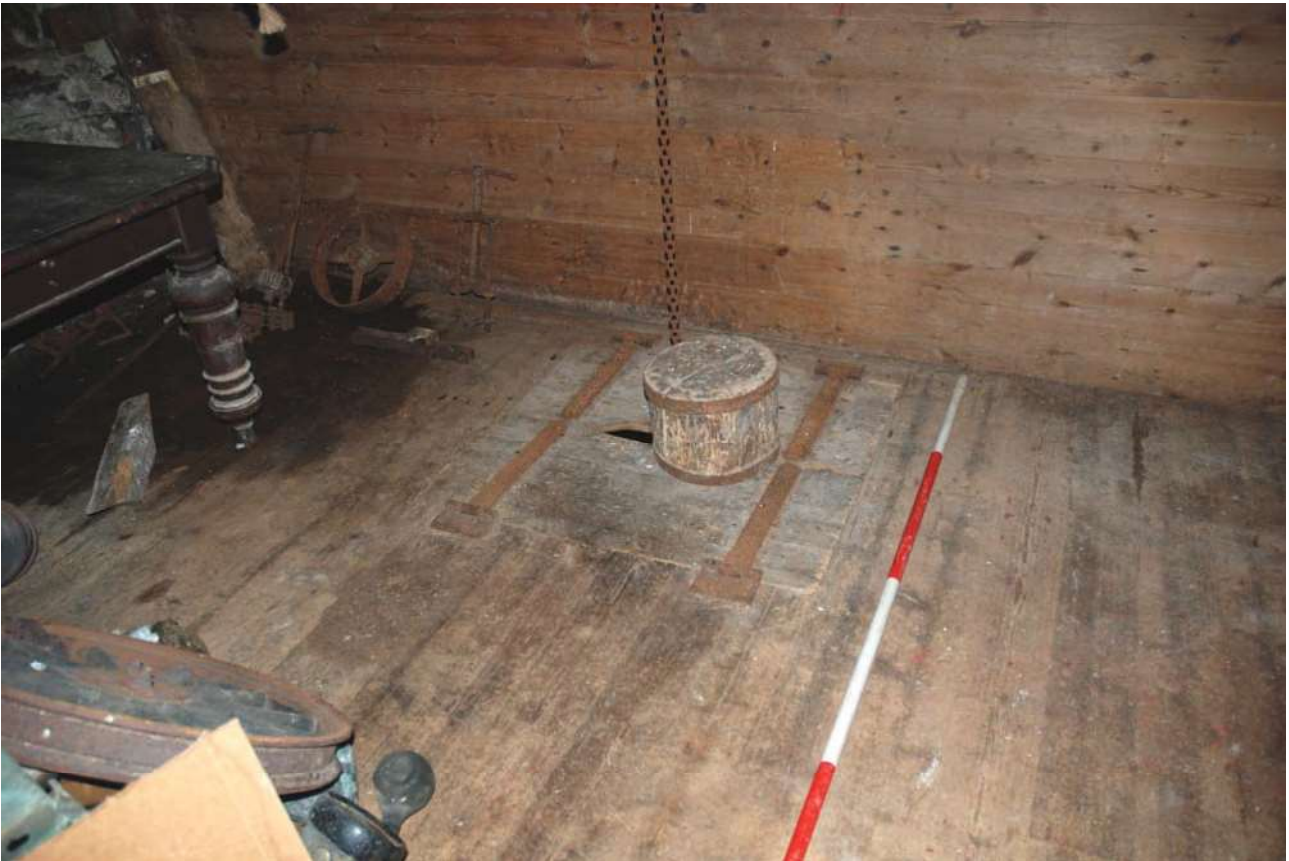
Plate 69: The mill, Room 1/2, detail of the trap door from the NWW

This small room located to the west of the kiln area and east of Room 1/1 continues the timber floorboard arrangement, although the floor beams are now north/south orientated. The room is dominated by a large dining table in the north-west corner, adjacent to another splayed window to the east of the north wall (Plate 67). The entire east wall is then timber panelled, similar to that forming the gearing cupboard on the ground floor, with small discrete spaces within. These were 'fed' by small chutes in the kiln wall to the north and south sides – the dried grain would have been discarded from the west wall of the drying floor above and deposited here in this space (Plate 68). A trap door sits in the floorboards in front of it, providing the means to move the dried sacks of grain easily to different floor levels of the mill (Plate 69).

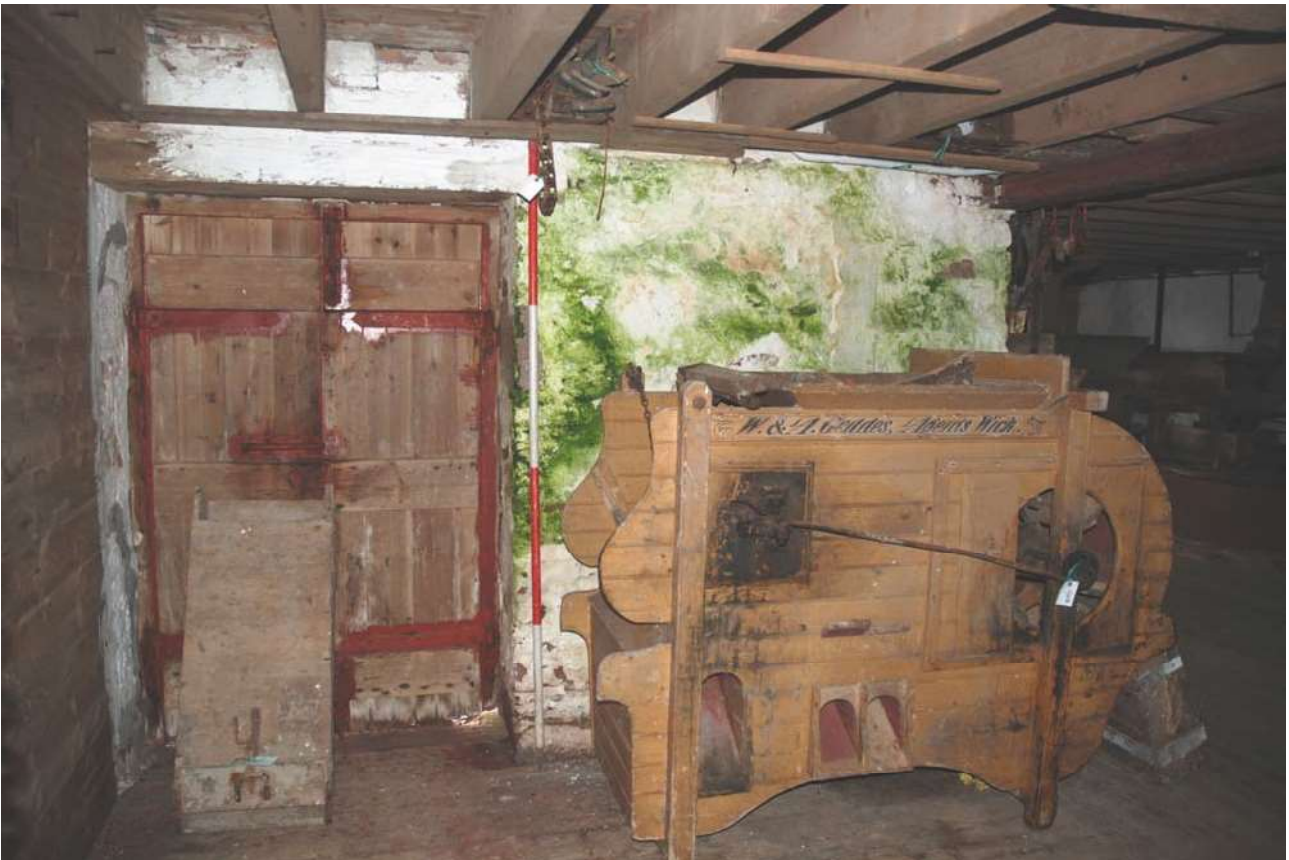
Plate 70: The mill, Room 1/2, general view of the south wall from the north

To the south wall is another inward-opening double door adjacent to a timber winnowing machine/fanner from 'W A GEDDES AGENTS, WICK' (Plate 70).
