# John O'Groats Mill, Huna, Caithness

## Archaeology & Inventory of Artefacts

### Report

AOC 22376

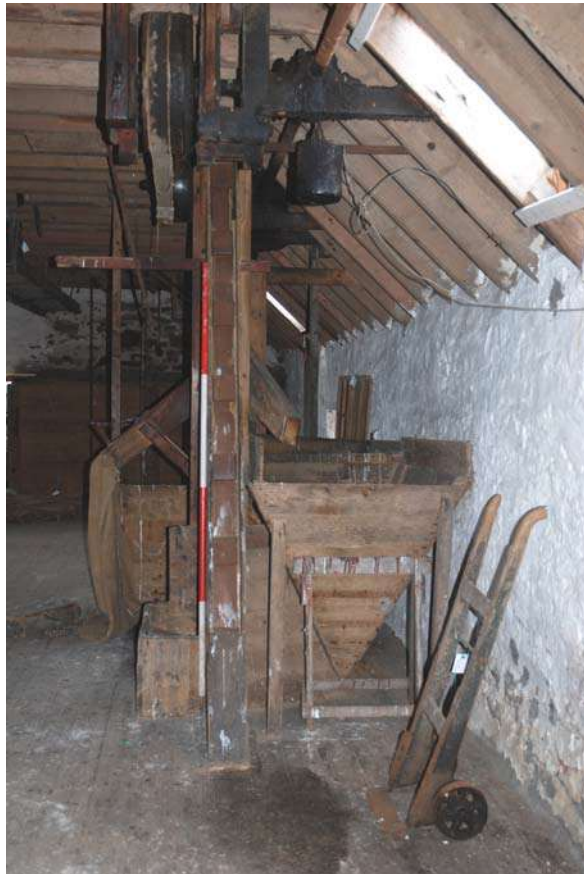
Plate 75: The mill, Room 2/1, detail of the hoppers against the west wall from the north

To the centre of the west wall, above the millstones to the first floor, are a collection of hoppers and bucket elevators associated with the processing of the grain (Plates 75 & 76). A splayed window is located to the west wall to the south of this (Plate 77). Opposite the hoppers there is another square-set window.

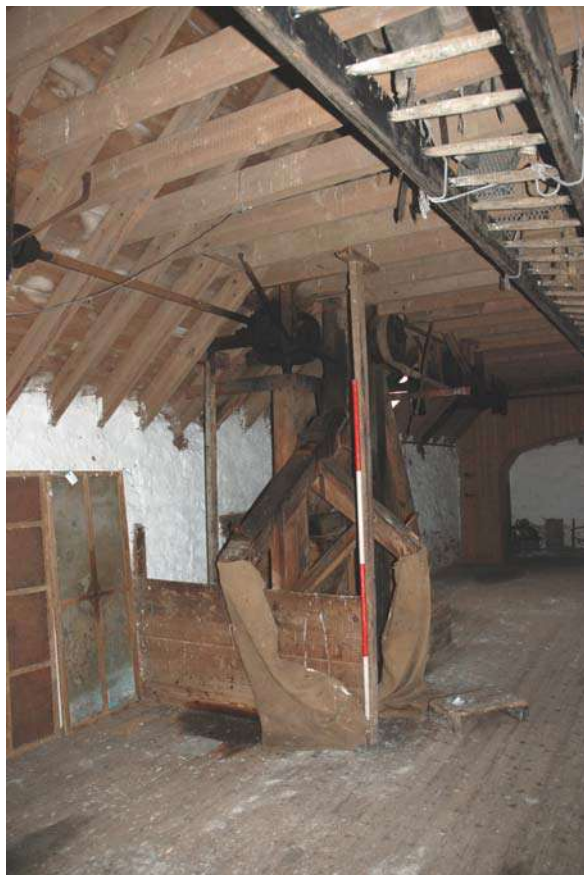
Plate 76: The mill, Room 2/1, detail of the hoppers against the west wall from the south-east

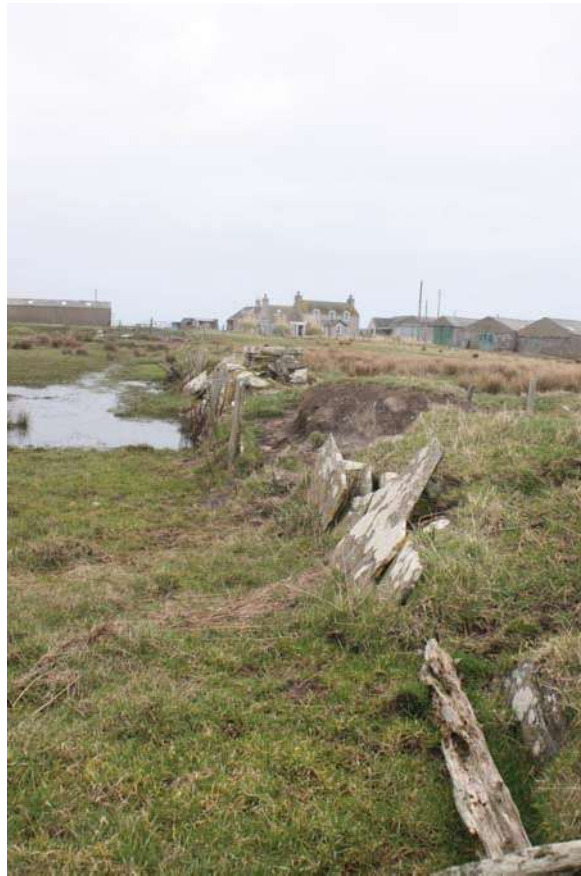
Plate 87: The mill pond, detail of the upright flagstones to the north side, from the east

- 6.1 The mill pond is located to the south of the mill, across the main road and to the east of Mill House. The exact date as to when it was established is unknown, although it first appears cartographically in the 1877 map (see [Figure 10](#)). It consists of a roughly rectangular pond, lined to the outer edge with Caithness flagstones, many of which have slumped and toppled, although the original character of it remains ([Plates 83 - 87](#)). The raised perimeter of the pond has also been eroded by cattle over the years, and small passageways at the weaker points have been broken through the mound.

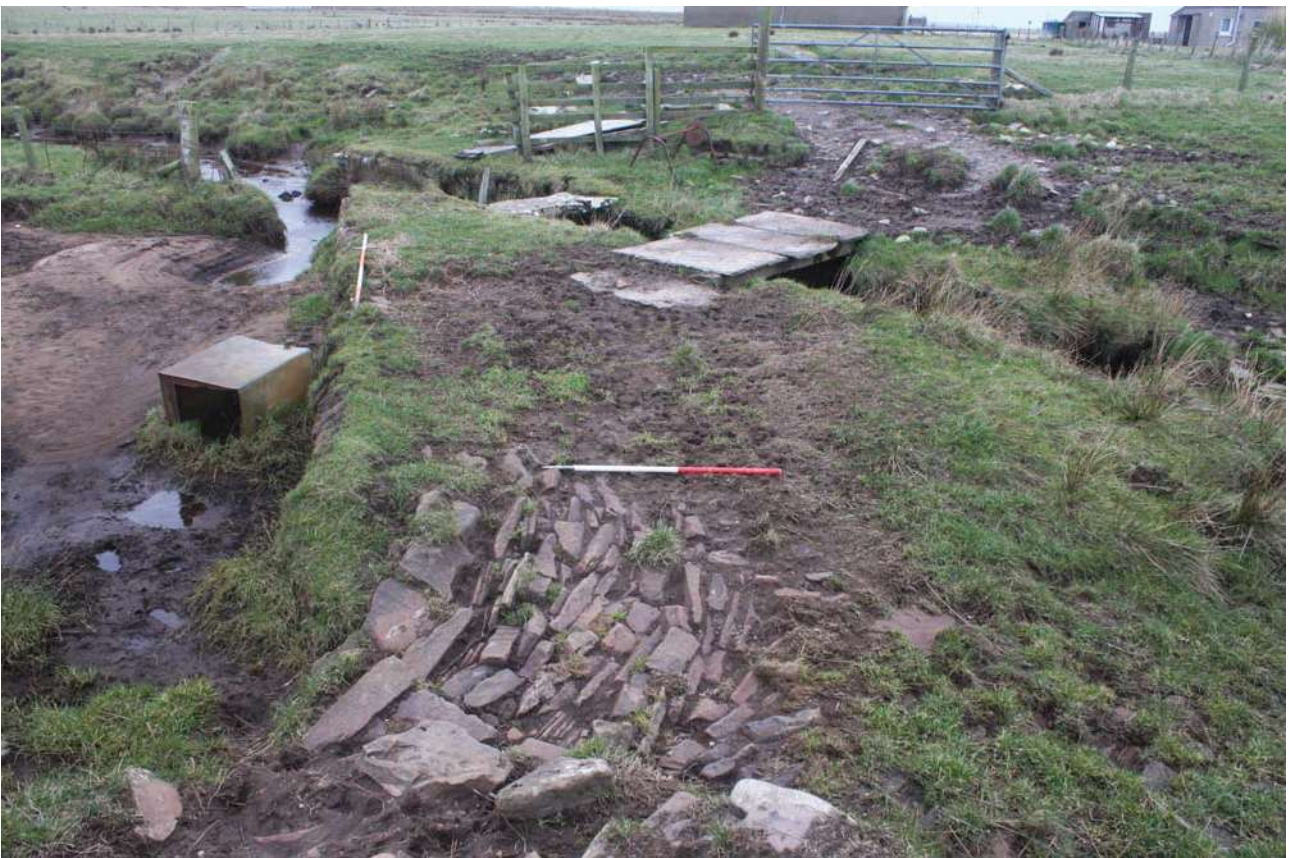
Plate 89: The mill pond, detail of the weir, from the SSE

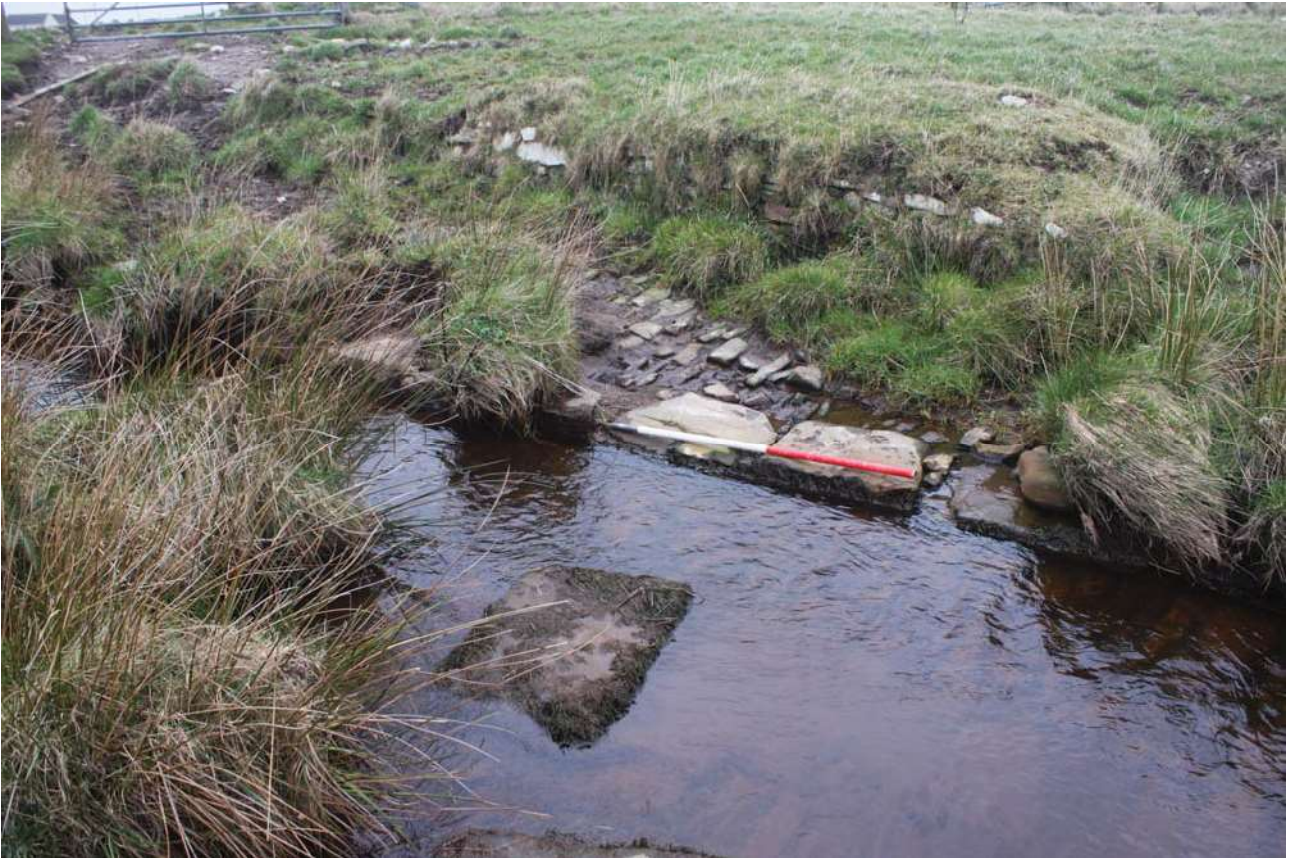
Plate 90: The mill pond, detail of the weir, from the north-east

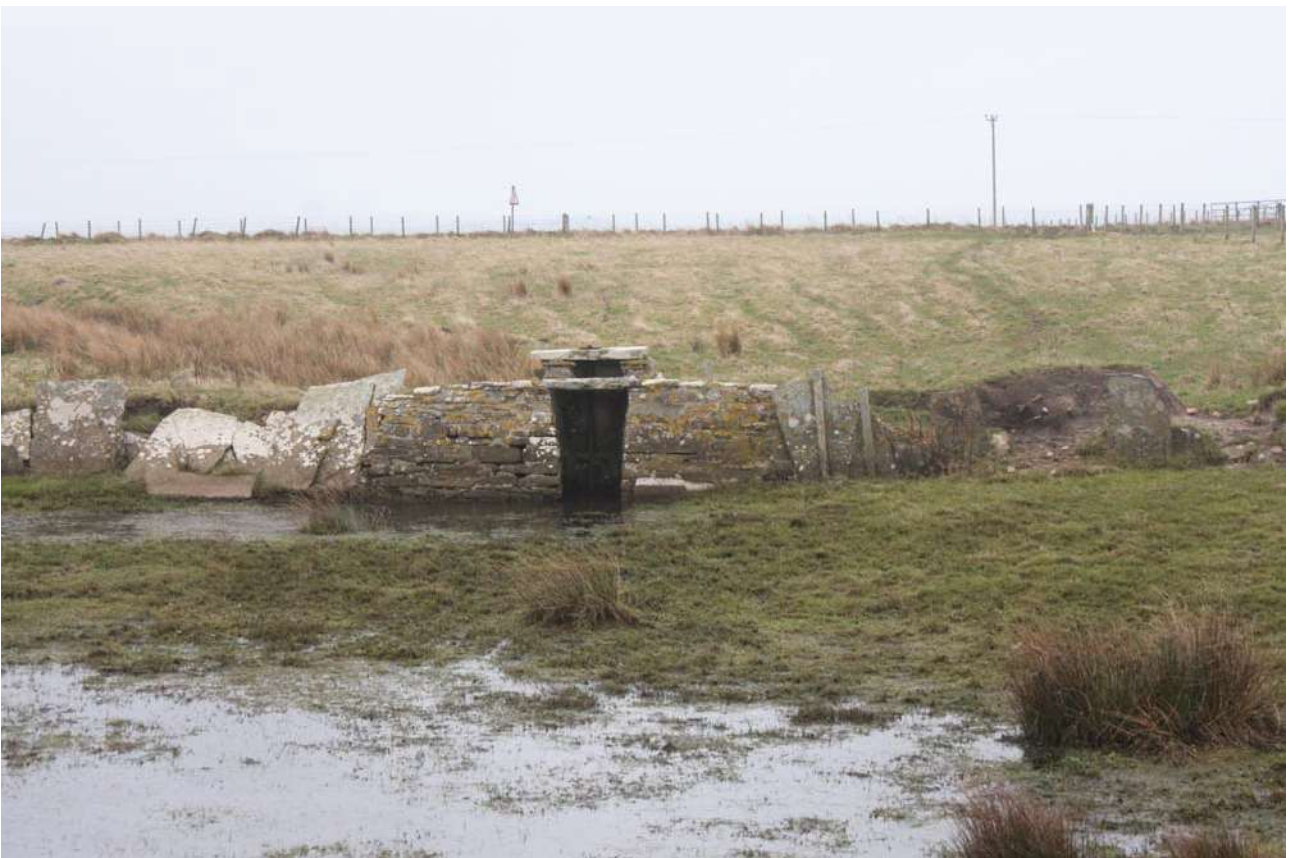
Plate 93: The mill pond, detail of the opening to the east side of the north wall of the mill pond for the mill lade, from the north

- 6.3 To the east of the mill pond, on the north side, is a large underwater culvert providing access to the main mill lade ([Plates 93 - 95](#)). A large drystone structure is placed over it with a cast-iron fitting in the top, presumably relating to the sluice gate mechanism ([Plates 96 & 97](#)). The remains of a timber sluice gate is located to the north side, now rotten ([Plate 98](#)).

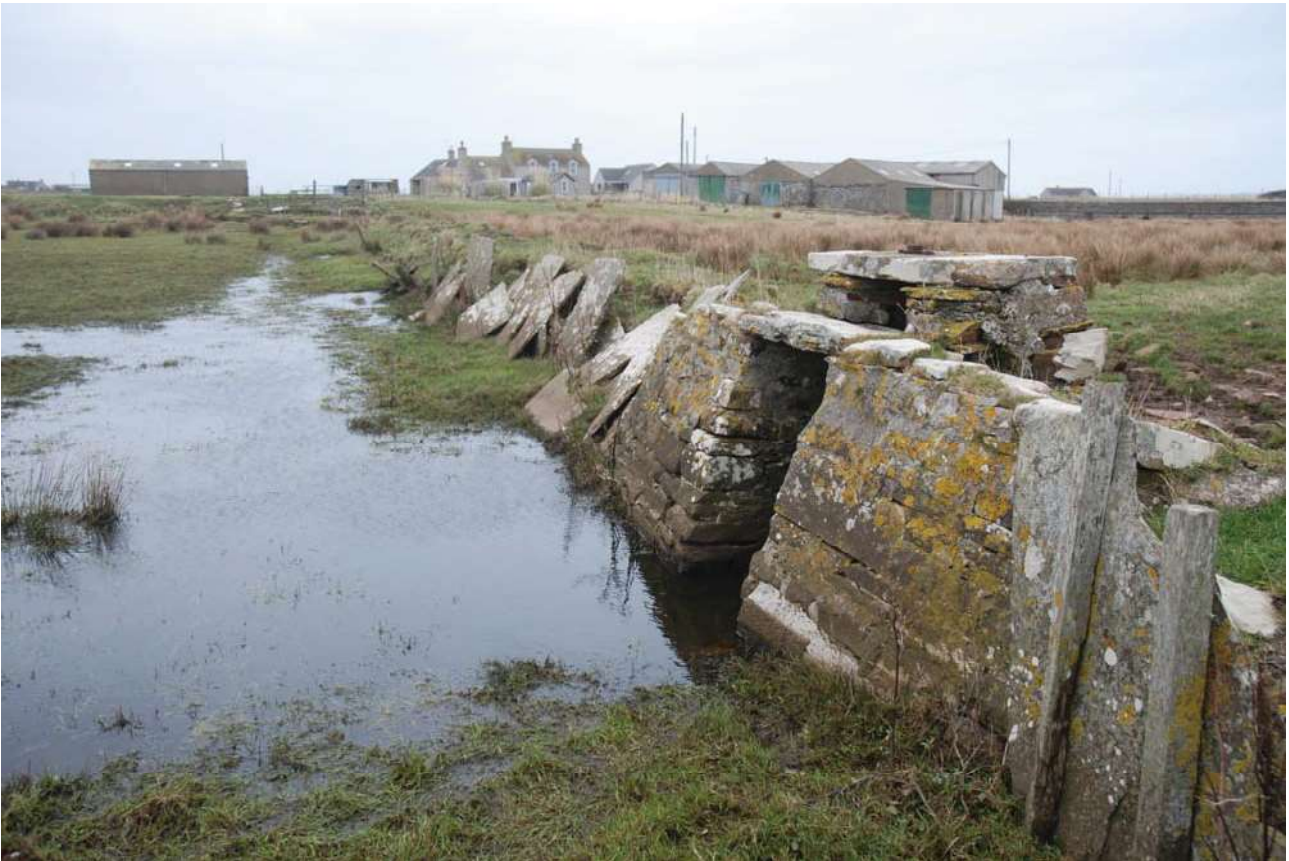
Plate 94: The mill pond, detail of the opening to the east side of the north wall of the mill pond for the mill lade, from the south

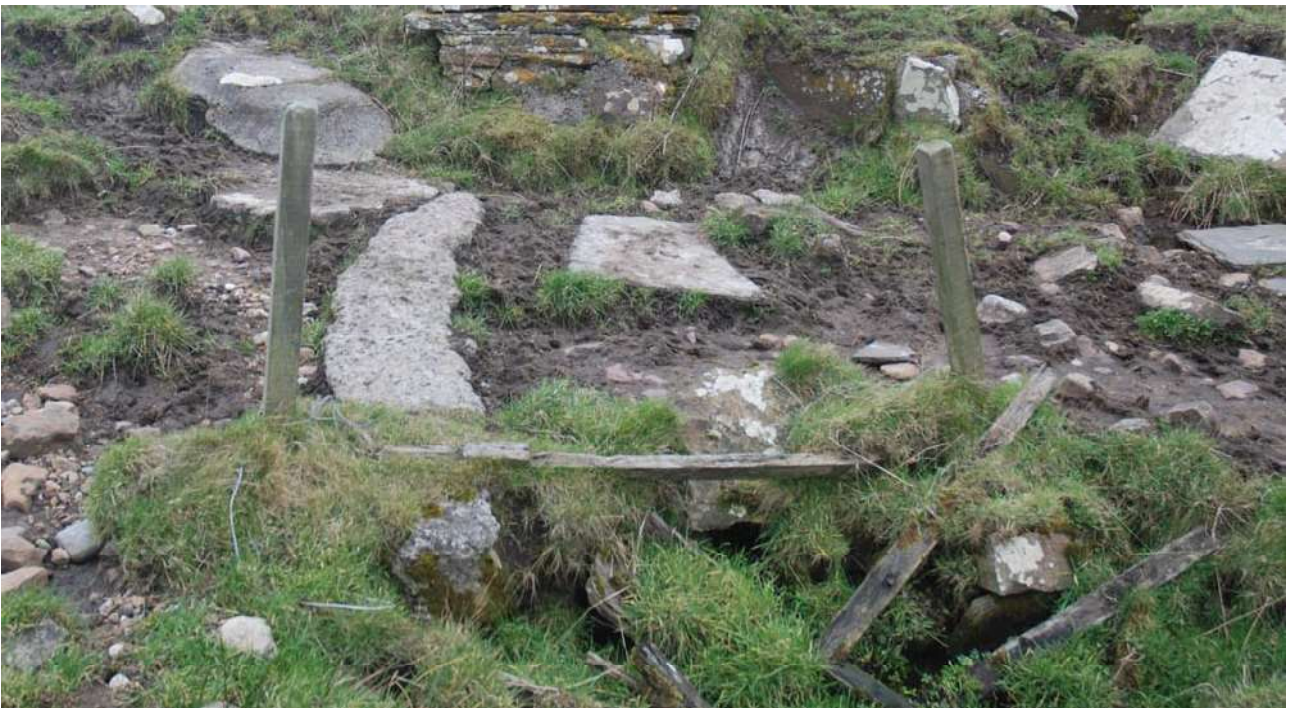
Plate 97: The mill pond, detail of the bolt fixing over the capstone over the entrance to the mill pond on the north side, from the east

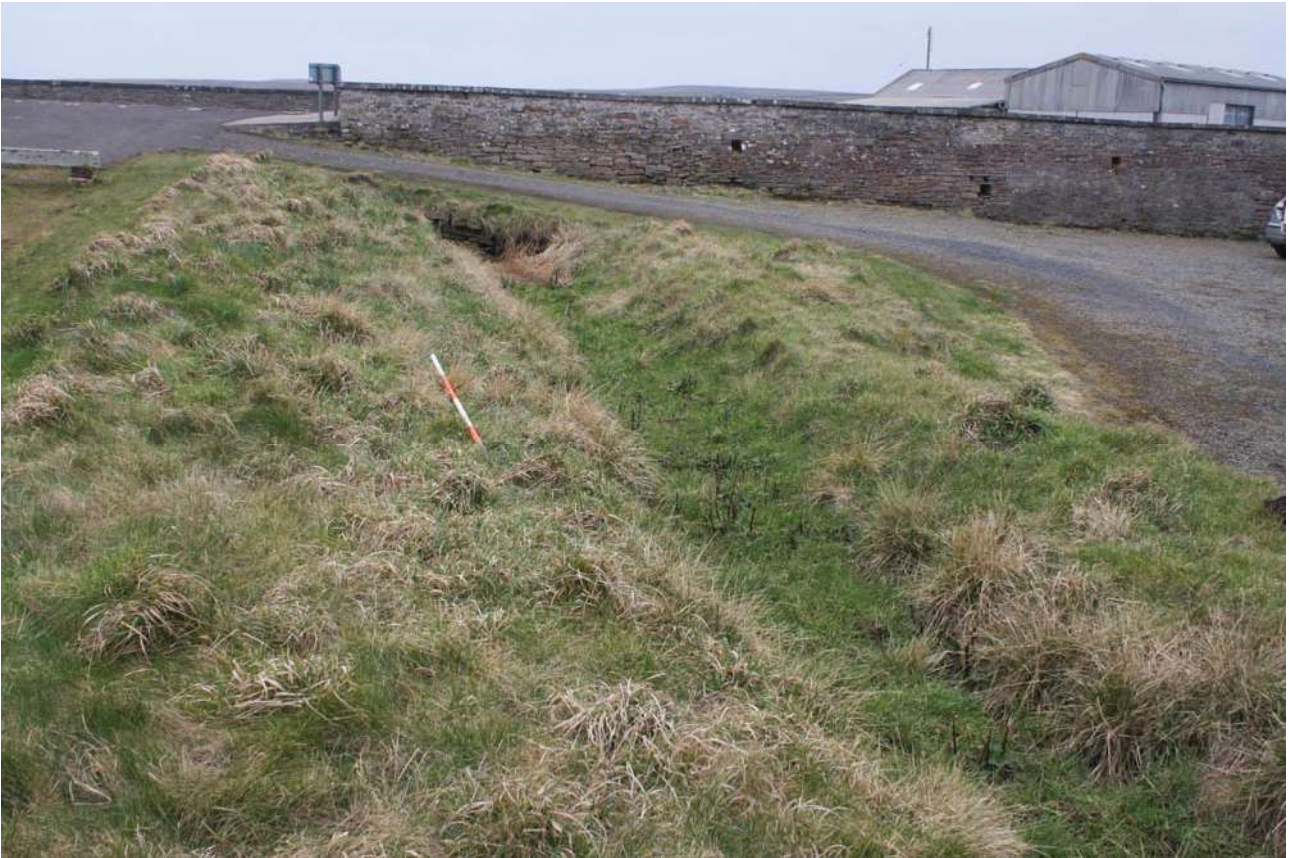
Plate 100: The mill lade, detail of the small capstone over the lead just to the south of the road, from the north-east

- 6.4 Moving northwards, the burn meanders, running beneath the road in a series of round-headed openings supporting the road bridge ([Plate 99](#)). The mill lade runs a much straighter course running under the road via an underground culvert, with a small stone cover on the south side ([Plate 100](#)). It reappears some 6 – 7 metres from the roadside and into the small steep-sided lade leading into the timber lades to flow over the overshot wheels ([Plates 101 - 103](#)). The grass was too overgrown to identify whether the lade here was stone lined.

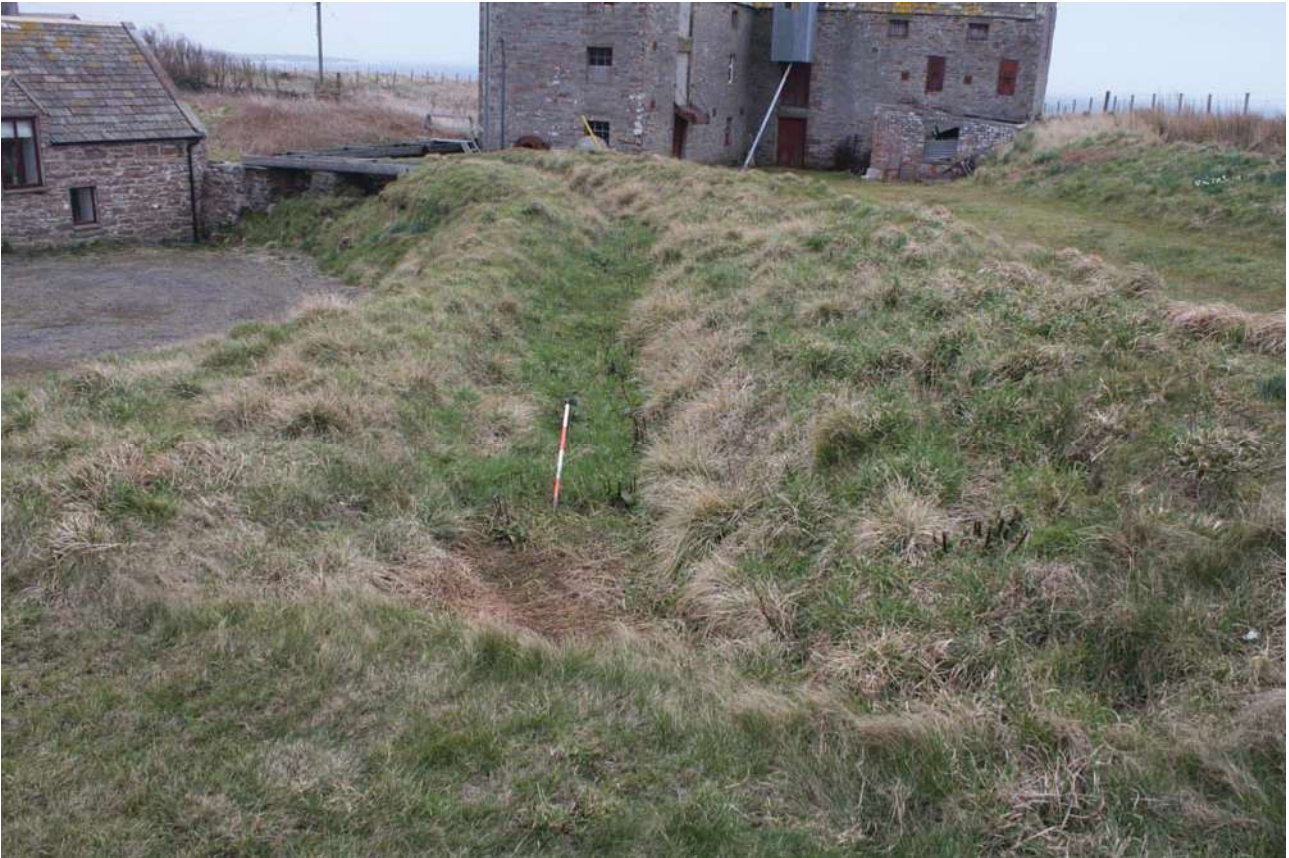
Plate 102: The mill lade, detail of the small north-facing entrance to the culvert from the north

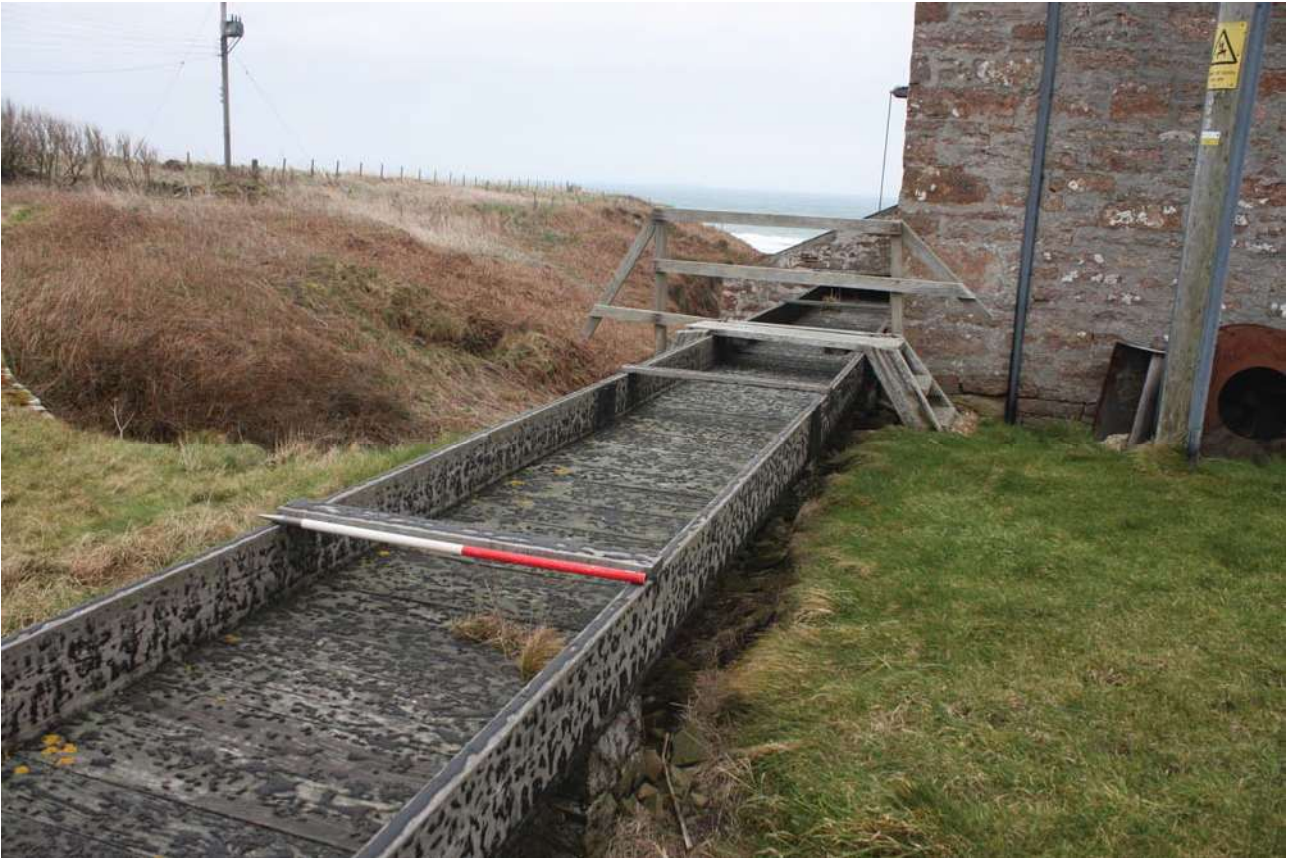
Plate 104: The timber mill lade, general view of the southernmost east/west lade from the north-east

- 6.5 The timber lades feeding the two waterwheels (the main mill and northernmost mill cottage) are mostly of timber with iron strapping. A single chute leads straight over the waterwheel to the north wheel pit of the cottage, with an off-shoot at 90 degrees leading to the larger waterwheel of the main mill on its west side ([Plates 104 - 106](#)). They are timber planked to the base and are lifted from the ground and supported by occasional stone rubble buttresses fixed to them via iron plates around the sides where the panels join ([Plate 107](#)). Occasional struts have been placed over the top. The remains of the sluice gate, which would have diverted water to one or the other mill, no longer exists apart from the only the iron hinges which are still in place (see [Plate 103](#)). Another interesting feature is a small trap door near the east end of the lade leading to the northernmost mill cottage ([Plate 108](#)). It appears to be two planks that are hinged to lift upwards.

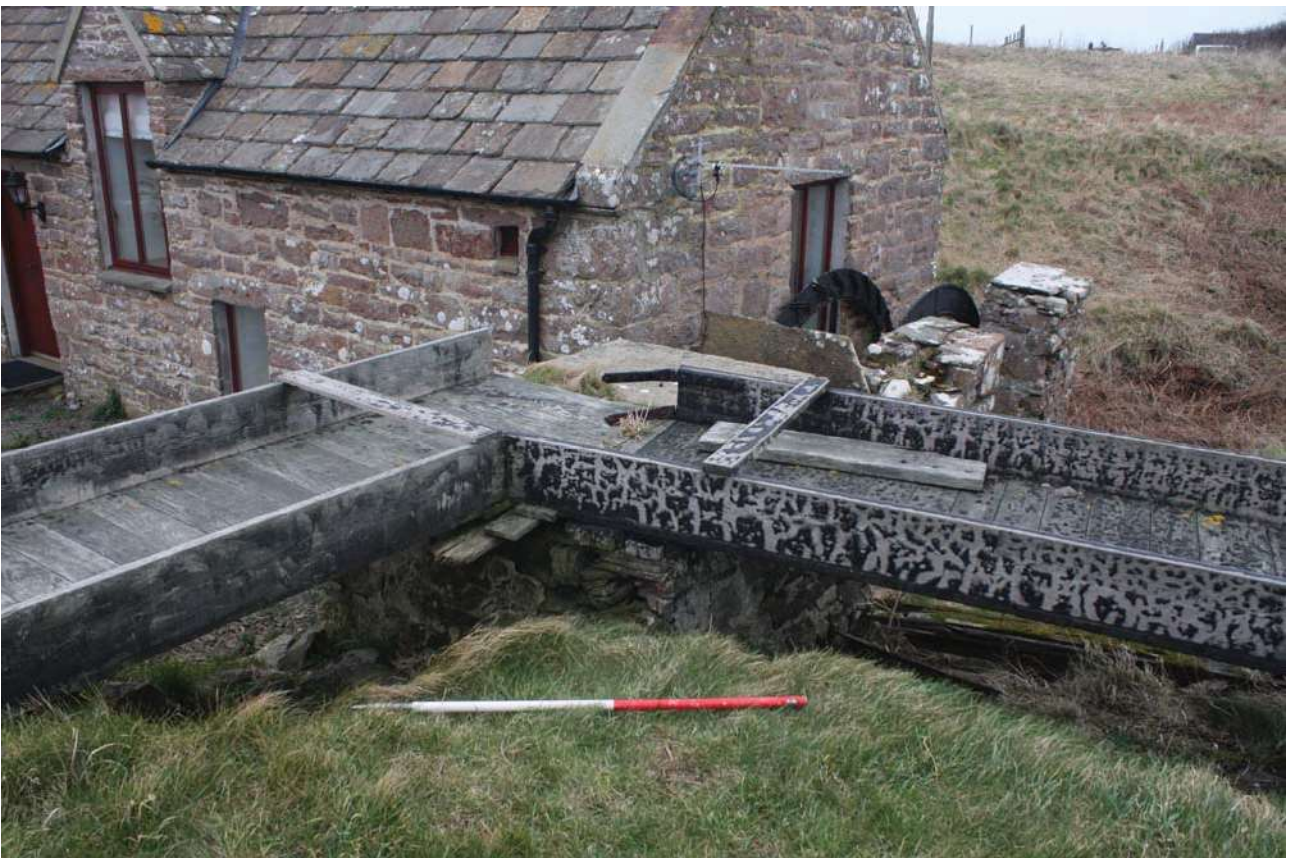
Plate 105: The timber mill lade, general view of the northernmost north/south lade from the SSE

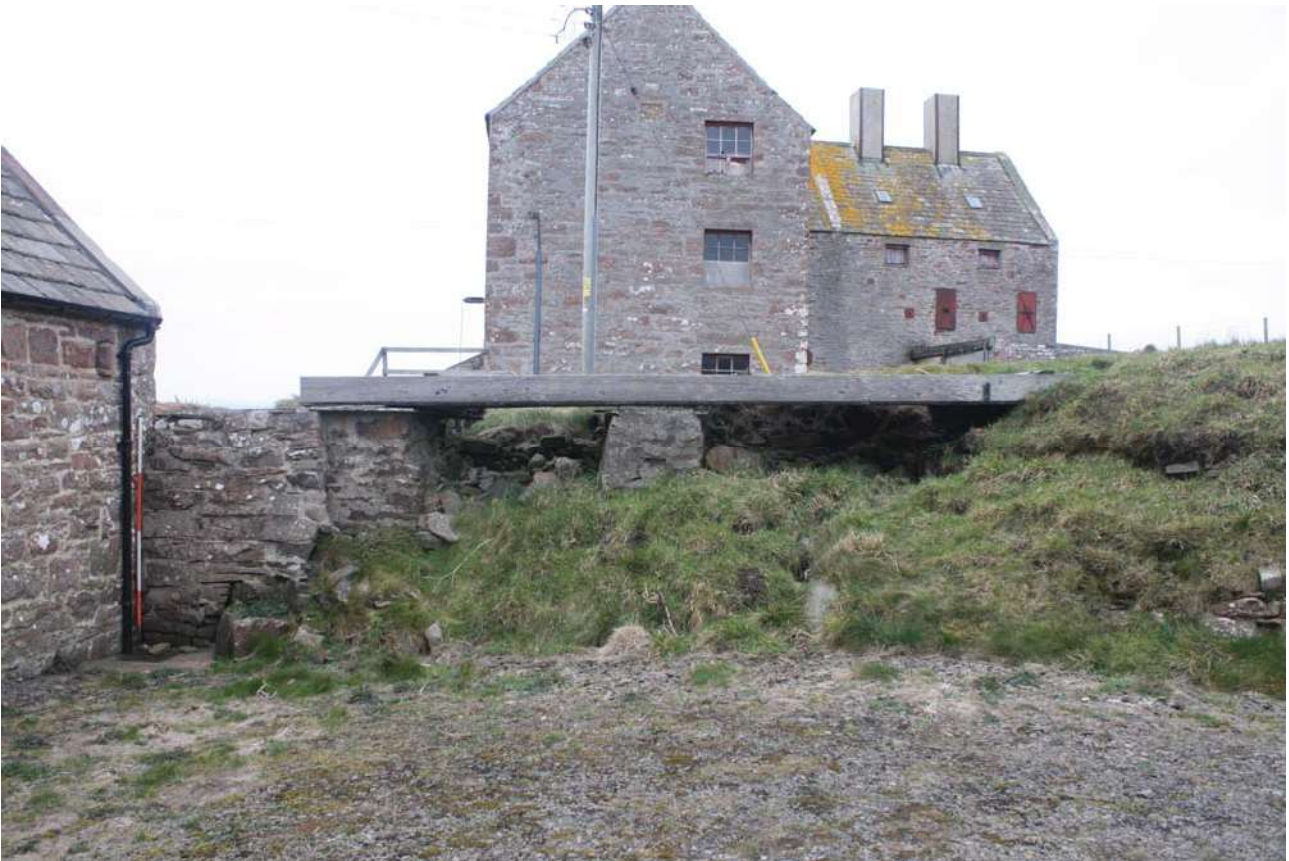
Plate 106: The timber mill lade, detail of the corner between the two lades, from the north-east - note the hinges for the former sluice gate

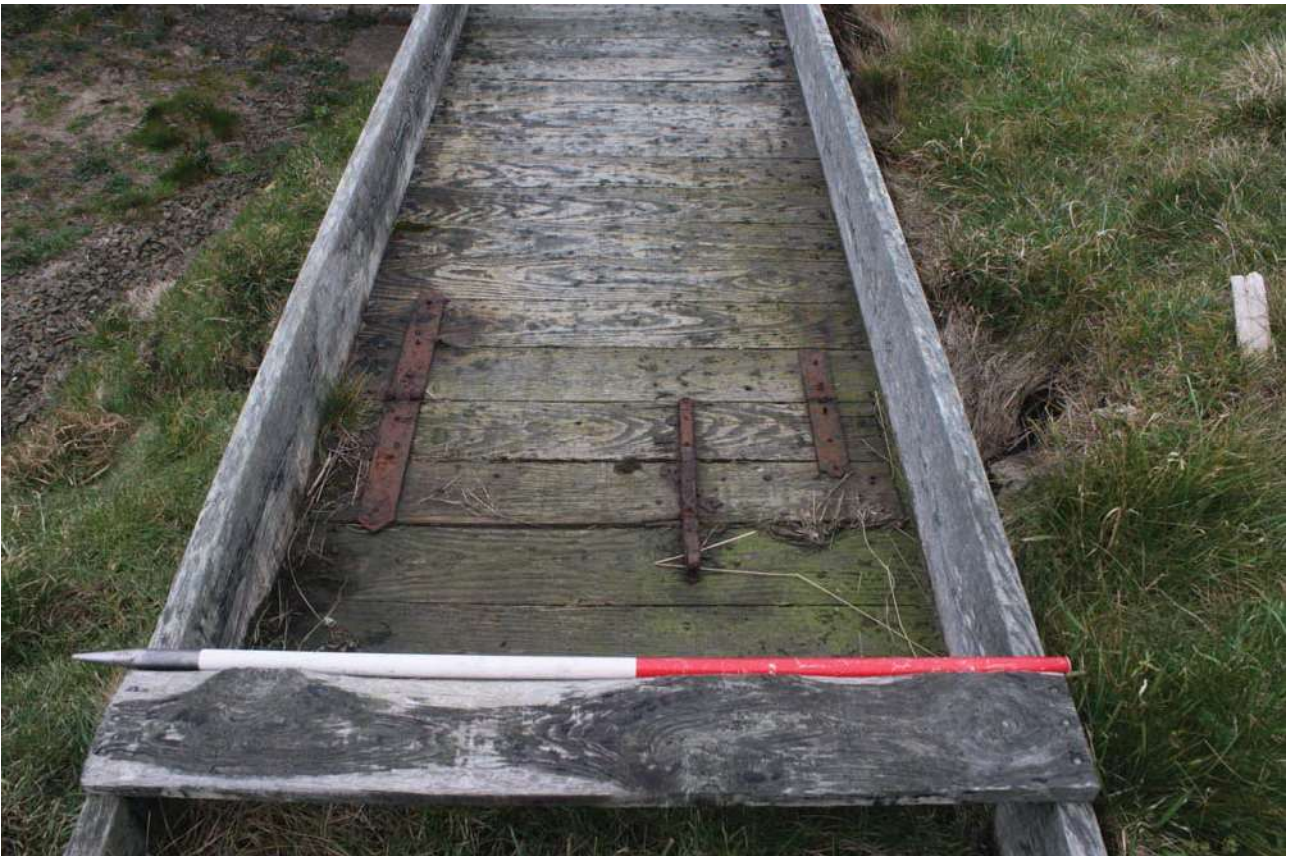
Plate 107: The timber mill lade, general view of the southernmost east/west lade showing the stone buttresses supporting it, from the south

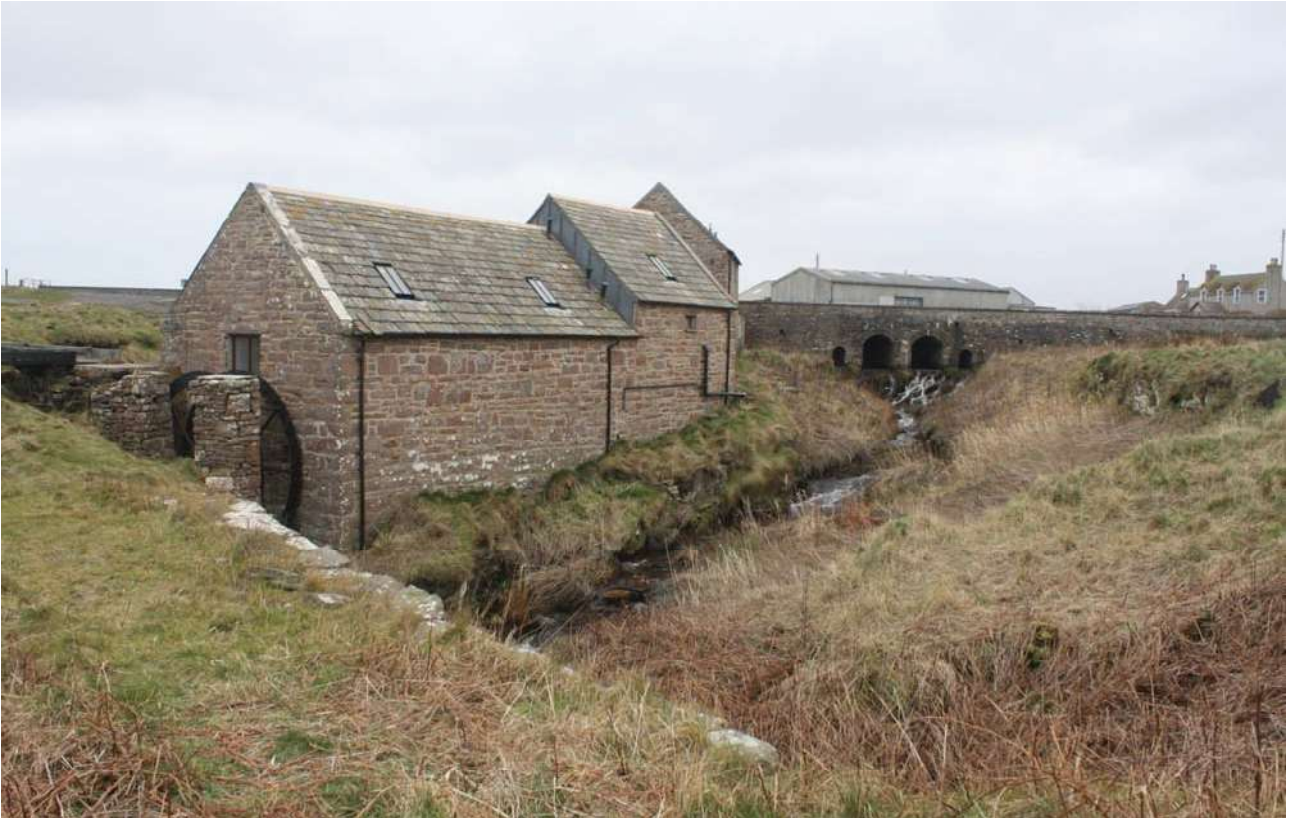
Plate 114: The northernmost mill cottage, general view of the north gable with waterwheel and wheel pit from the north

- 7.1.3 The south elevation is a gable with raised skewes and a tall window. A short passage separates the two buildings here ([Plate 113](#)).
- 7.1.4 The north elevation is taken up with the wheel pit, an overshot wheel attached to the north gable with a stone wall enclosing the waterwheel to the north ([Plate 114](#)).

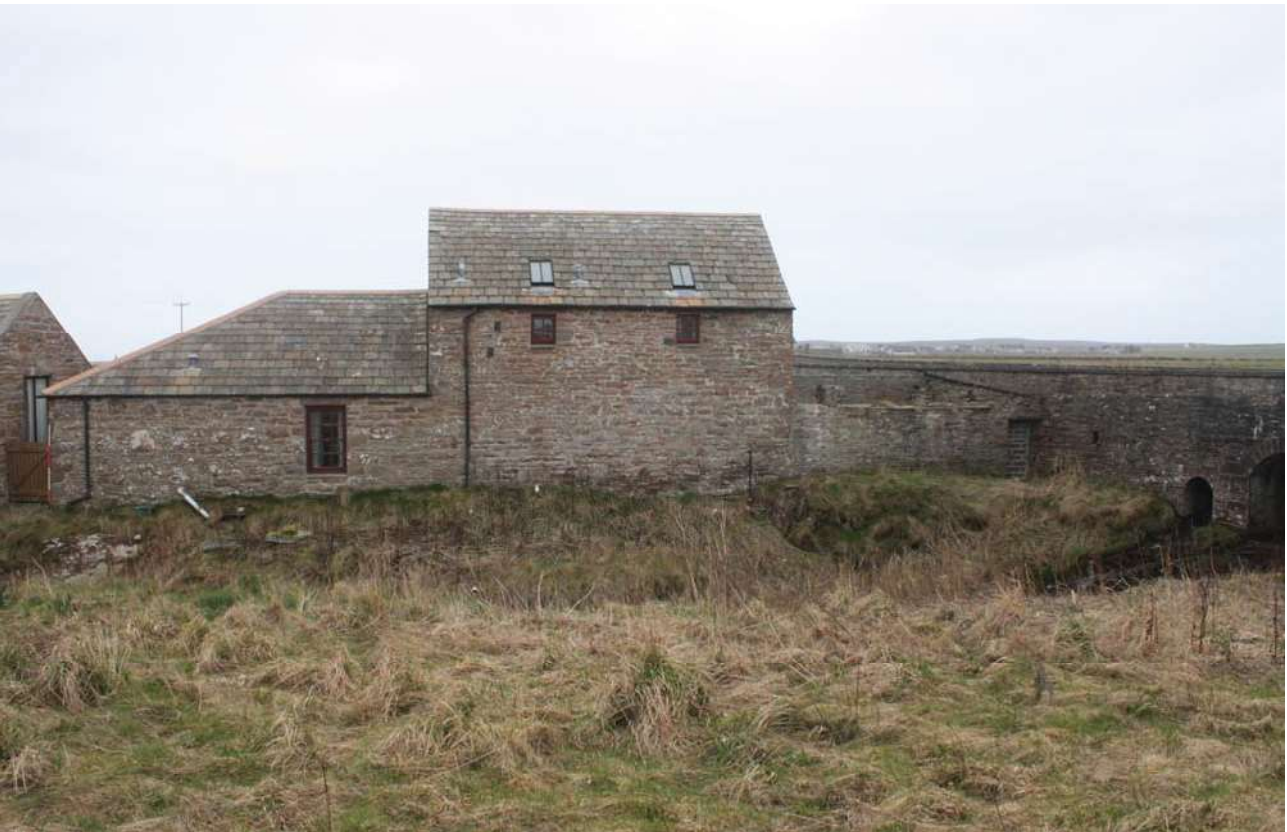
Plate 119: The southernmost mill cottage, detail of the stone-blocked window on the south elevation from the south

- 7.2.3 The north gable is plain with the hipped roof over and the south gable is the taller two-storey gable with a stone-blocked window in the ground floor; there looks to be at least two phases of blocking (Plate 119). The west elevation is relatively plain with two skylights and two stout first floor windows to the main mill and a tall rectangular window to the single-storey garage (Plate 120). Looking at the mortaring below this window, it looks to have been reduced in height and may have once been a larger opening.
- 7.2.4 The cottage is abutted to the south by a boundary wall forming a former cart entrance, now a garage. Dooks in the walling represent that it may have once had panelling attached on the internal side.

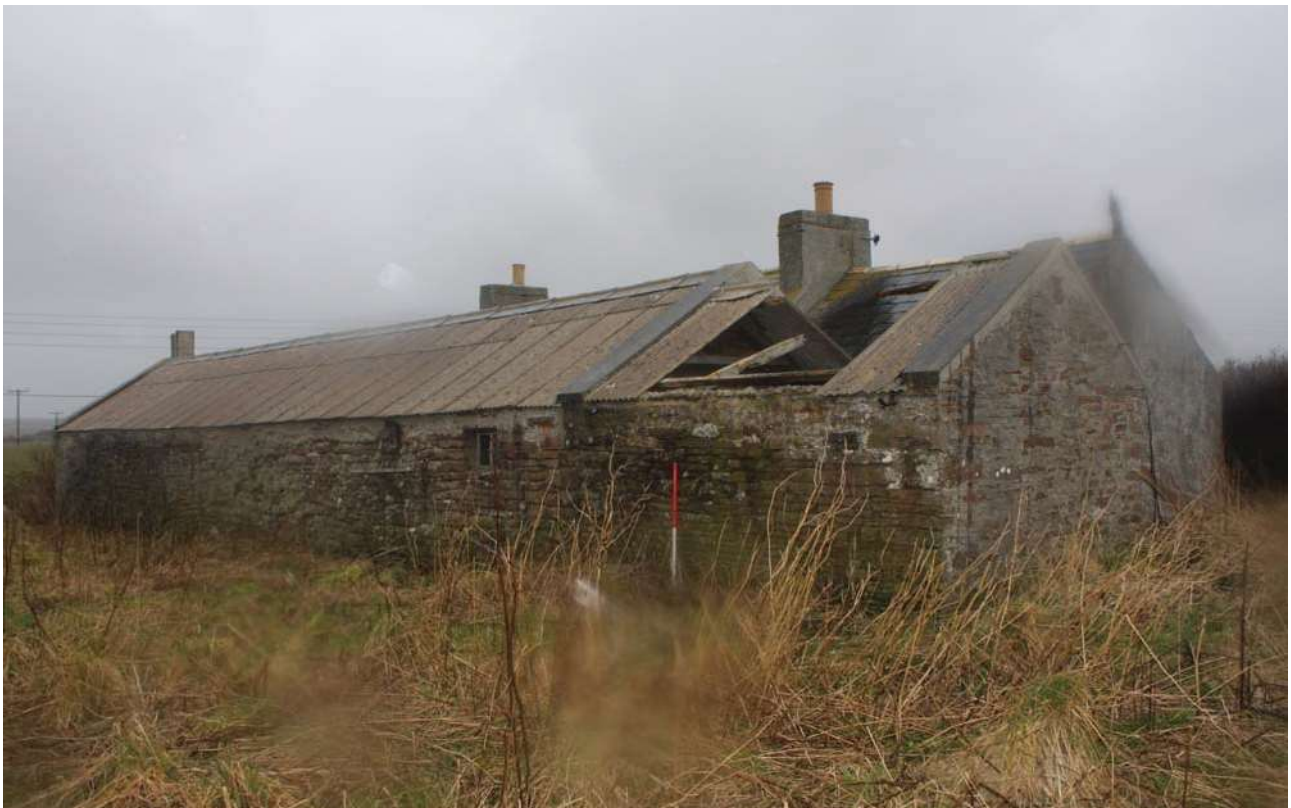
Plate 125: The southernmost abandoned mill cottage, general view of the east gable from the east

- 8.1 The two abandoned cottages were not part of the main survey as they are outwith the ownership of the mill owner (S Houston, pers comm). However, it is prudent to put some record of them here to place the site into context as a working landscape. There are two cottages, and the NMRS records the southernmost building as being C Listed, referring to it as 'Mill Cottage' (Plate 121). The building is a three-bay single-storey building of stone rubble covered in a roughcast render. There is a projecting porch on the south side, reported to be a later addition by the listing description (and indeed, it does not appear on the 1907 map) with an east-facing door (Plate 122). There is a three-over-three timber sash window to the immediate east of this on the main south elevation. Moving round to the west gable, there is a small off-set window, frame missing, to the east side (Plate 123). The north elevation facing the other cottage (a small passage between them) has only two small windows roughly in the centre with projecting sills (Plate 124). Another later wing then projects from the east gable with a small vertically-panelled door on the north-facing side. This terminates in a chimney breast with a large concrete tank to its north side (Plate 125).

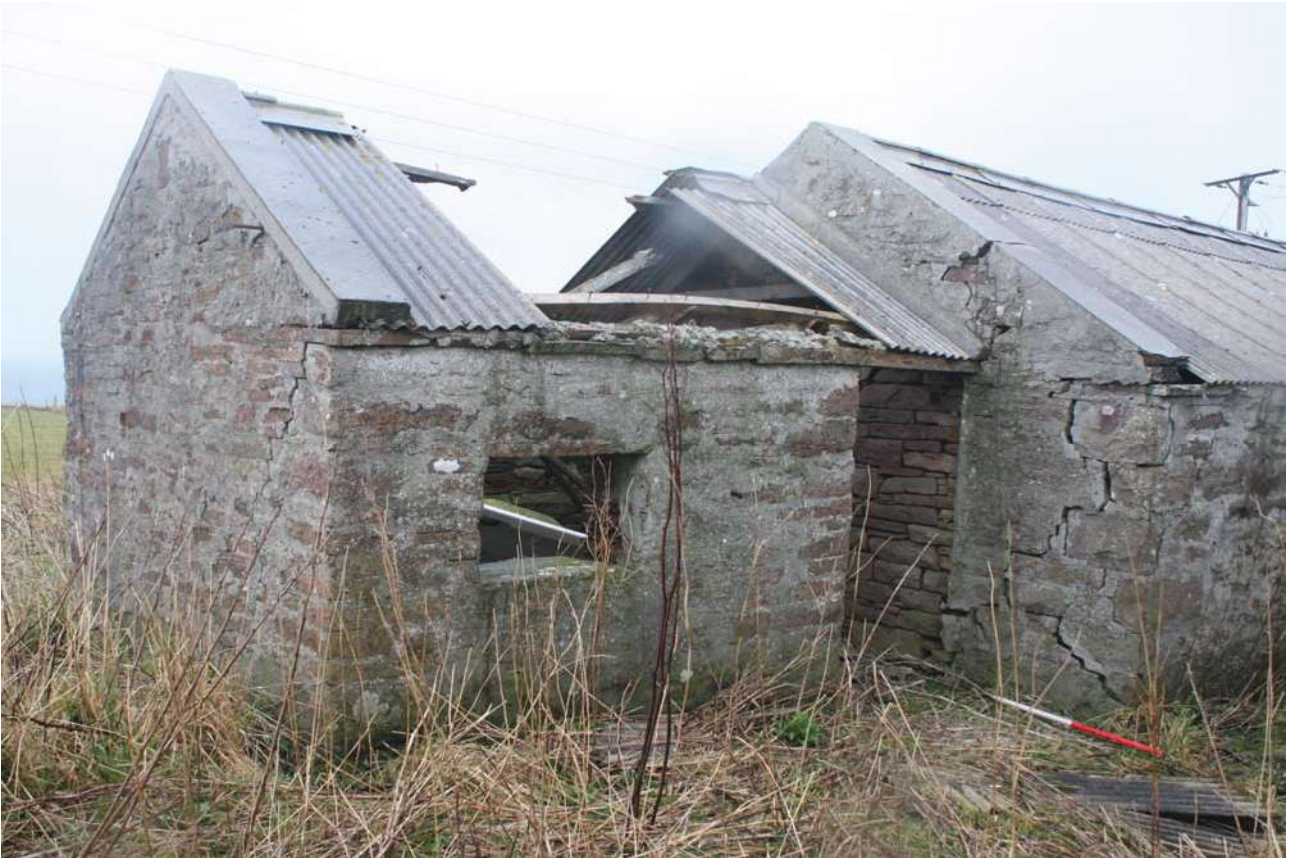
Plate 129: The northernmost abandoned mill cottage, detail of the western annexe from the south-west

- 8.2 The northernmost abandoned 'cottage' is not recorded as being listed and is an open stone-rubble built three-bay single-storey barn with pitched corrugated asbestos roof. The north elevation is relatively plain with a single window to the west and stone-blocked doorway to the east (Plates 126 - 128). The east gable is plain with a large concrete tank attached. Moving round to the south elevation facing the south cottage, there are three main doorways (the doors have long since been removed, the frames remain). The western end forms a smaller annexe added on to the main building, the north gable of which is in a bad structural condition and has a dangerous crack along the south side (Plates 129 & 130). The south elevation has three doorways into rubbish-filled rooms (Plate 131).

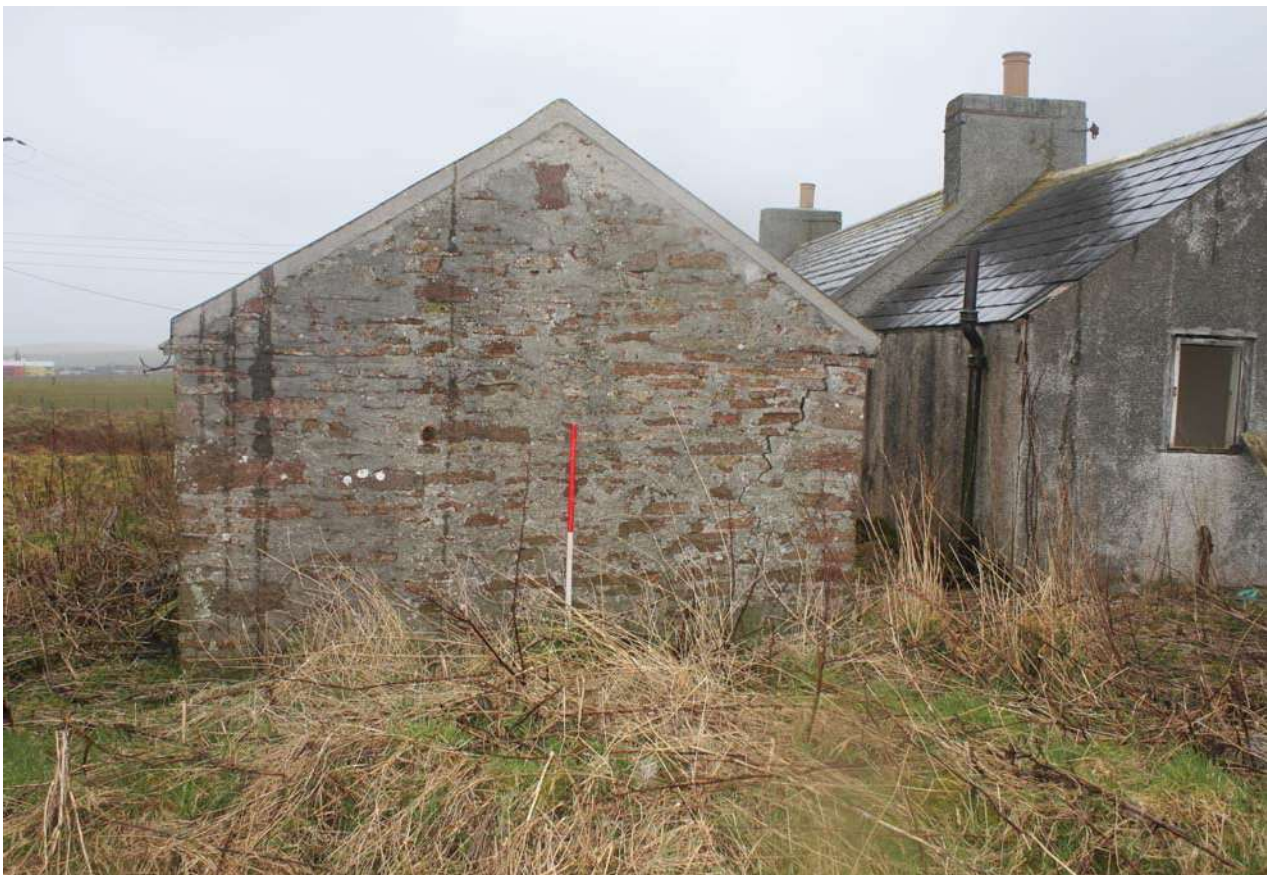
Plate 130: The northernmost abandoned mill cottage, general view of the west gable from the west

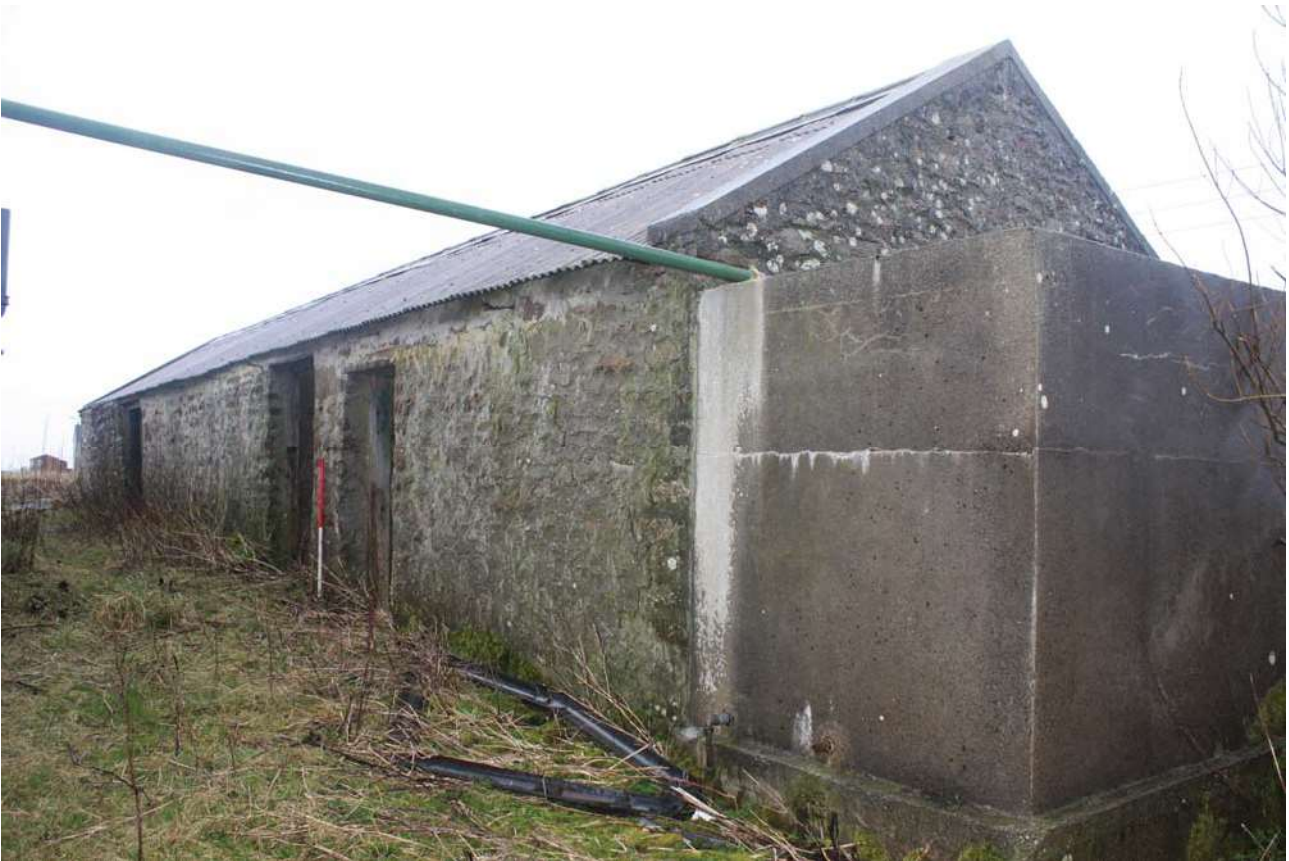
Plate 131: The northernmost abandoned mill cottage, general view of the south elevation from the south-east
