# John O'Groats Mill, Huna, Caithness

## Archaeology & Inventory of Artefacts

### Report

AOC 22376

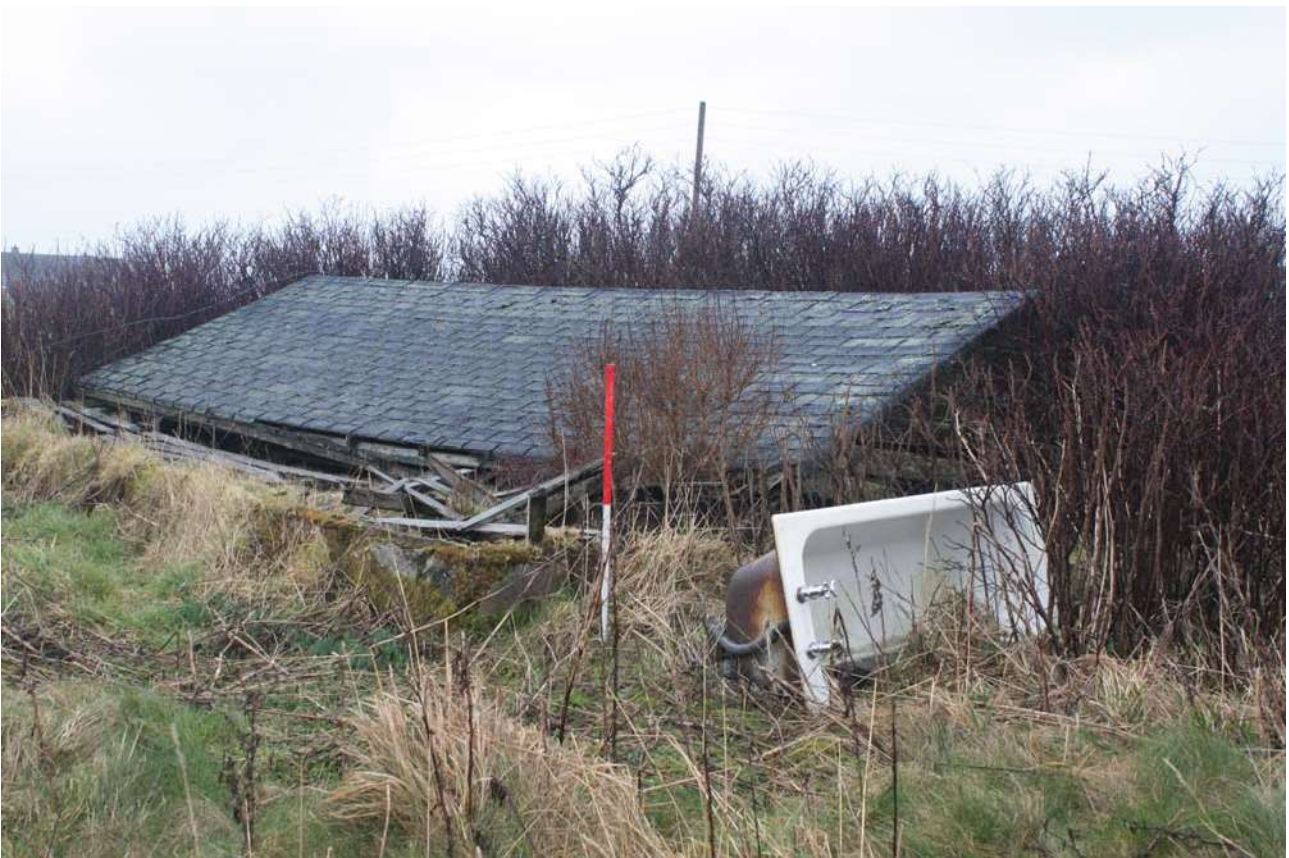
Plate 132: The abandoned mill cottages, detail of the small building to the south from the south-east

- 8.3 To the south side of the southern cottage there is a small enclosure in timber with a lean-to roof, the function of which is unsure, being set so low to the ground (Plate 132). To the north-east of the cottage, there are the remains of a stone rubble enclosure, the outline of which can be seen on the 1877 Ordnance Survey map.

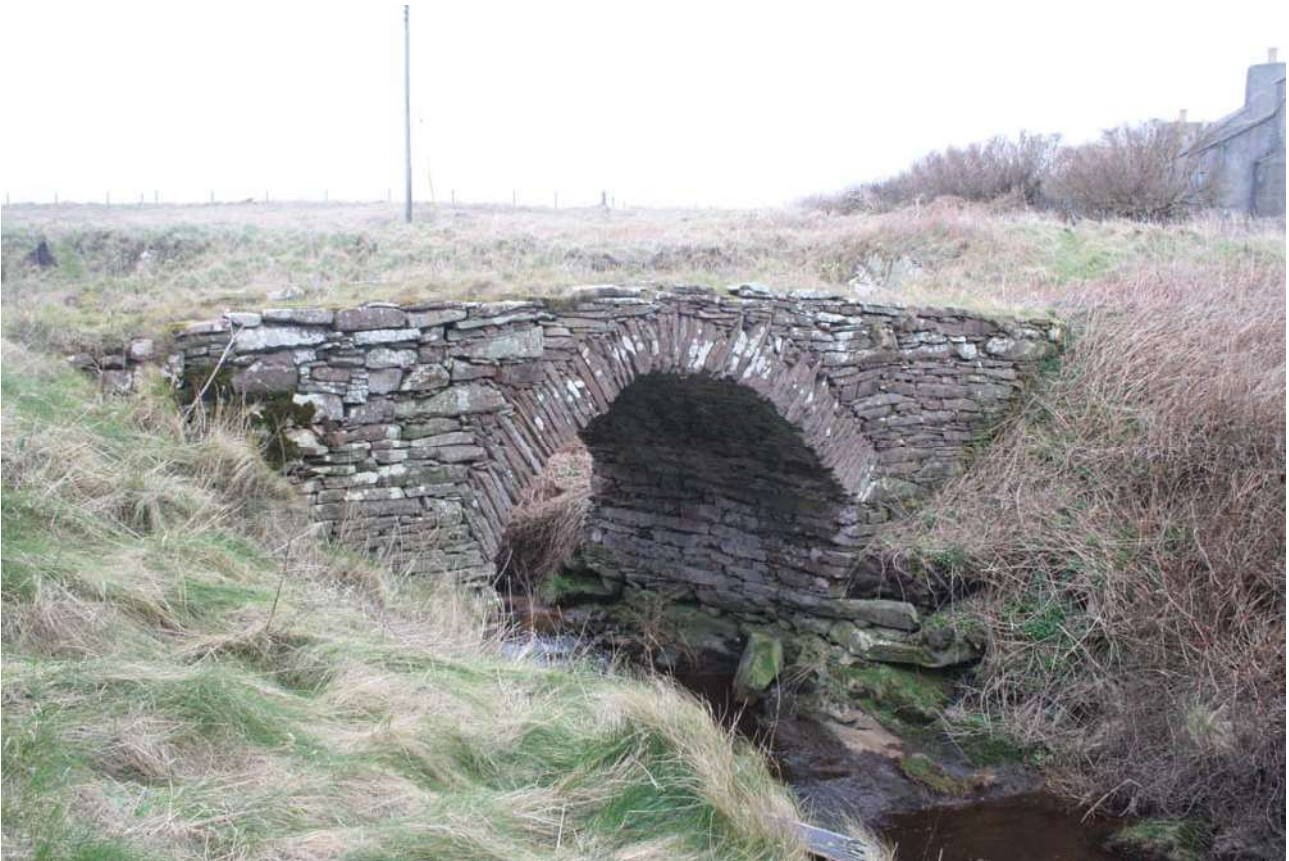
Plate 133: The Cromwellian bridge, general view of the north face from the north-east

- 9.1 The Cromwellian bridge is thought to date to 1651 and is a plain single span bridge over the main burn standing over bedrock to both sides (Plates 133 – 135; Figures 21 & 22). The top of the bridge has evidence that the walls either side were a lot more substantial than they are today, with an outer wall of stones to either side and an inner core of rubble, the whole approximately 0.75m in width to both sides, flanking the main road span about 1.90m wide (Plate 136).
- 9.2 The voussoirs are cut from tall thin stones and have stood the test of time, although there does appear to be some evidence of slippage to the centre, where the stones have slightly slumped out of alignment with the arch.

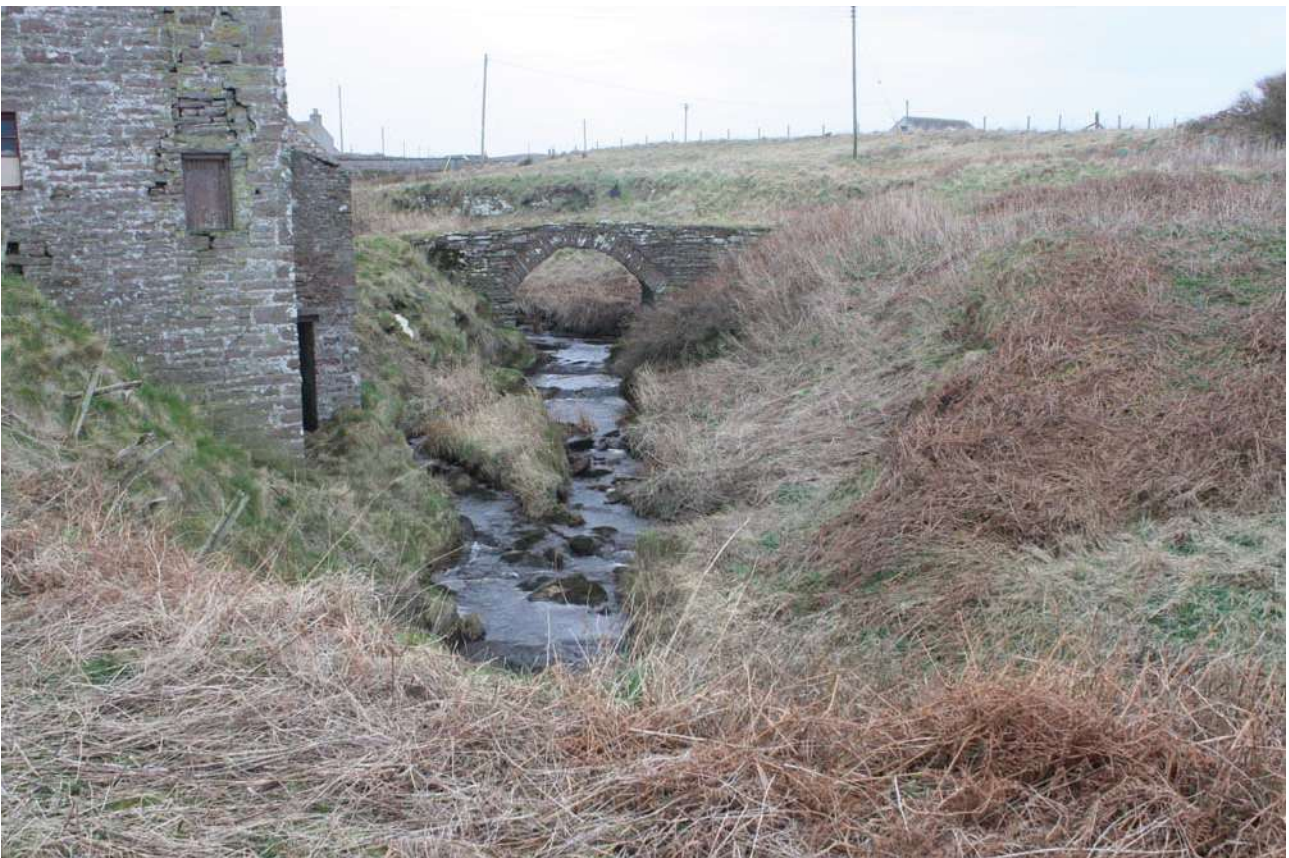
Plate 134: The Cromwellian bridge, general view of the north face from the north

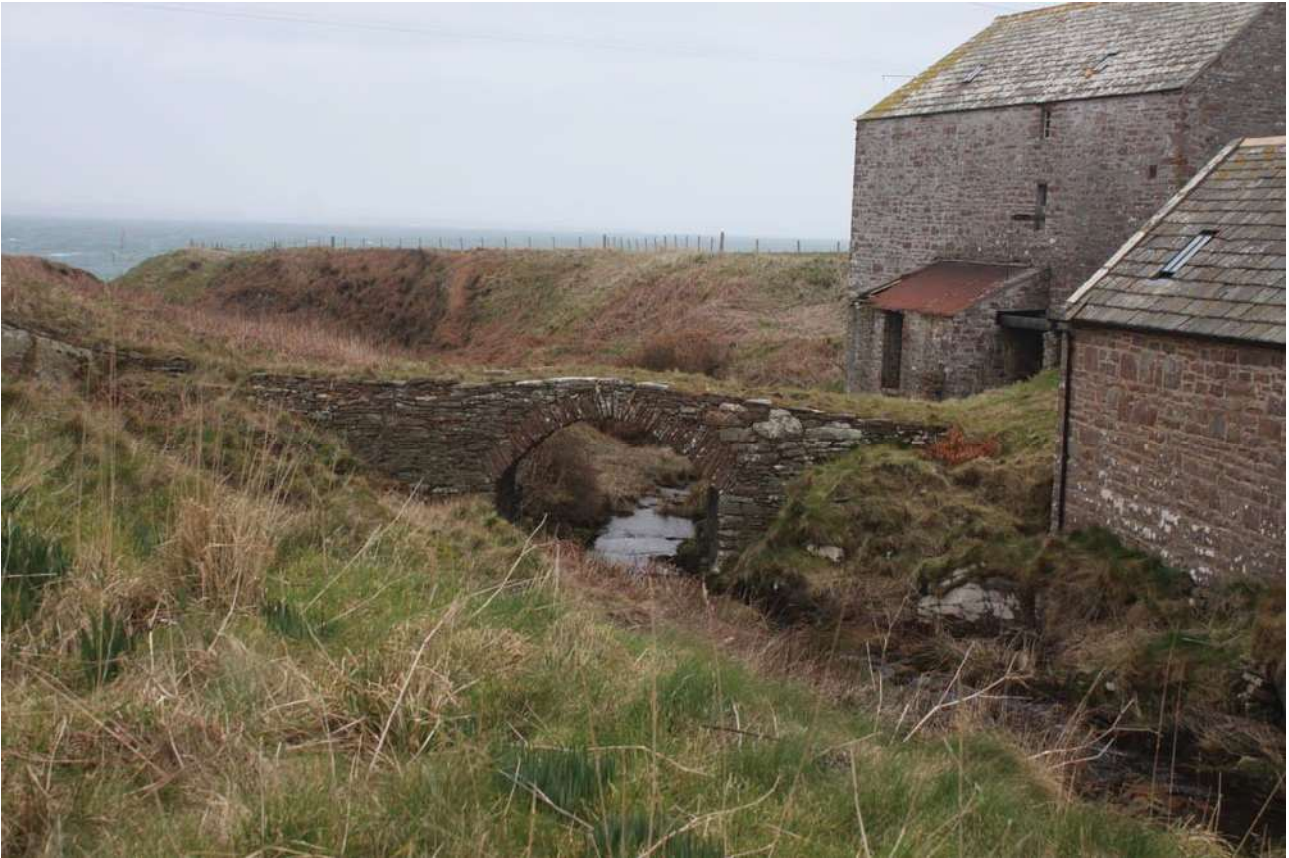
Plate 135: The Cromwellian bridge, general view of the south face from the SSW

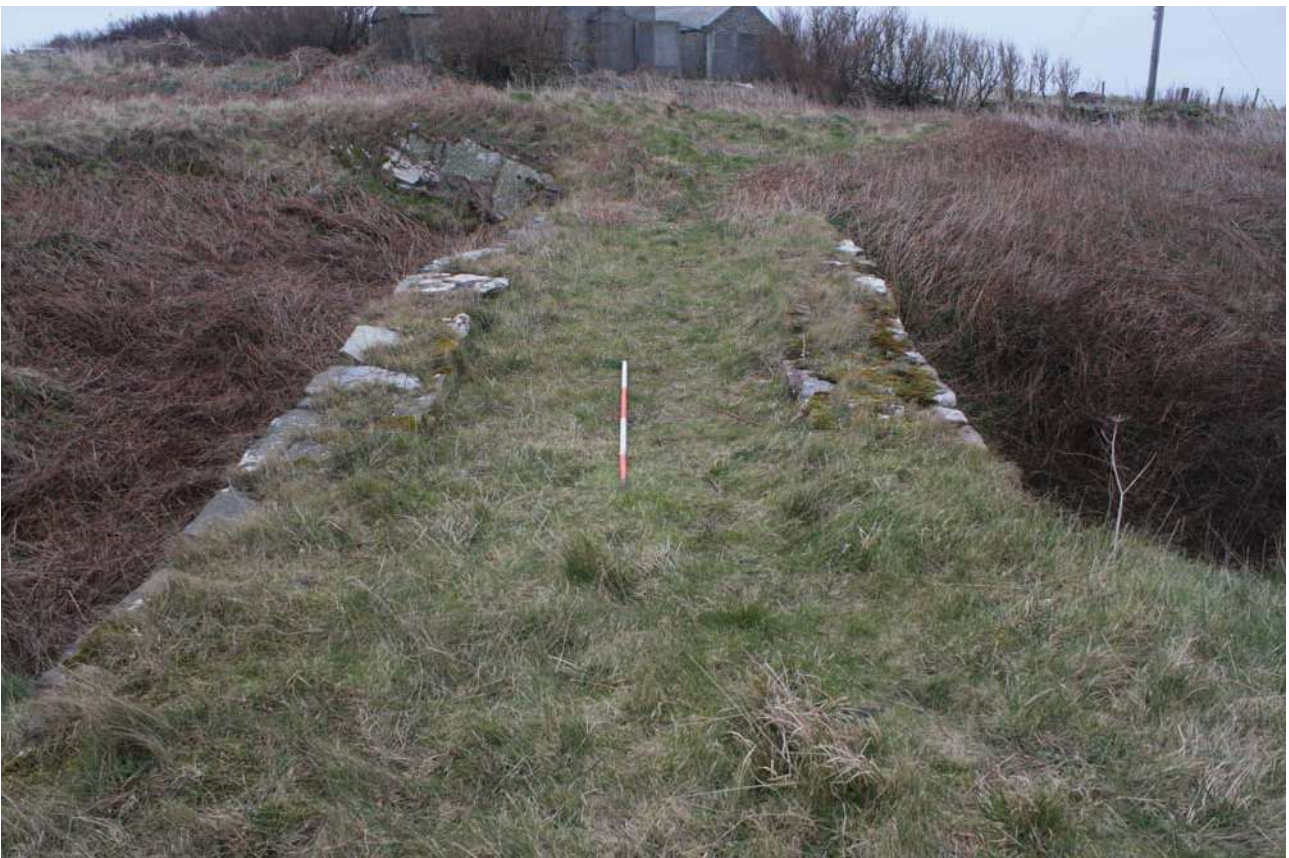
Plate 136: The Cromwellian bridge, general view of the top of the bridge from the east

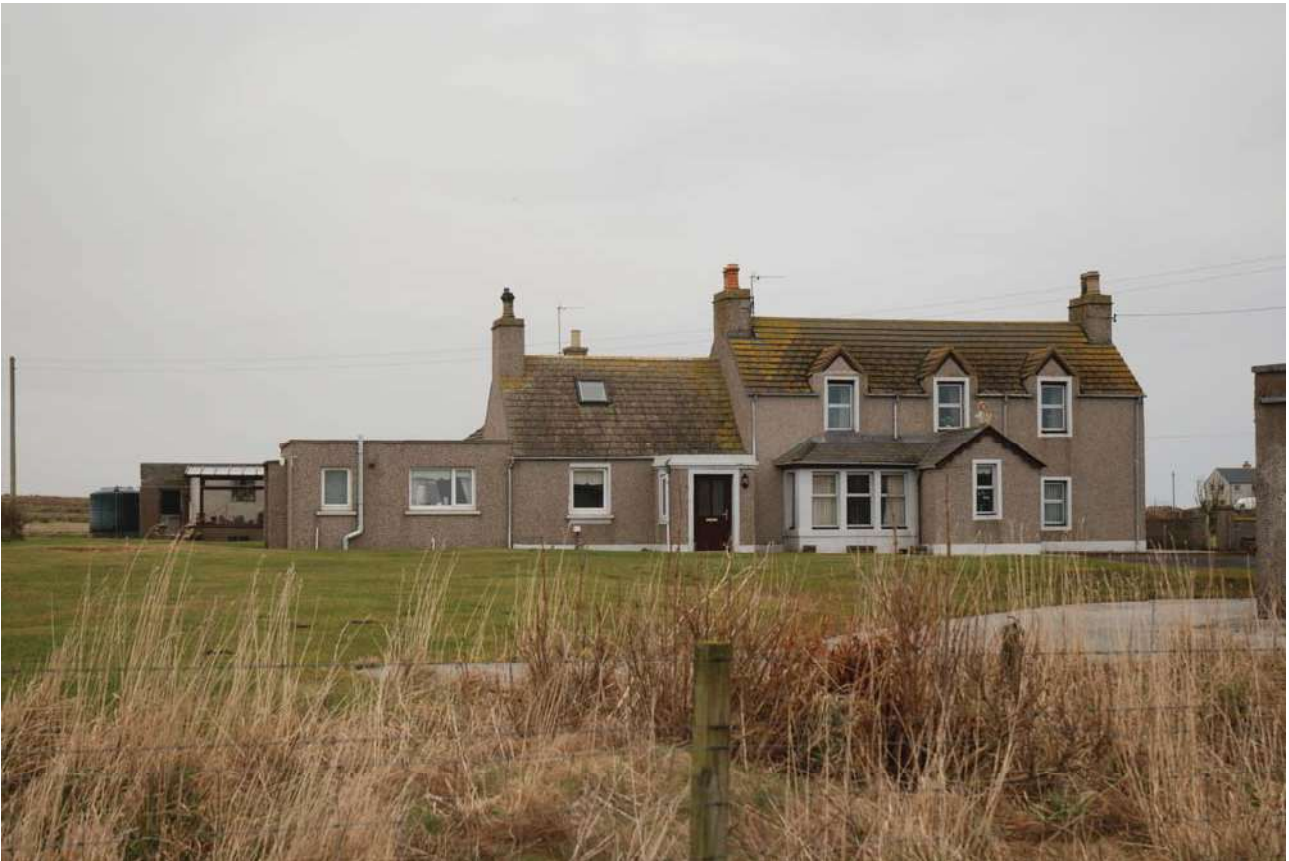
Plate 137: Site 7, Mill House, general view from the east

- 10.2 Sites 1 – 5, 8 & 9 have been dealt with in previous sections.
- 10.3 Site 7, Mill House, appears on the 1877 Ordnance Survey map as a simple north/south linear building although by the time of the 1907 map, it has an extension to the west. Today, the building is covered in a roughcast render with a smooth rendered footing course and surrounds to the openings with a pitched slate roof, raised dormers and another flat extension to the south side (Plates 137). Site 6, presumably a former outbuilding, has now been demolished and replaced with a modern shed (Plate 138).
- 10.4 Sites 10 refers to an L-shaped cottage to the corner of a plot of land to west of Mill House which also appears on the 1877 Ordnance Survey map. It is now referred to as Horseman's Cottage and is clearly a private residence (Plate 139). Despite being a similar layout, the present is a new build. The 1960 Ordnance

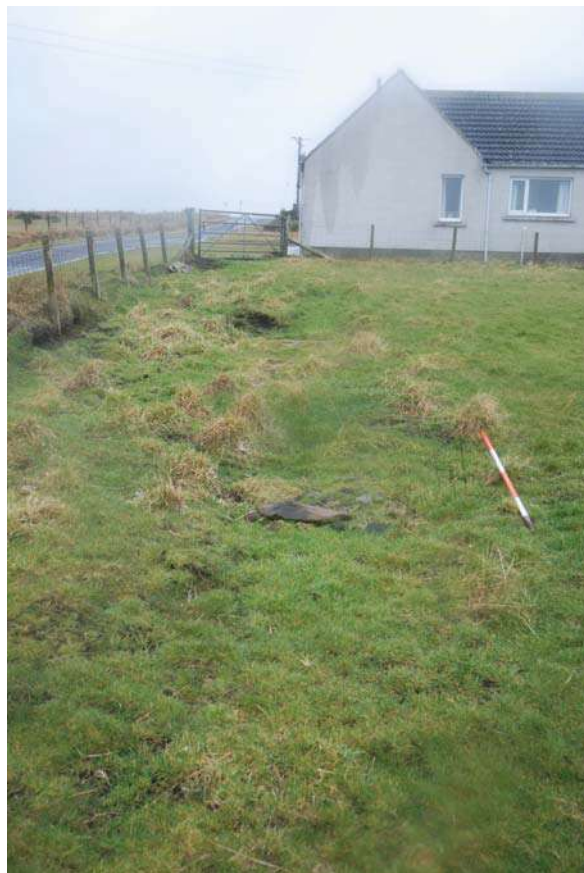
Plate 140: Site 11, building foundations, general view from the north

Survey map shows the cottage to have been removed, as does the 1968 map. Site 11 is a linear north/south barn which also appears on the 1877 map, although no sign of it could be seen on the ground to the north of Horseman's Cottage apart from some evidence of stone rubble foundations ([Plate 140](#)). The 1960 and 1968 maps show the barn to be still upstanding, so was demolished after this, perhaps when Horseman's Cottage was built.

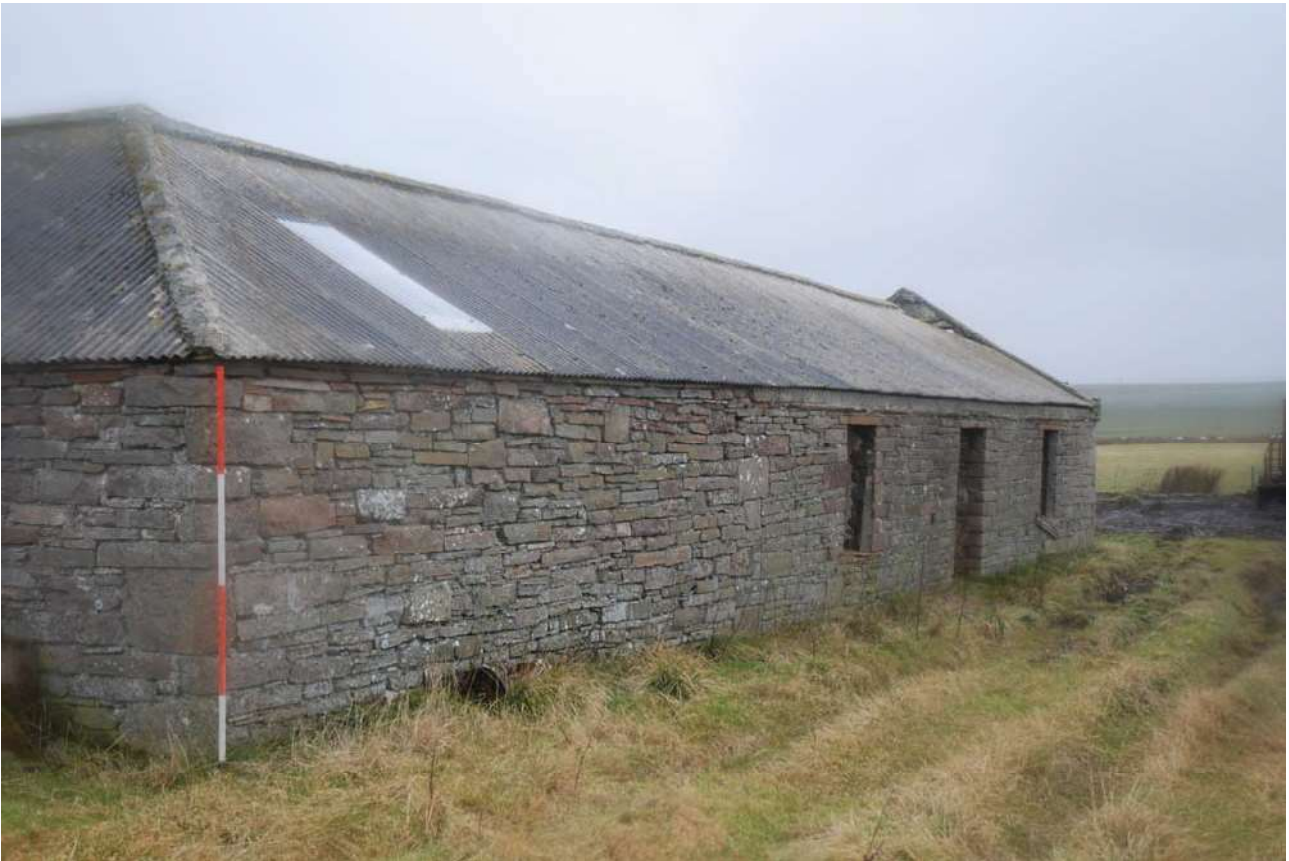
Plate 141: Site 12, steading, general view from the north-west

- 10.5 Site 12 is an abandoned steading, appearing on the 1887 map as an enclosed steading with the gap to the east side. It now survives as a ruin – clearly formerly used as a cow byre – with only the north and west extent surviving ([Plates 141 & 142](#)). It comprises stone rubble walling with a pitched and hipped corrugated asbestos roof with very plain surrounds to the openings. It has an upper loading window in the south gable, indicating the presence of a former hay loft with a large barn door below covered in corrugated-iron sheeting. Another barn door is located on the eastern gable ([Plate 143](#)). Site 13 refers to some other remains of stone walling located to the north-east of the field in which the steading resides. These are very fragmentary and form the remains of a corner of the wall enclosing the field, possibly relating to the boundary ([Plate 144](#)).

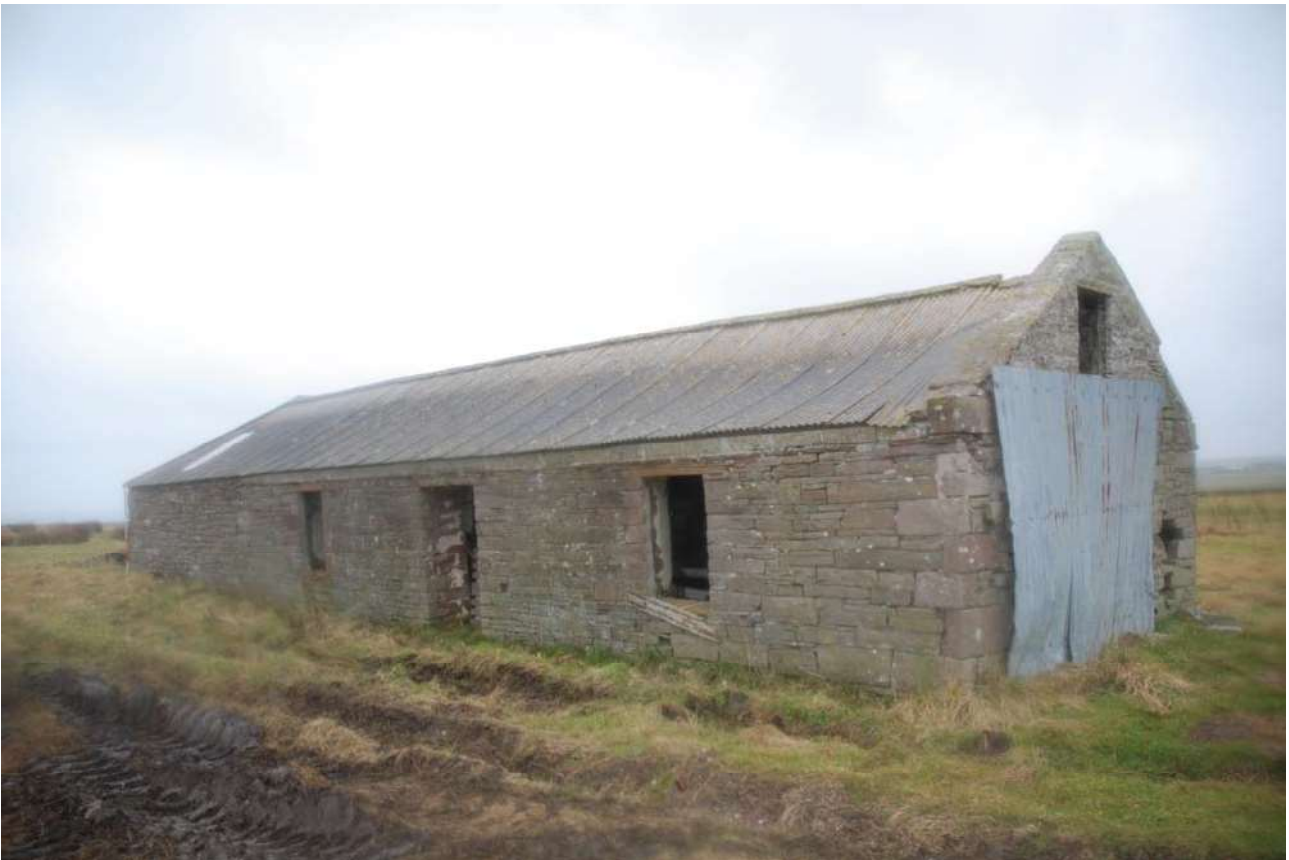
Plate 142: Site 12, steading, general view from the south-west

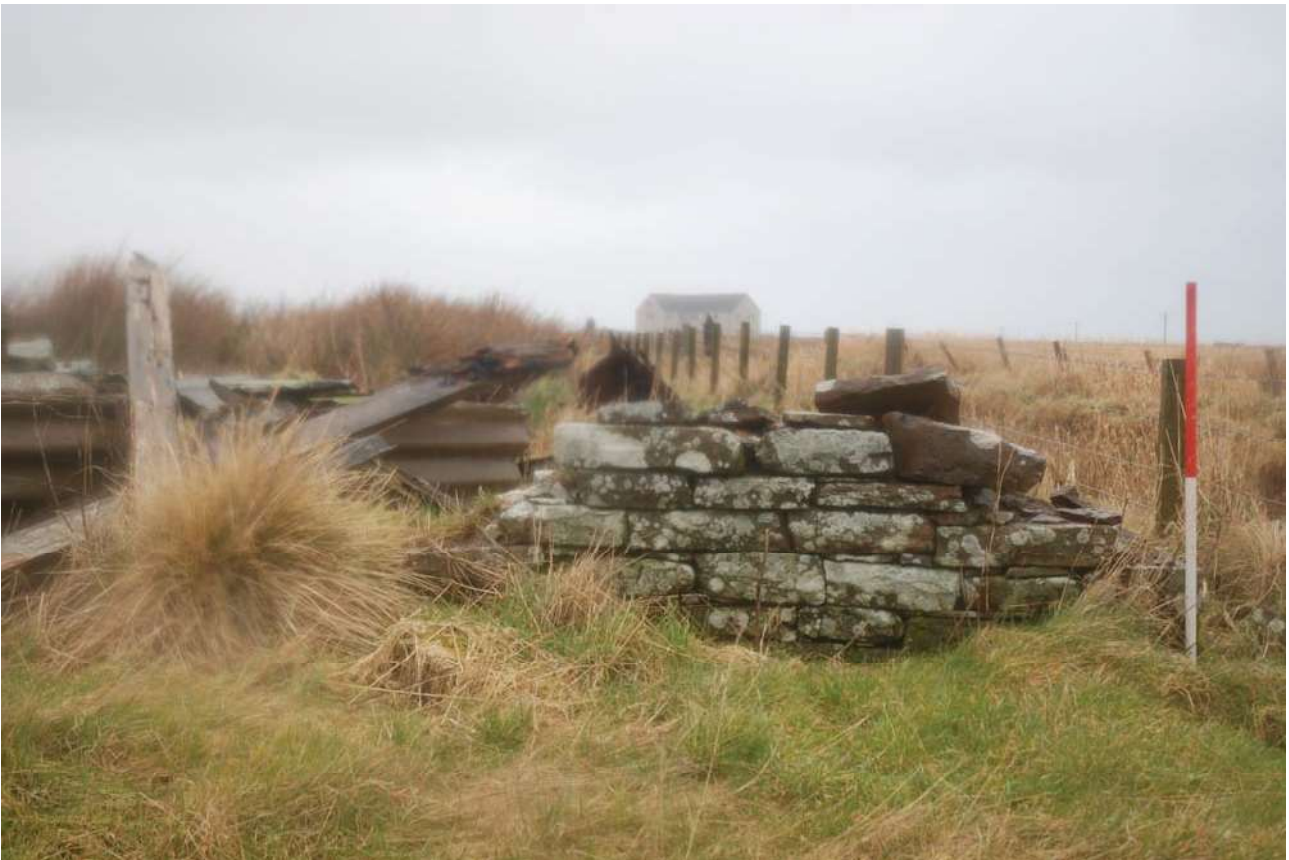
Plate 144: Site 13, stone walling remains, general view from the south-west

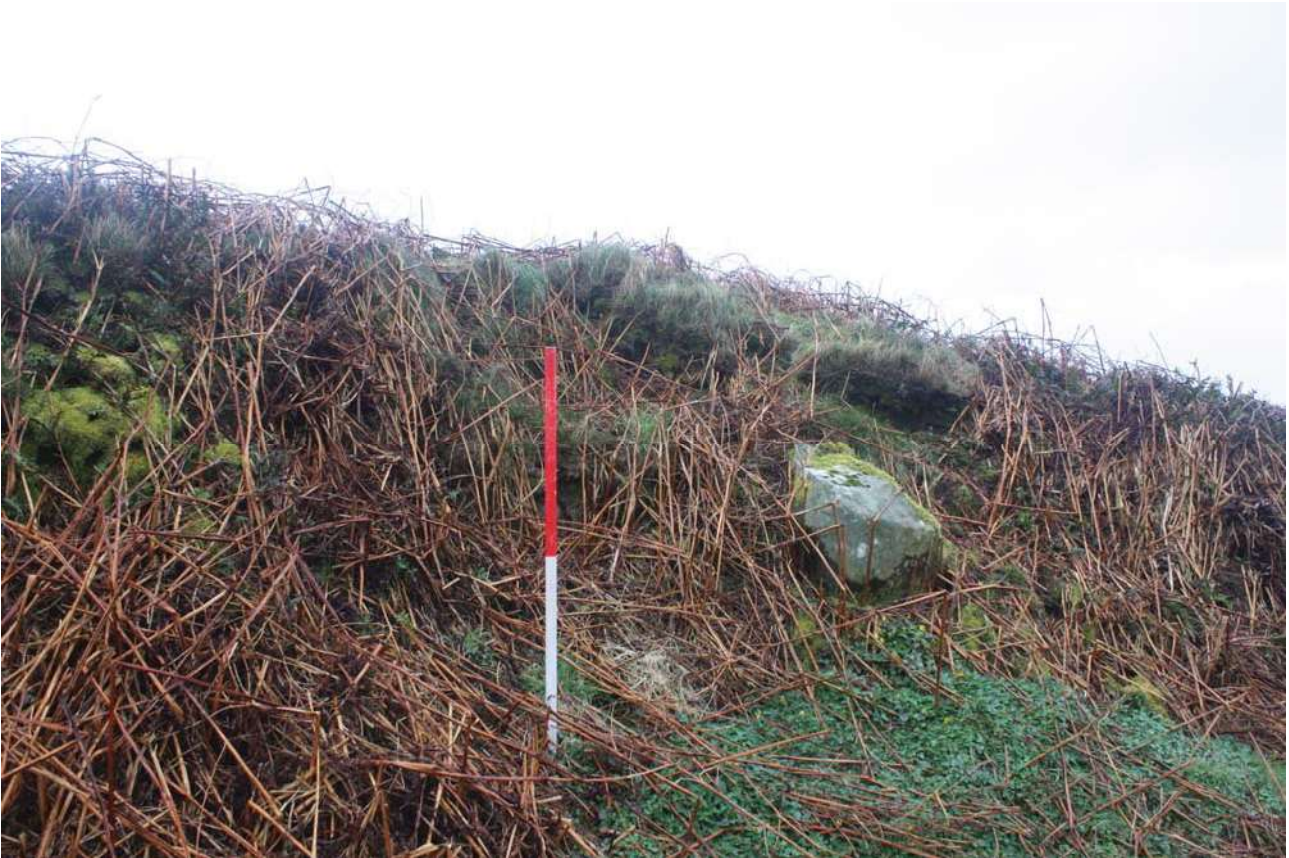
Plate 145: Site 14, stone walling remains, general view from the east

- 10.6 Sites 14 and 15 refer to small areas where stone walling may have survived to the north of the mill, on the west side of the bank, at the top ([Plates 145 & 146](#)).

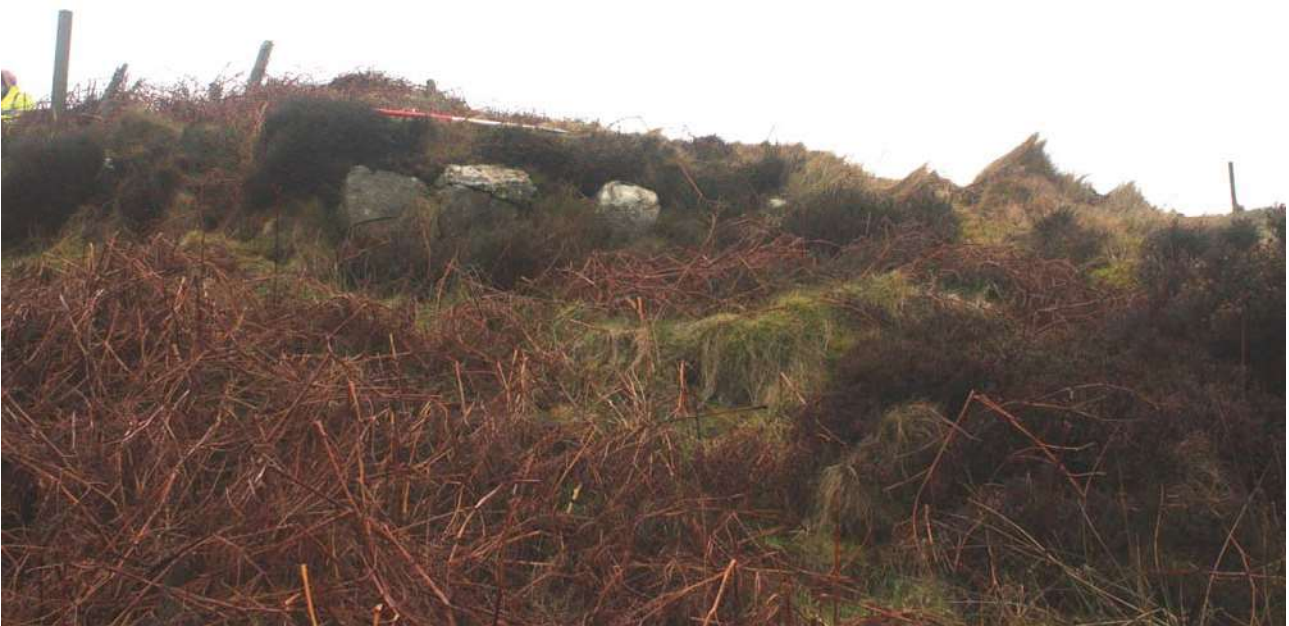
Plate 146: Site 15, stone walling remains, general view from the east

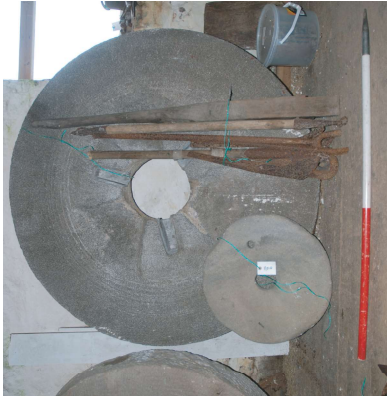
1/008 (millstone) & 1/012 (spiders)

1/007	1/1	Six assorted millstone dressings tools, including an iron cutting/incising tool with a wooden handle and other objects that look to be broken/partial versions of this	General Tools
1/008	1/1	Millstone 1.3m in diameter and 0.19m in thickness although it curves out to be 0.25m in the centre	Working Element
1/009	1/1	Millstone 1.36m in diameter, 0.08m in thickness, 0.15m thick to the centre, with sandstone backing	Working Element
1/010	1/1	Top millstone for a hand quern 0.50m in diameter and 0.05m thick at its widest part in the centre with a small 0.08m hole to the centre	Working Element
1/011	1/1	Collection of mixed tools on the northern windowsill including three traps, four nuts and bolts and three square nails	General Tools
1/012	1/1	Spider to drive the millstone lying in front of the used millstones 1/008 and 1/009. Full width 0.09m to centre. 0.30m from the outer spoke to the centre of the interior hole which is 0.055m in diameter	Working Elements

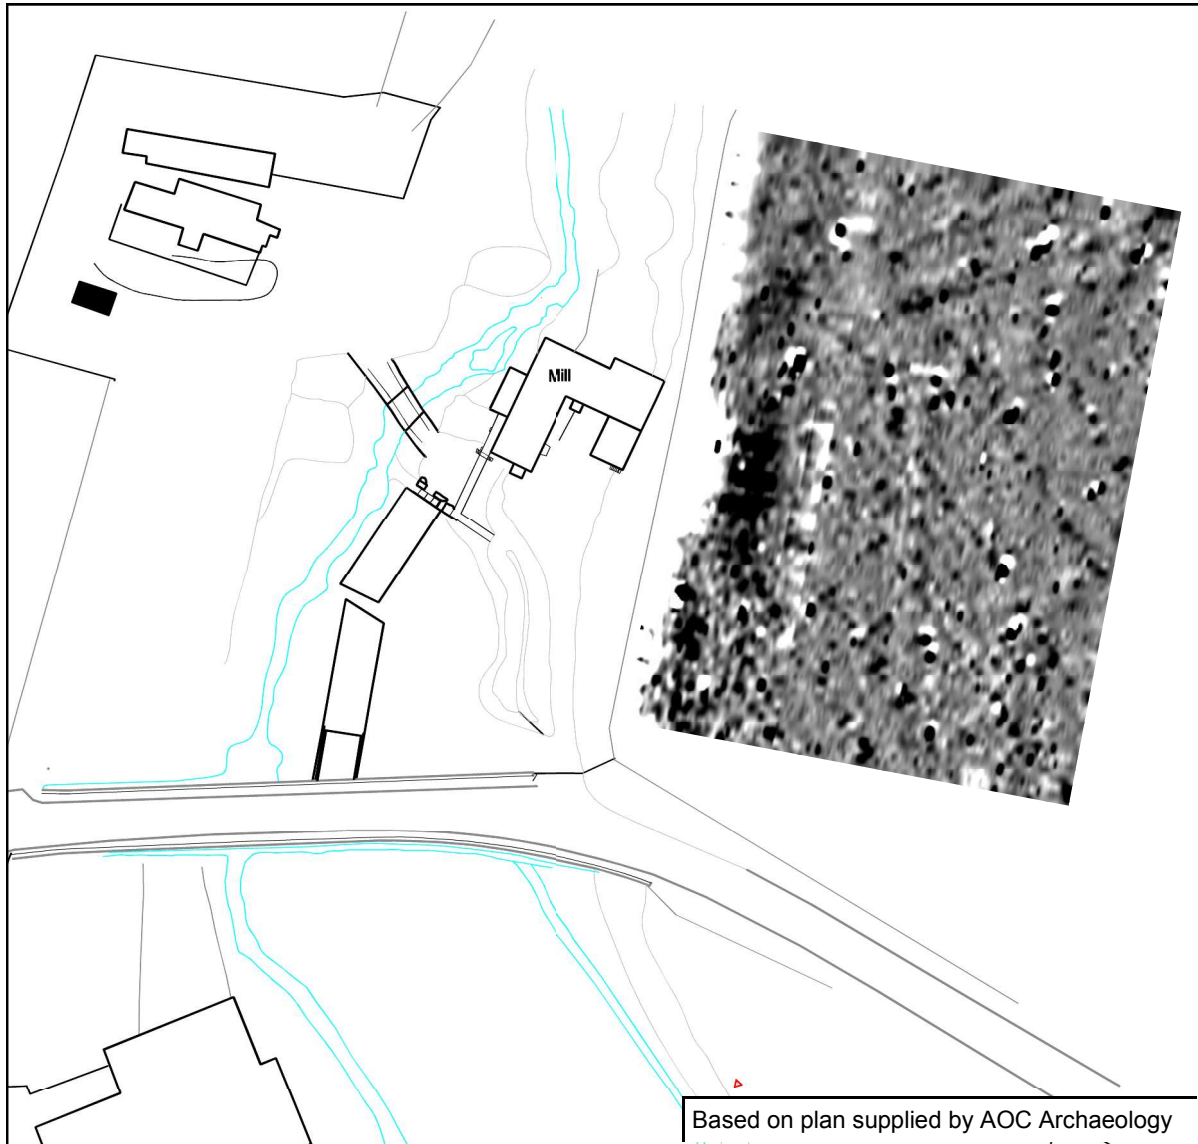
**JOHN O'GROATS MILL**  
**Gradiometer Survey**  
**Summary Greyscale**

- 2.6 Gradiometer survey was undertaken using a Bartington Grad601-2 gradiometer. The gradiometer comprises two fluxgate sensors mounted 1m apart on a vertical axis. Each sensor measures the earth's magnetic field, in nanoTesla (nT), and the instrument records the difference between the observed readings for each sensor. As a result the instrument is able to record subtle changes or anomalies in the earth's magnetic field caused by material in the top metre or so of the earth's surface. Data was collected at 0.25m intervals along traverses 1m apart within the series of 20m grids, which were later merged together.

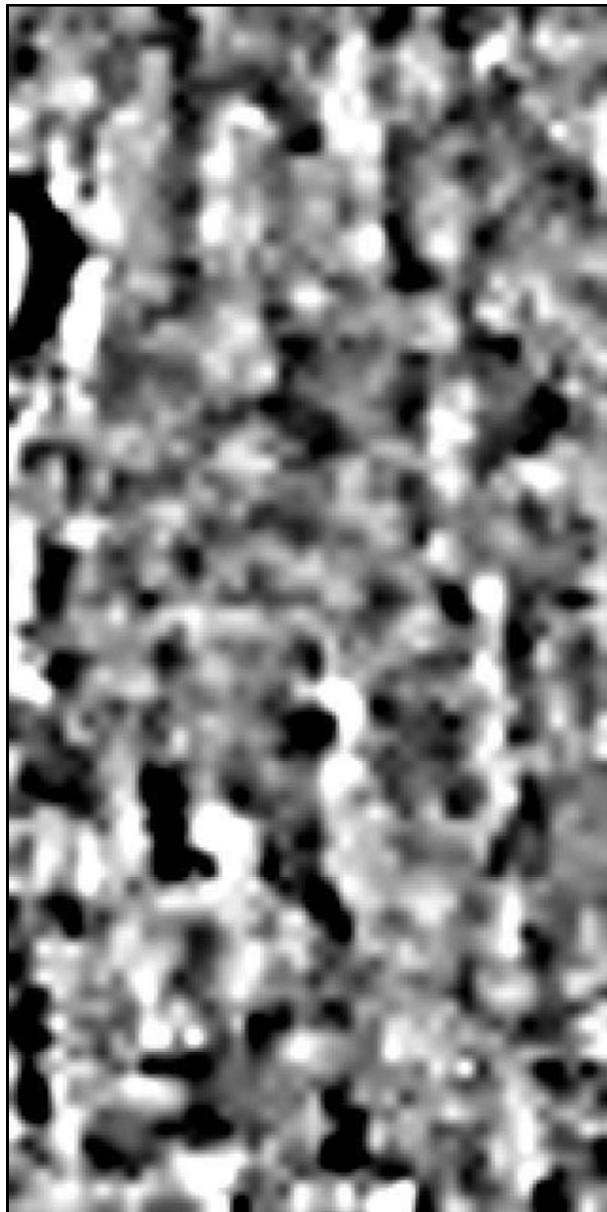
**JOHN O’GROATS MILL**

**Area C**

**Resistance Survey: High Pass Filtered Data**
