**A Project to Identify, Survey and Record  
Archaeological Remains in Strathconon, Ross-shire**

**Report of Phase One  
Scatwell and Lower Strathconon  
November 2006 - April 2007**

# **The Report of Phase One Lower Strathconon and Scatwell**

**November 2006 to April 2007**

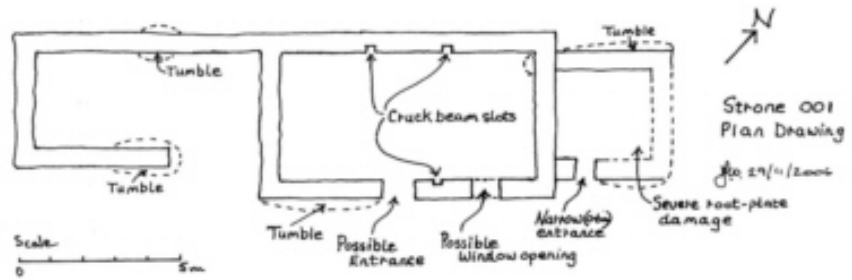
**002 Building** - This substantial well constructed drystone building, the main building of the site, is on a NE-SW alignment and measures 20.5m x 5m overall. The walls are 0.5m thick and largely intact to a height of 1.2m. The building comprises 3 compartments. The central or main one is 8m x 4m internally, has 3 well

preserved cruck slots, a 4<sup>th</sup> slot is missing (it should be near to the entrance and suggests a partial collapse of the front wall and a rebuild using some other form of roof support). One of the cruck slots tapers towards the wallhead clearly indicating that the walls were built to fit the cruck frames which were not matching.

Only one small widow space survives but it is reasonable to assume that there was a second “matching” window in the other part which has been destroyed by recent windblow. A possible entrance exists in the SE wall too(see plan and photos). The west compartment measures 7m x 3m and has a wide entrance in its SE wall. The east extension is 3m x 3m with a narrow entrance in its SE wall. The whole building is overlain with windblown trees and there is severe root damage at the east end. Unable to determine whether or not there was a garden to the front of the building because of windblow.

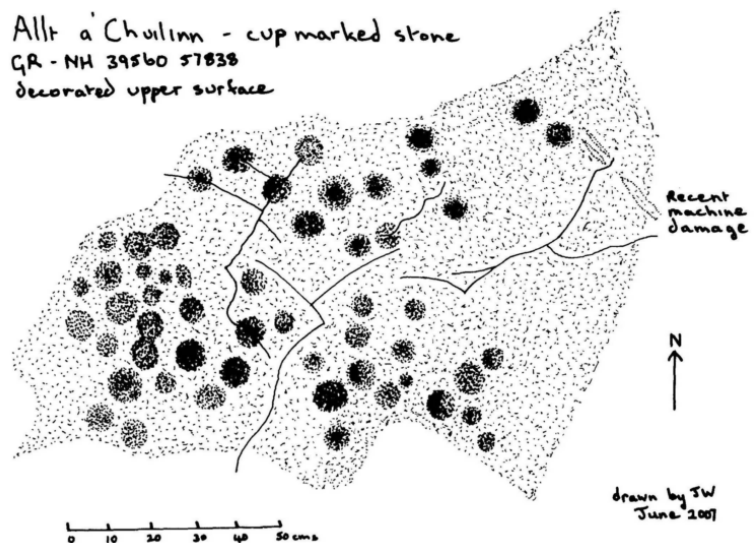
**056A Cup Marked Stone** - NH 39560 57838. A large boulder of sparkling mica schist measures 2m x 2m x 1m height. The upper surface is slightly tilted to the northeast and has 54 discernable cups, and probably a further 10 or 12 now too eroded to be sure of. The cups are approx 5 - 7cms in diameter, with the smallest being 4cms and the largest 9cms. Maximum depth of the cups is 2cms. Of note are the two pairs of cups running together and the probable use of natural cracks in the boulder to join some of the cups. On the east edge of the upper surface there is an obvious score which could have been caused by heavy machinery during the tree planting process (ie. it appears to be not too recent). The damage does not encroach on any of the cups.

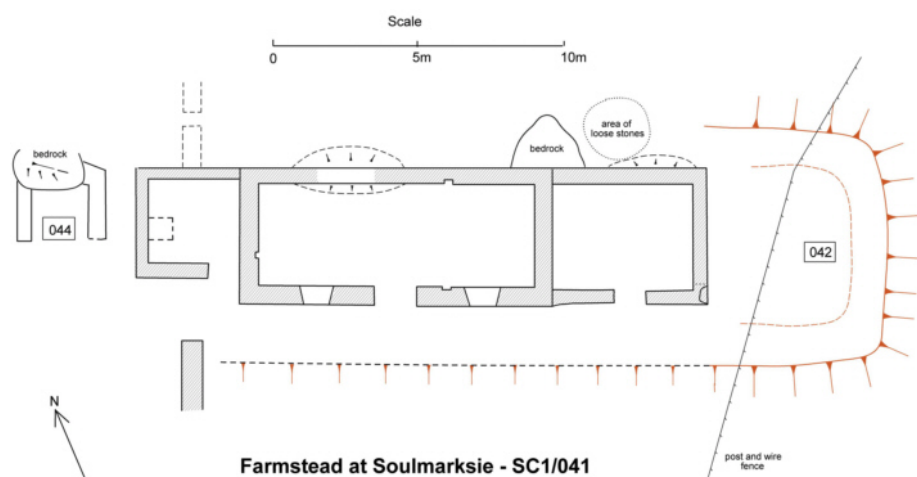
38495 58006 The main building is 19.90m E-W by 4.80m and the walls are largely intact up to gable height at both ends. There are 3 compartments each with S facing entrances. The E compartment may have been extended to the S (there is an indication of a wall join on the external face, this is less pronounced on the inner face.) The W wall is partially tumbled. There are no internal features (apart from a corrugated iron arc). The central

compartment has a tapered window space on either side of the doorway. To the E of the doorway there is a cruck slot and also a corresponding one on the N wall. There are no cruck spaces to the W of the doorway. The N wall is partially tumbled. The W compartment has no internal features apart from a setting of loose stones that appears to be recent and may be a fox trap. The S wall is set back from the general line of the S wall. The outer face of the east end of the central compartment and the W end of the E compartment is

inaccessible due to a fallen tree. Along the front (S) of the building there is an apron or platform 2.10m wide. 1m to the W of the main building is a small structure set into the bedrock. To the S of the main building are the upstanding (c.0.75m) remains of an enclosure wall. To the N and abutting the building is a more tumbled enclosure wall. There may be an entrance through this wall c.1m N of the building but it has been filled with tumble.

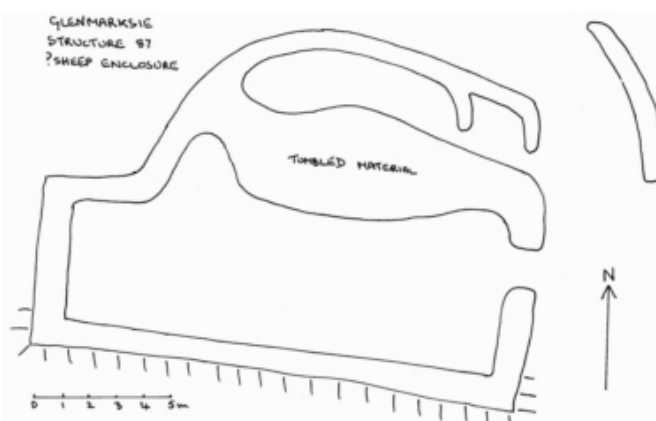
**087 Enclosure/ Possible Building** - NH 37670 57994 A complex irregular structure with considerable tumbled material such that it was very difficult to determine the form to it. It lay on a NW-SE axis and had internal dimensions of 16m x 11.2m. The S side is raised to form a platform and the wall is 1m high here with a thickness of 2m . The central and north part of the structure were

more complex - see plan. There is a detached curving section of wall to the east which is 6.6m long x 0.7m high x 1m thick.

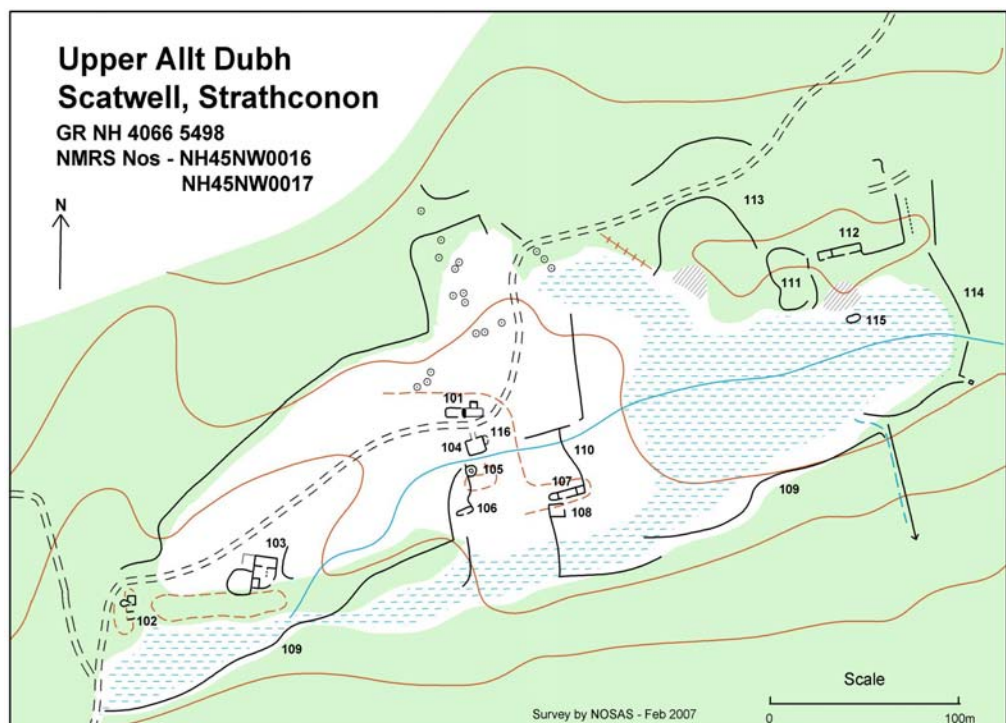
**East Township/Farmstead, enclosures, building and dam (111 – 115)** (Nmrs No NH45NW0017)

Centred on NH 4086 5509 The site of this settlement is used for feeding deer and has been limed in recent years. Much of it is heavily trampled by deer and the deep furrows of tractor tracks cut up the area (particularly relevant to enclosure 113) This east group of structures comprises 2 buildings and at least 2 enclosures. Included here also is a dam which lies to the SE of these structures. There appears to be 2 different phases with one of the buildings, 115 (in the middle of the marsh/former pond!) being earlier. The site appears on 1<sup>st</sup> edition OS survey as a single unroofed building.

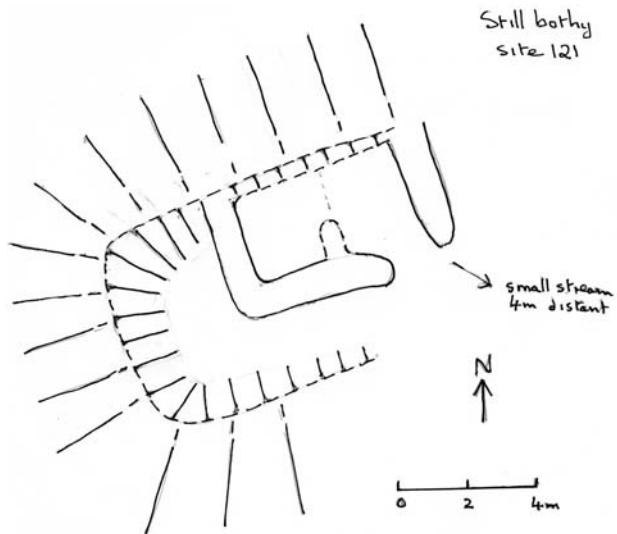
**Still bothy 121** NH 4012 5495 Tucked away in a small re-entrant/valley to the south of the main Allt Dubh and just a 100m from it, this site is well hidden and in natural birch woodland. The rectangular building is on a WSW-ENE axis and is constructed within a larger recessed area, see sketch. The building measures 5m x 2.5m internally. The north side is recessed into the slope, with a bank of 0.5m. The structure has dry stone walls of 1m thickness and 1m height at its W end. The south wall is 1m thickness and 0.6m height. Two compartments are formed by a partition with the westmost compartment possibly on a slightly raised level. There is an entrance 1m in width at the E end of the south wall of the building. A very small burn runs down the slope a few metres to the south. Overgrown with bracken and heather

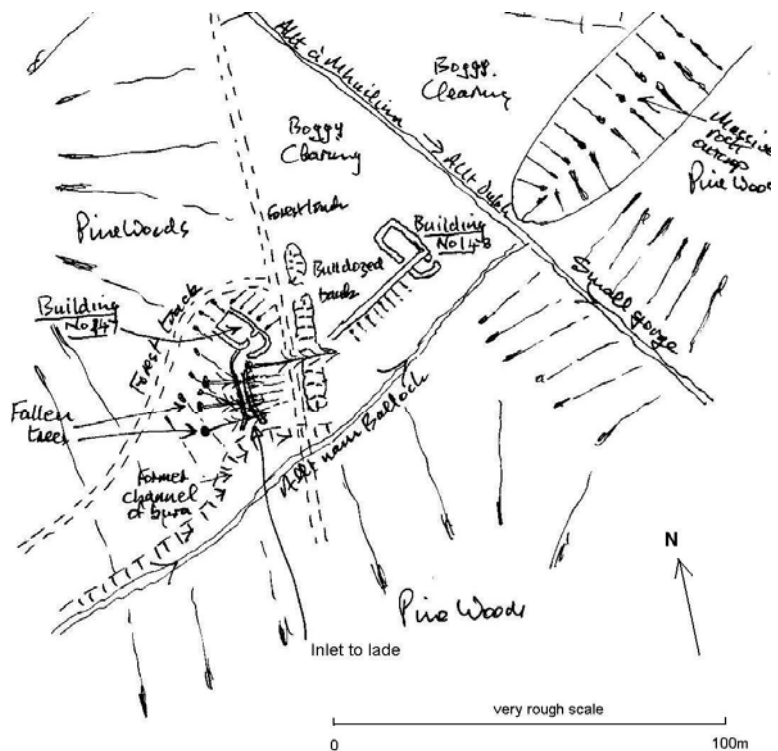
SKETCH PLAN OF CLEARING AND THE 2 BUILDINGS

**Shielings 125** NH 4005 5465 At an altitude of 160m and on an east facing sheltered slope on an otherwise north facing slope. This relatively fertile area has remnants of tree stumps and is bracken covered. Three small rectangular buildings with rounded ends were identified:

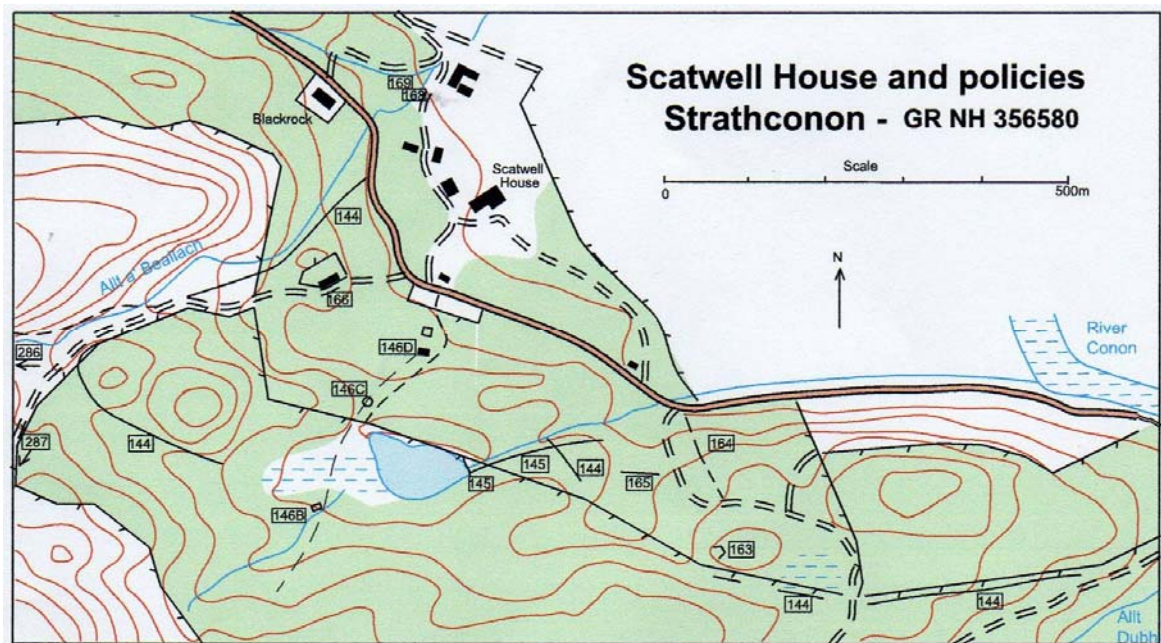
**A Dam - NH 39847 55525** 350m to the south of Scatwell House and c450m and to the WSW of the site of the original township of Milltown of Scatwell. A small burn (originally tapped for the hydro-scheme) feeds the pond, but the main Allt a Mhuillin has been diverted to run eastward down the Allt Dubh. This diversion was probably achieved at the time of the construction of Scatwell House and its policies in 1850 as part of

attempts to improve the drainage of the area as it is marked on the 1<sup>st</sup> edition OS survey of 1872. The earth dam, 50m long and 3m thick, is at the east end of a small artificial pond, 200m square and now partly silted up.

**B Lade** is approx 200m in length and running east from the east end of the pond on the south bank of the natural watercourse. It is cut into the hillside and built out on its north/down side by an embankment of random boulders up to 1.5m in height and 1.5m in thickness. The lade turns and follows a northerly direction, descending steeply down to the line of the former burn, the bank at this point is composed of larger boulders. The boundary wall, 144, crosses the lade at NH 39952 55555. A well made track follows the line of the former burn on its north side from the dam to ?Scatwell House. It is 2m in width

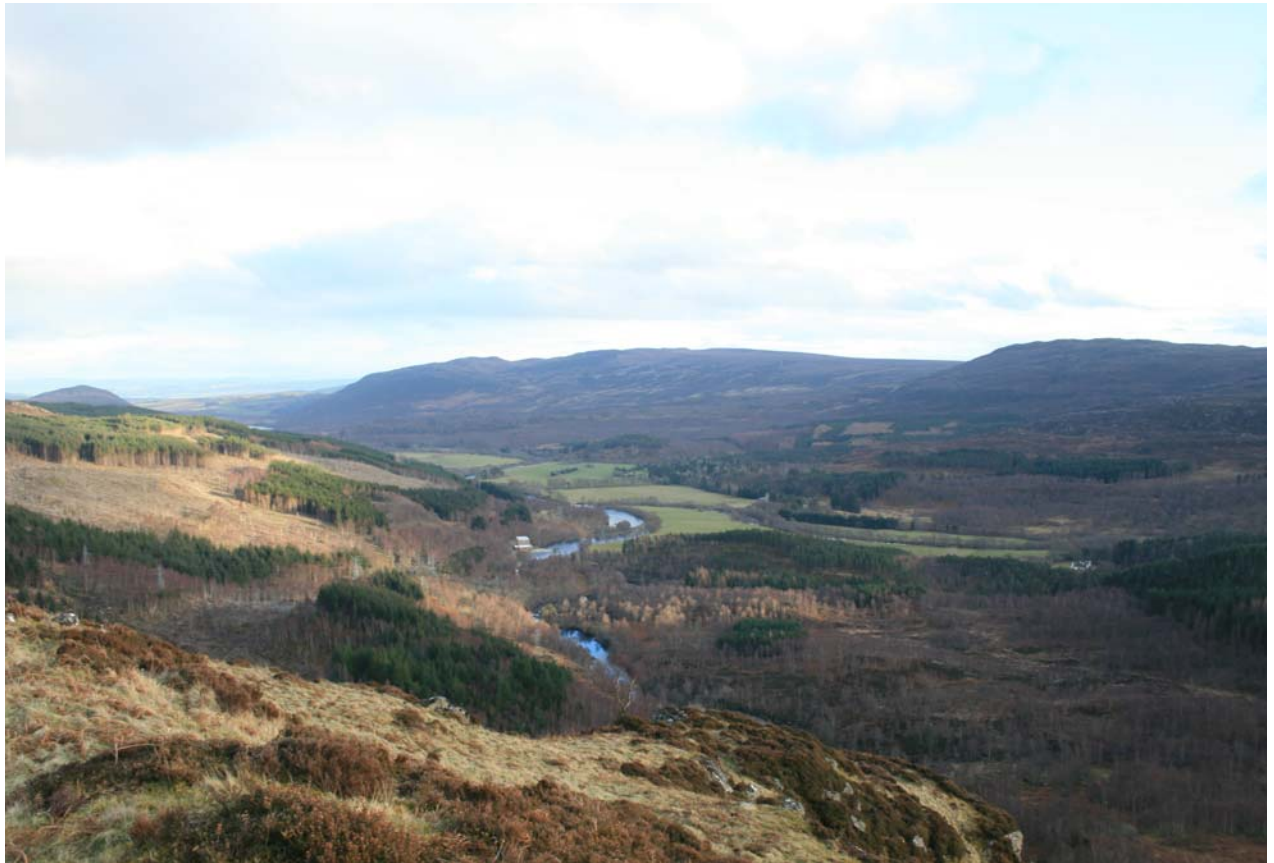
*Fig 1.* General view of the lower part of Strathconon from the northwest. Scatwell lies to the right

Phase 1 (SC1) of the Strathconon Project covers an area defined by the 3 dams of Achonachie, Lochluichart and Meig. To the north, the west end of Loch Achilty is taken as the limit. The area covers a total of 15 km<sup>2</sup> (Fig 1.) and is principally the estate of Little Scatwell, but it also includes a small part of the Lochluichart Estate to the north and the Fairburn Estate to the east. Most of the land is in the Parish of Contin, but a small part in the lower glen, to the east of the Allt na Fannaich is in Urray Parish. At the time of the 1<sup>st</sup> Edition Ordnance Survey, 1872, the boundary between the parishes was the Allt na Criche which runs parallel to the Allt na Fannaich a few hundred metres to the northwest.

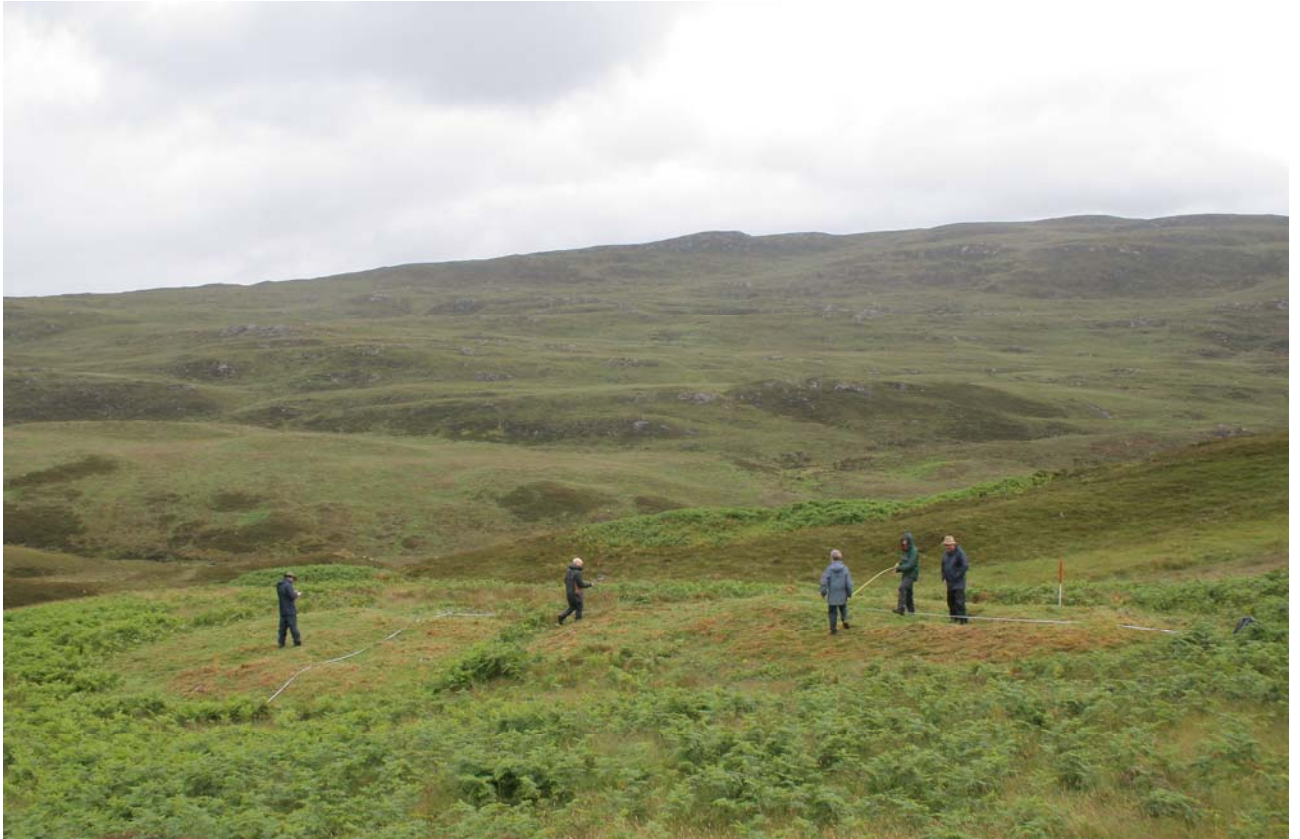
*Fig 3. Surveying sheilings 307 and 308 in upper Glen Marksie using taped off-set method*

**307 Building/Sheiling** (Fig 3) - NH 35460 58054 A rectangular building on a NW-SE axis, has internal dimensions of 4m x 2m. An outshot outside SE corner, roughly circular and 2m diameter. Further outshot outside NE corner is possibly semi-circular and 1.5m x 1m.

**308 Building/Sheiling** (Fig 3) - NH 35447 58059 A rectangular building on an E-W axis, has internal dimensions of 5m x 2m. Circular outshot at SE corner, 1.5m diameter

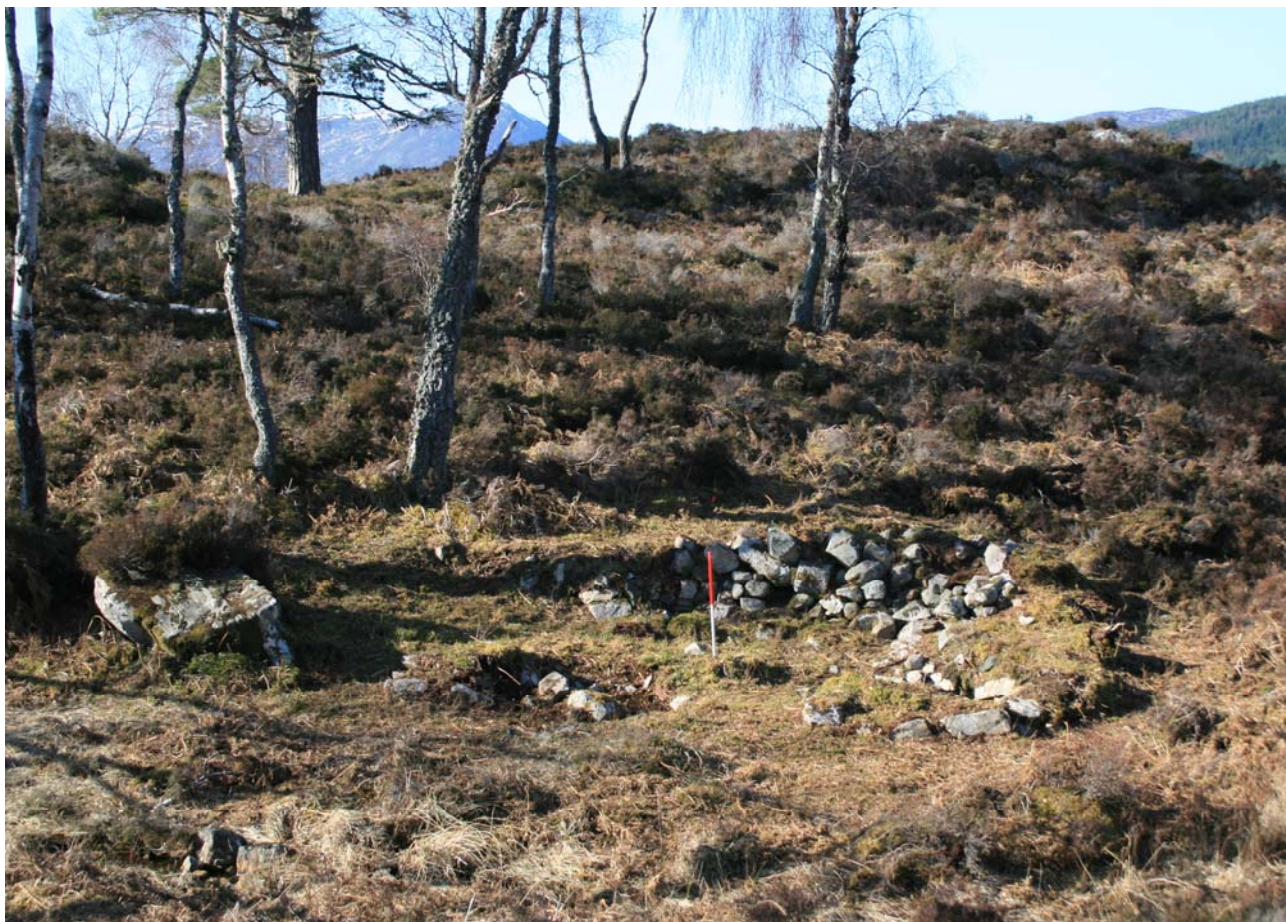
*Fig 5. Still bothy 201 at Drumandarroch*

**201 Still bothy (Fig 5)** - NH 41825 55132 This structure is on the edge of derelict birch woodland, on the NW side of a small un-named burn, above and to the WSW of the large enclosure at Drumandaroch (west end Loch Achonachie). The ruined remains of this probable still bothy measure c6.75m SW/NE x 3.75m internally. The front of the structure sits c4m back from the burn. The wall tops are covered in heather and moss. It appears that the structure was open fronted facing SE. The

back of the structure and the SW wall are dug into a rising bank, whilst the NE wall is free standing. The structure may well have been deliberately destroyed as much tumbled stone lies within it. That part of the drystone rear wall towards the N corner survives in a tumbled condition to a max of c1m high, and it appears that the walling against the cut bank was single faced, and there is clear indication that there was a semi circular feature built into the N corner c1m in diam. This is a feature found in many of the Strathconon still bothies and better preserved specimens show within evidence of a half-

The ground vegetation around the structure is rank heather, whilst inside the structure it is fine grasses, bracken and heather. Considering its position and the other structures to be found in the surrounding landscape 201 may well be associated with the production of illegal whisky.

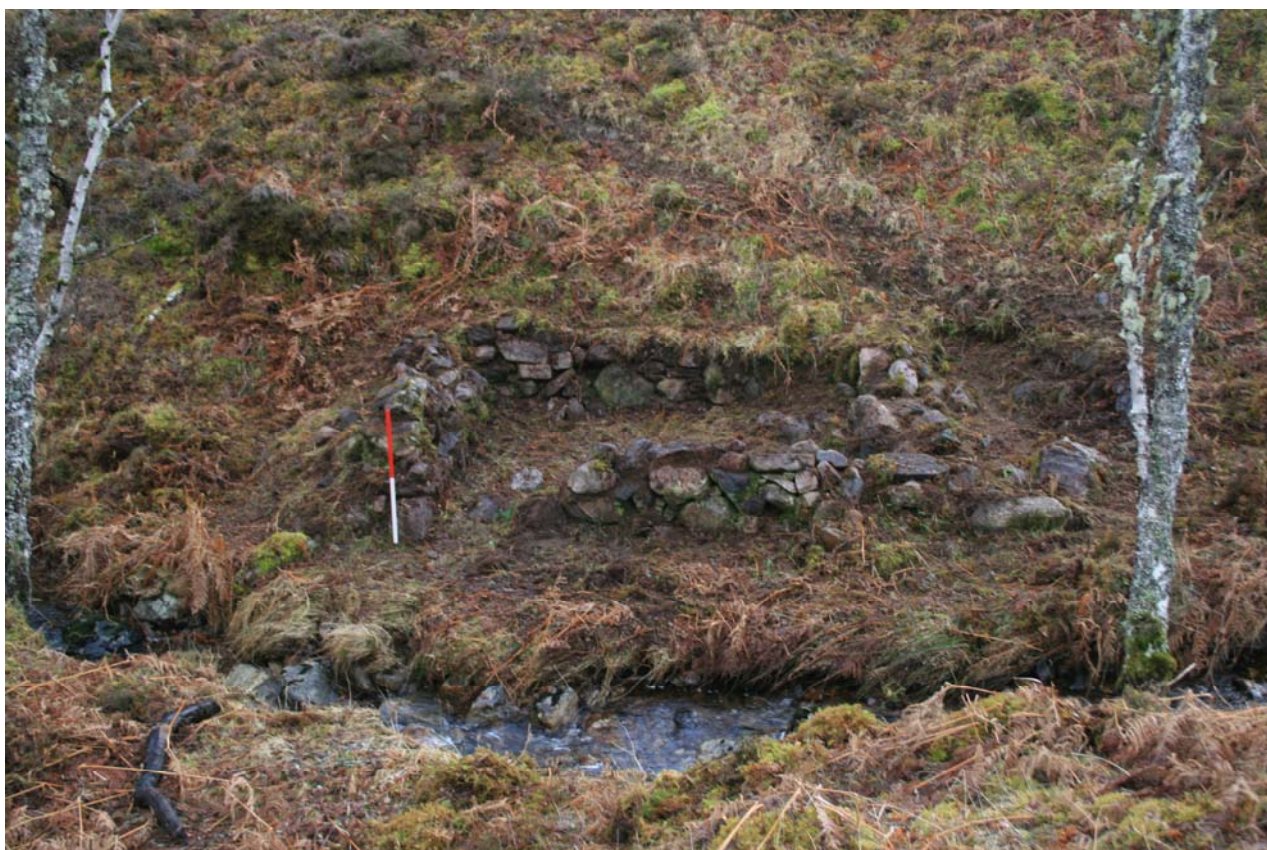
*Fig 6. Probable still bothy 161 at Allt Dubh*

Site 122 appears to have been the centre of some activity or process on a semi industrial scale. In view of the surrounding landscape it may well have been associated with the production of whisky. Site 161 is almost certainly a still bothy.
