REPORT TO SCOTTISH & SOUTHERN ELECTRICITY NETWORKS

LOCHAILORT TO GLENFINNAN 33KV OVERHEAD POWER LINE REPLACEMENT

ARCHAEOLOGICAL WALK-OVER SURVEY APRIL 2017

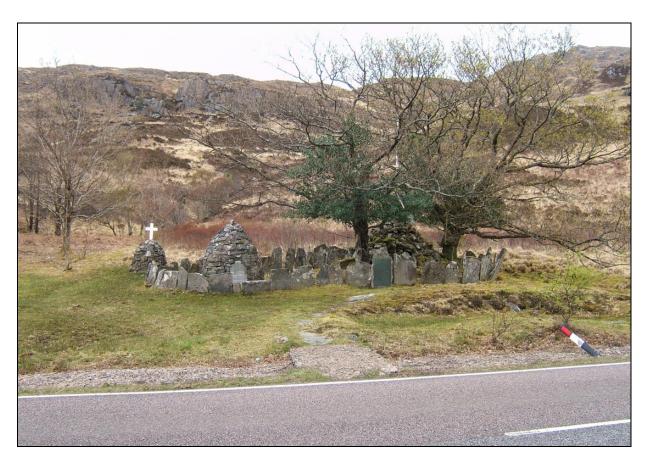
1 NM88SW 6 Loch Eilt: memorial cairn (Map 1)

Memorial cairn to Duncan Cameron of Lochailort at NM 8008 8273, viewed from the south.

Site 1, the memorial cairn to Duncan Cameron (NM88SW 6) stands in a prominent position by the side of the A830 road and should not be difficult to avoid during the line refurbishment. Similarly, the settlement of Ranochan (Site 2; NM88SW 4) is easily recognizable but should any work be necessary in this area, care should be taken to avoid any upstanding remains of derelict structures associated with the early occupation of this site.

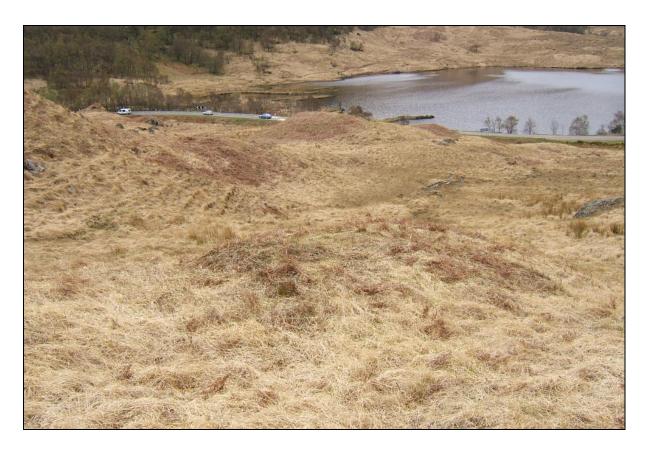
3 MHG 30162 Platform (Map 2)

The platform described as being at NM 8430 8180 proved difficult to identify. There is no real evidence of any man-made structure at this location.

The photograph below was taken at that location where there is little to suggest that this feature is anything other than a natural one. It comprises a rounded mound, probably of glacial origin, measuring some 4m by 3m.

The surface of this feature undulates considerably and not really suitable as a house platform. In addition, there was no evidence that it had been used as a charcoal-burning stance.

Putative platform MHG 30162, viewed from the north

Although there is little evidence that Site 3, the putative platform MHG 30162, is anything but a natural feature, care should be taken to avoid it during any development work in its vicinity.

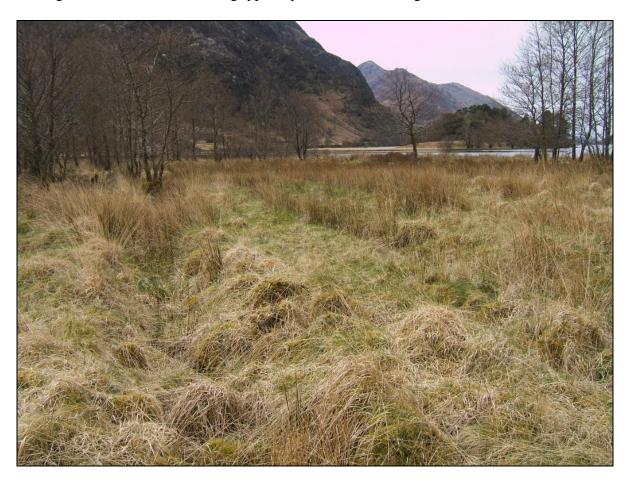
4 NM98SW 26 Cultivation remains (Map 2)

The cultivation remains centred on NM 90685 80554 appear to comprise a series of lazy beds running north/south and measuring typically 2.2m between ridges.

Putative lazy beds at NM 90685 80554, viewed from the north

The cultivation remains of Site 4 (NM98SW 26) at Glenfinnan may lie beyond the limits of the redevelopment. However, should work extend into this area, it is recommended that the integrity of the lazy beds be preserved.

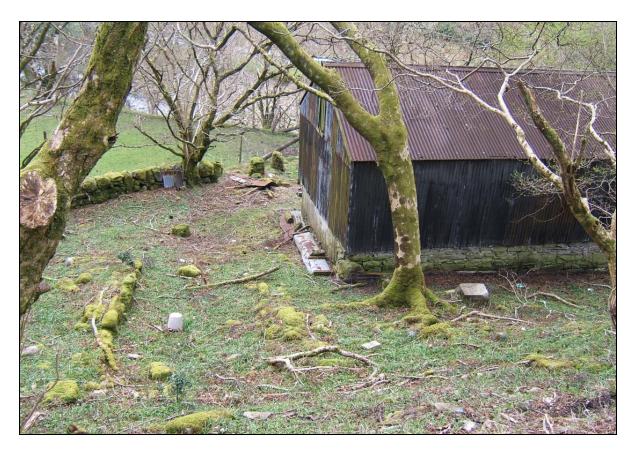
5 **Structure** (Map 1)

A short distance from the west terminus of the survey, at the base of a slope and close to the River Ailort at NM 76846 82334, are the scant remains of a rectangular structure. It measures 5m east/west by 2.5m wide within drystone rubble walls, 0.6m wide and surviving to a height of only one course above ground.

No trace of an east gable was visible, perhaps because of stone-robbing although it may have been an open-ended building. There is some evidence of a return northwards from the northeast corner of the building although the stonework did not extend far. No features were evident within this structure.

Structure at NM 76846 82334 with extant farm building to its right, viewed from the west

Adjacent to this structure is a much larger building with stone foundations 1.1m high supporting walls and roof of corrugated iron. This structure, currently used as a farm building, is shown on the first edition OS map of 1876 whereas the scant remains nearby are not although it is possible that they co-existed at some stage.

The slight remains of the small structure (Site 5) adjacent to an extant farm building at Lochailort, but not depicted on any known map, may represent a remnant of a pre-Improvement settlement. Similarly, the short stretch of boundary bank (Site 6), 1.2km east of Lochailort, appears also to be related to pre-modern farming. Both features should be avoided during the line refurbishment.

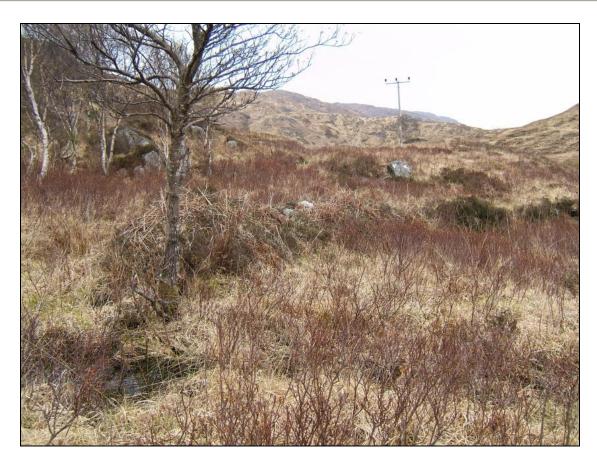
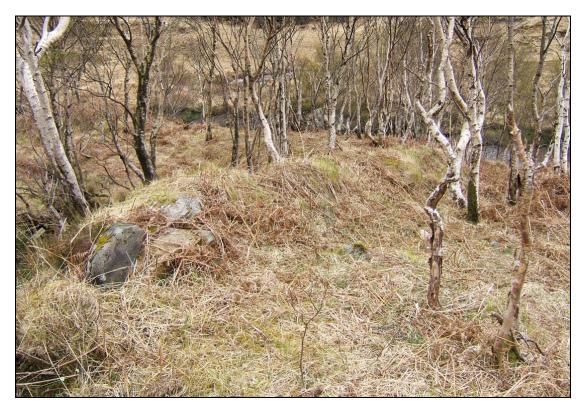
6 Boundary bank (Map 1)

Remnants of a stone and earth bank were encountered at NM 77803 83031. It runs south-eastwards for 8m before being cut by a small stream from where another stretch continues downhill towards the River Ailort. The bank measures 1.2m wide at its base and 1m high. Although now covered with vegetation, some of the stones of its construction are still visible.

Turf bank at NM 77803 83031, viewed from the west

Turf bank approaching the river, viewed from the north

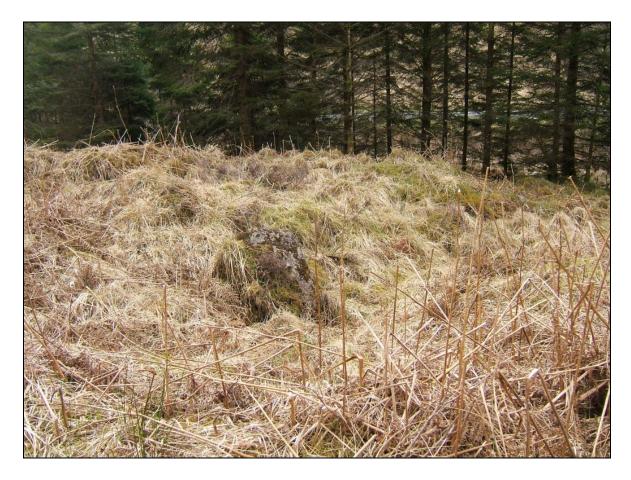
Possible borrow pit (Map 2)

At NM 87842 81770, within a cleared corridor through coniferous forestry, is what appears to be an artificial scoop, measuring approximately 12m by 12m. Its location, close to the A830 road, suggests that it was a borrow pit utilized during one of the road's phases of construction.

Putative borrow pit at NM 87842 81770, viewed from the south

Of less significance is the possible borrow pit (Site 7) some 3km west of Glenfinnan. This feature may be related to the construction of one of the phases of the nearby A830 road and is considered of little archaeological or historical significance.
