Glen Brown Woodland Creation Dorback Estate Archaeological Walkover Survey Report

AOC 70511

June 2021

On Behalf of:	Galbraith
National Grid Reference (NGR):	NJ 09811 18723 (centre)
AOC Project No:	70511
Prepared by:	Lindsey Stirling
Illustrations by:	Lindsey Stirling
Date of Fieldwork:	2 nd -4 th , 15 th -16 th & 22 nd June 2021
Date of Report:	25 th June 2021
OASIS No.:	aocarcha1-424845

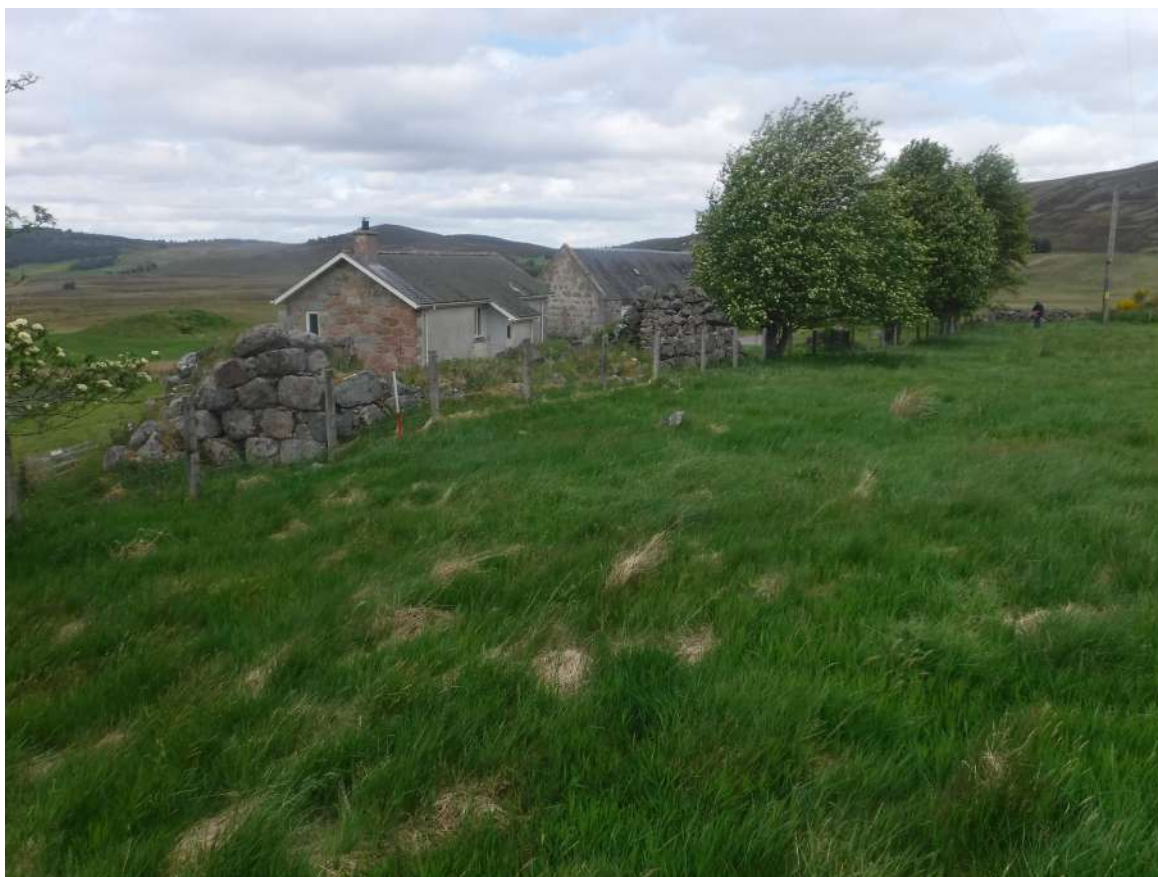
Plate 5: Modern settlement and ruined structures 87c at Sliabhclachd

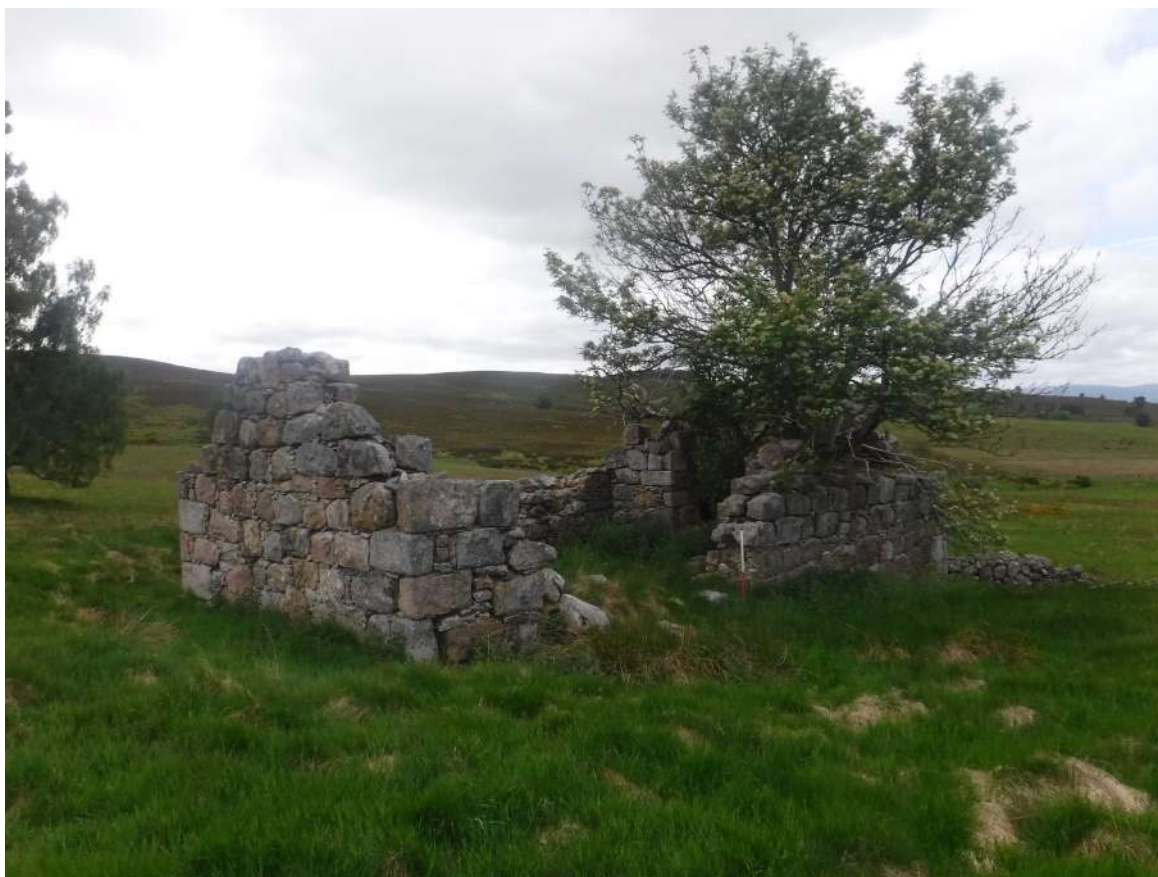
Plate 6: Ruinous kiln barn 87b, facing SW

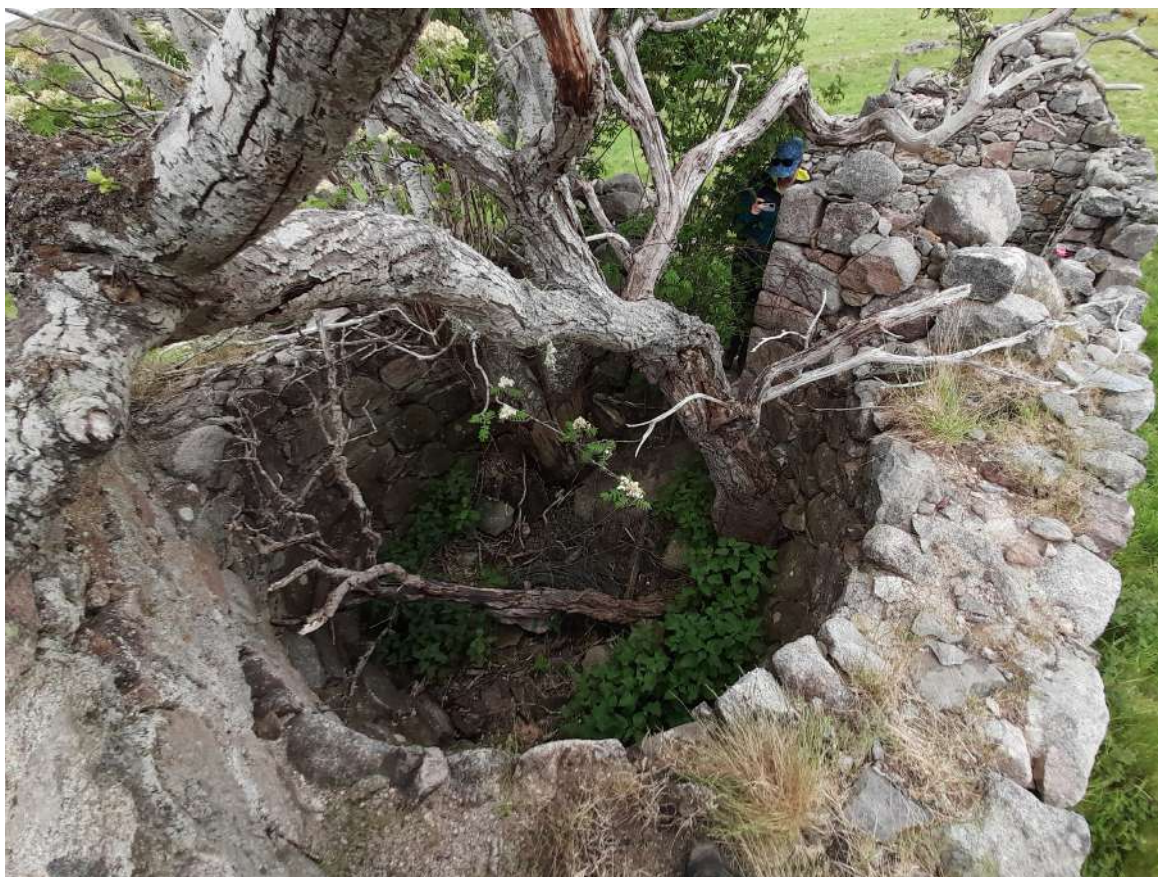
Plate 7: Interior of ruinous kiln barn 87b, facing NE

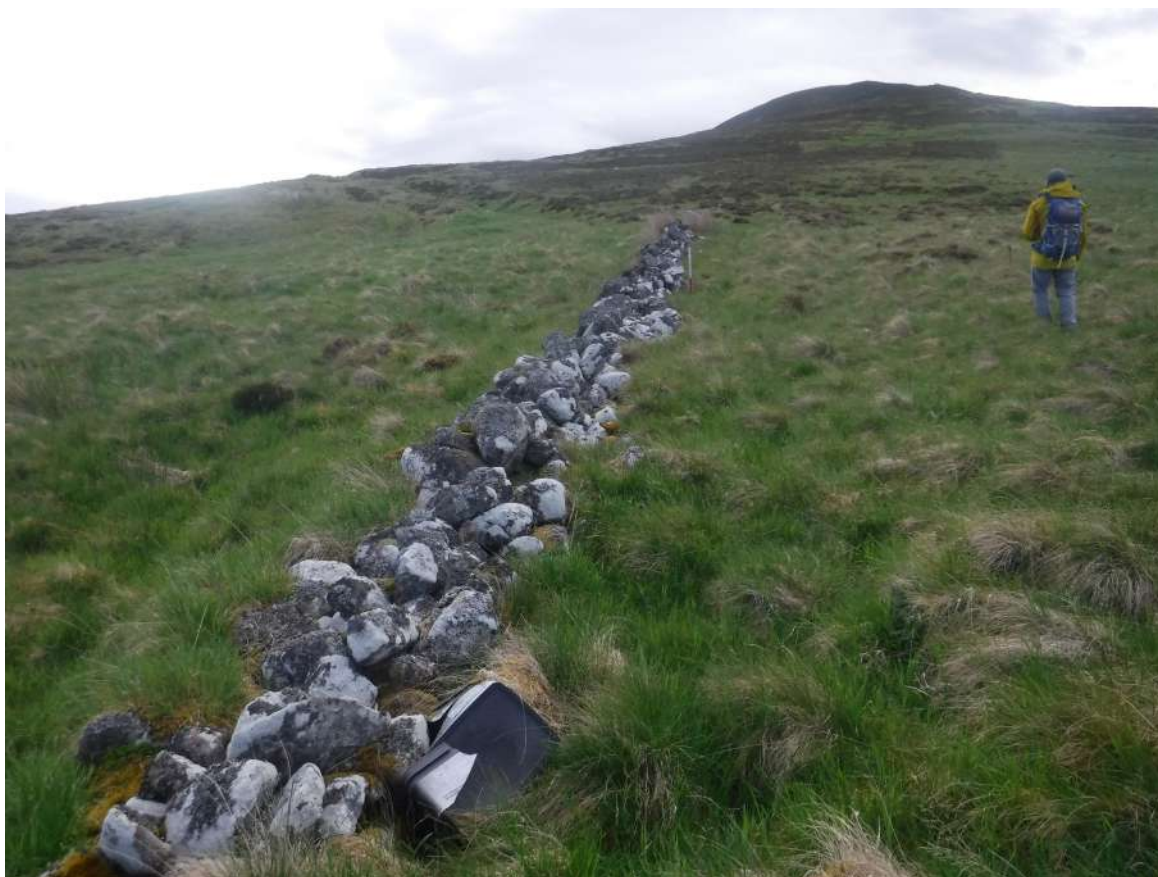
Plate 8: Stone enclosure wall 81, facing E

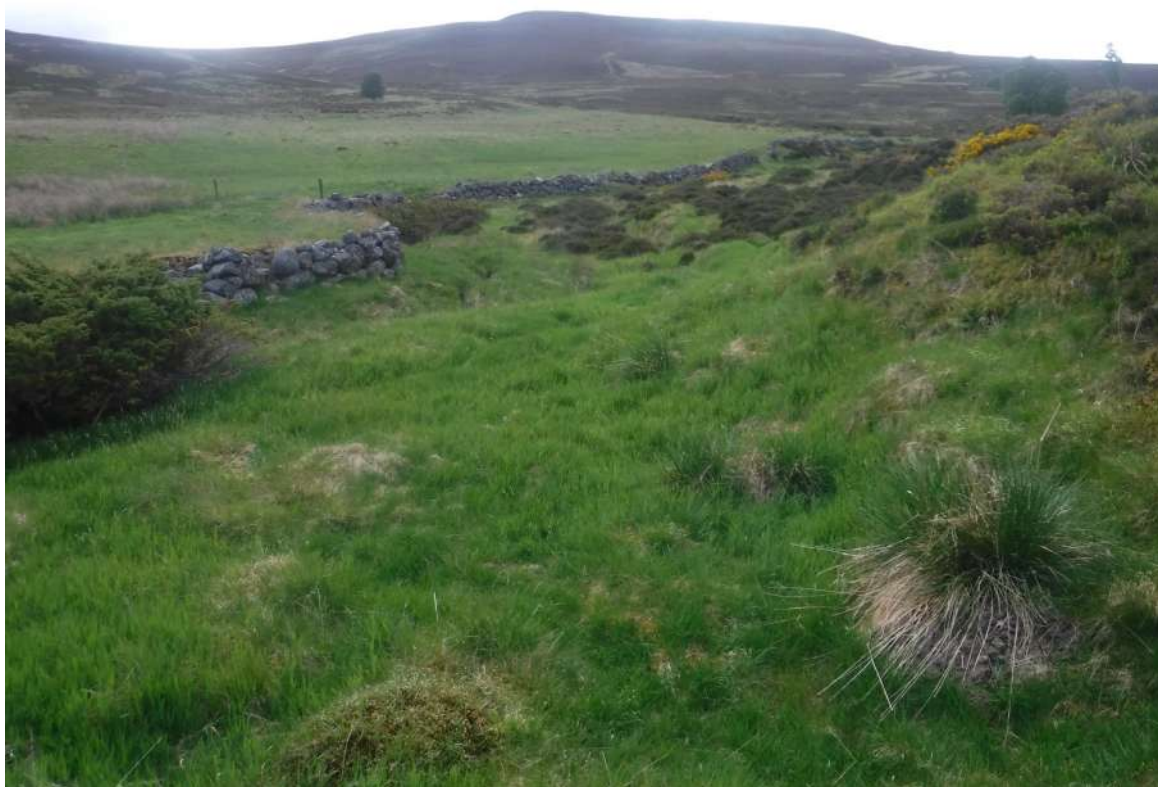
Plate 9: Stone revetment wall 86, facing SE

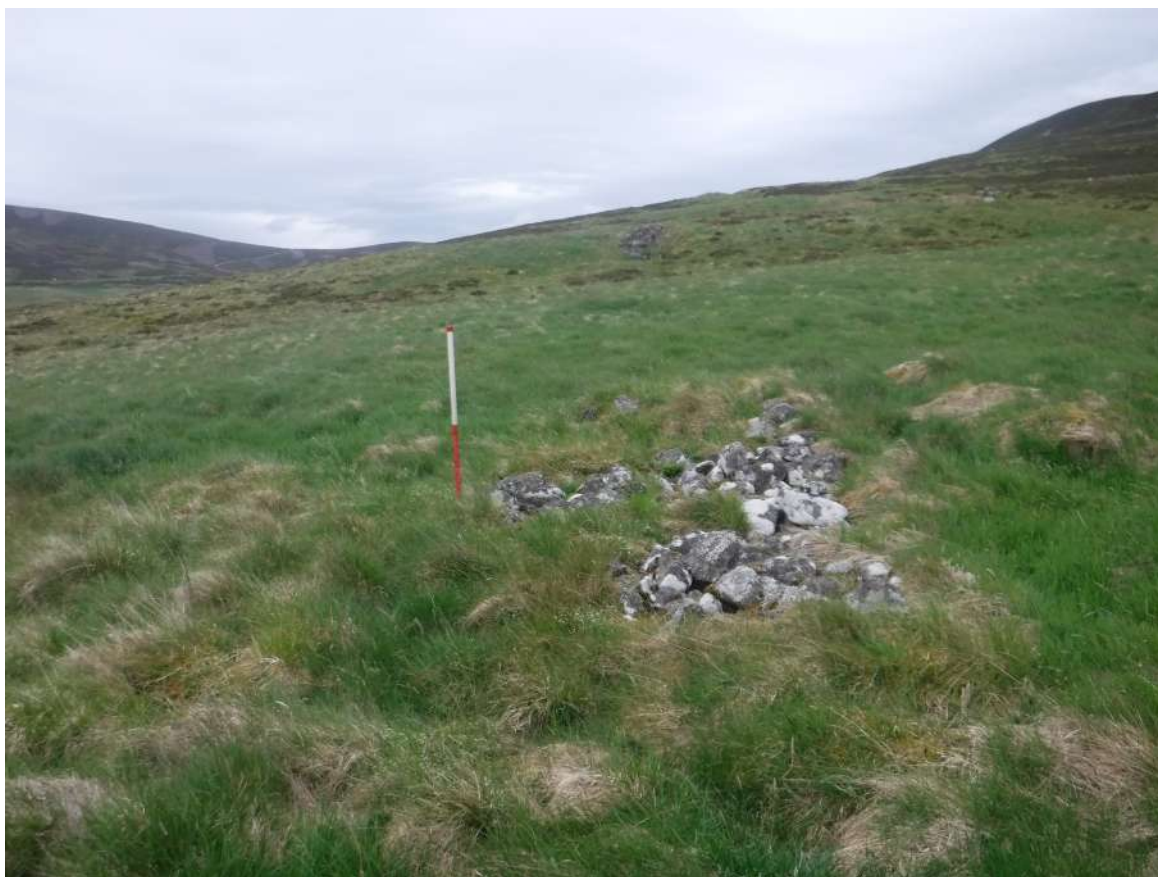
Plate 10: Stone cairn in cairnfield 2, facing E

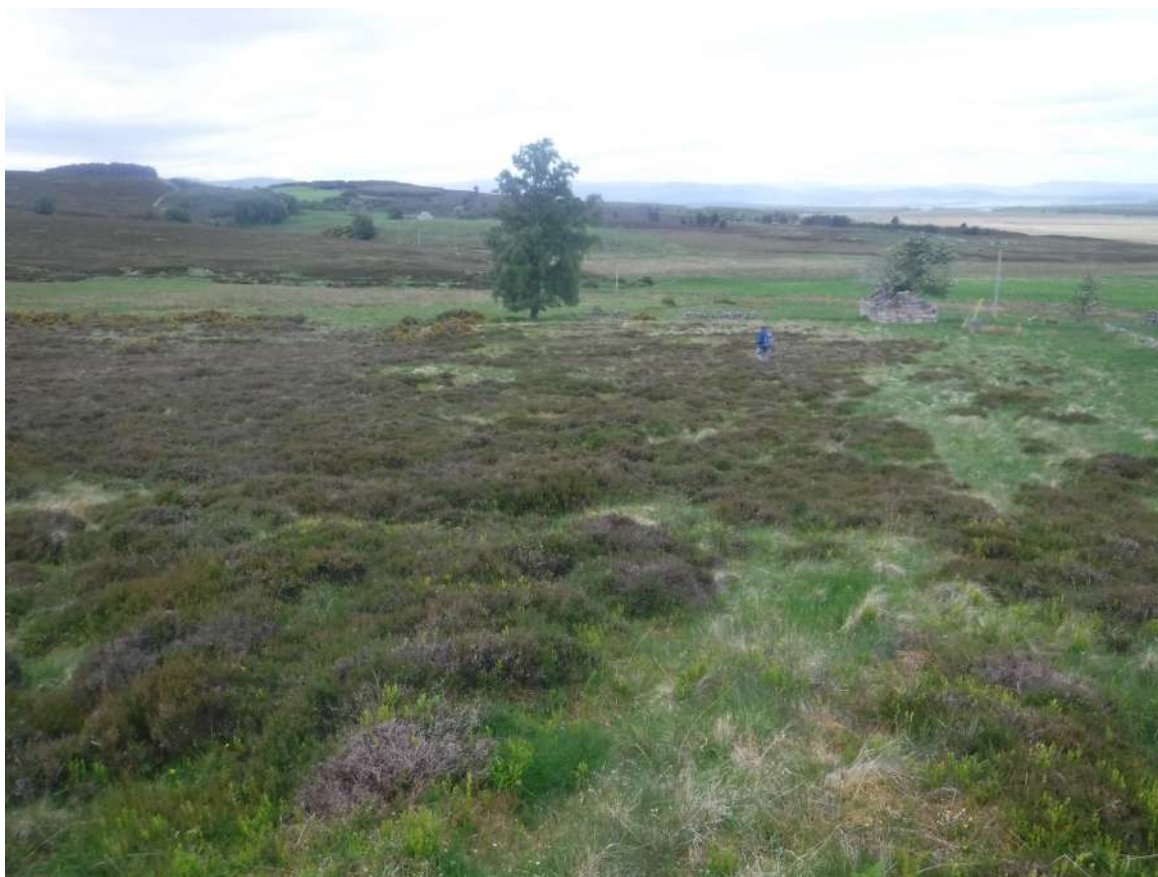
Plate 11: Overview of cairnfield 5, facing W

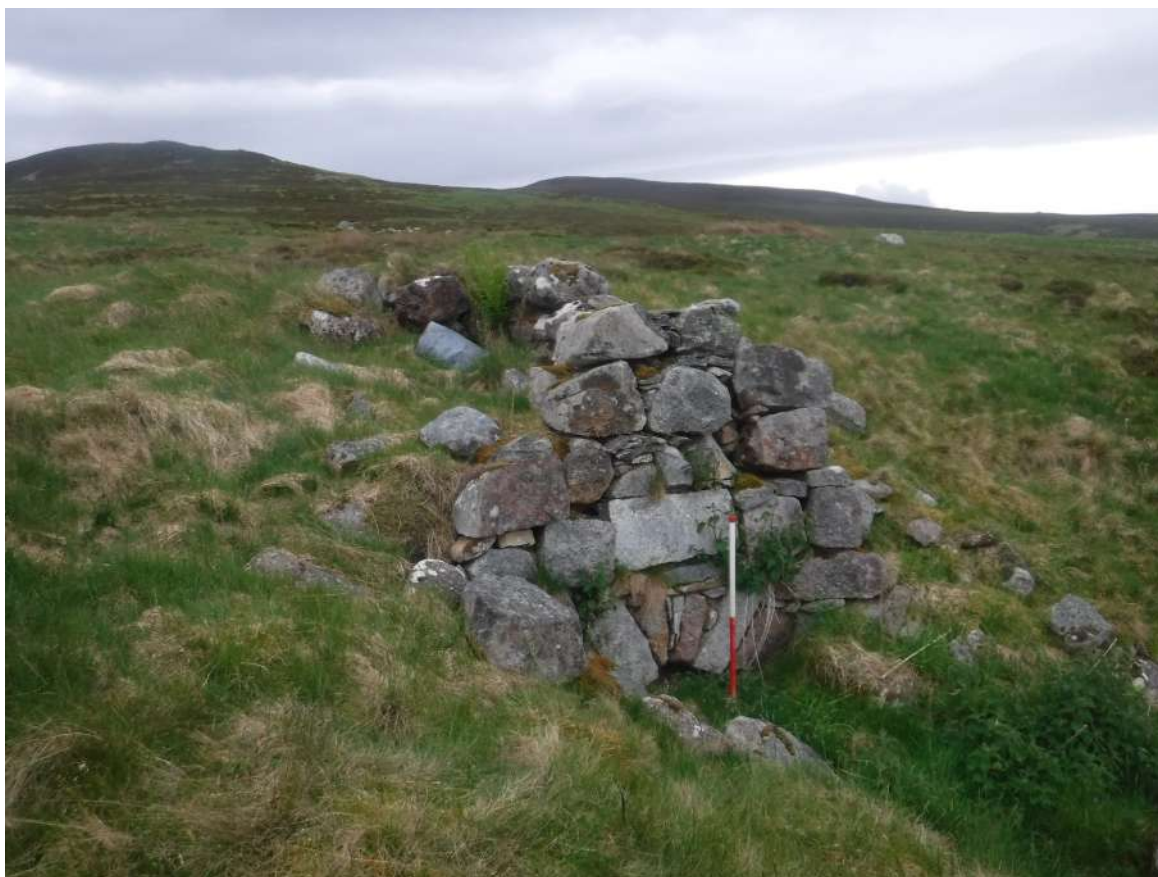
Plate 12: Stone-built lime kiln 80, facing SE

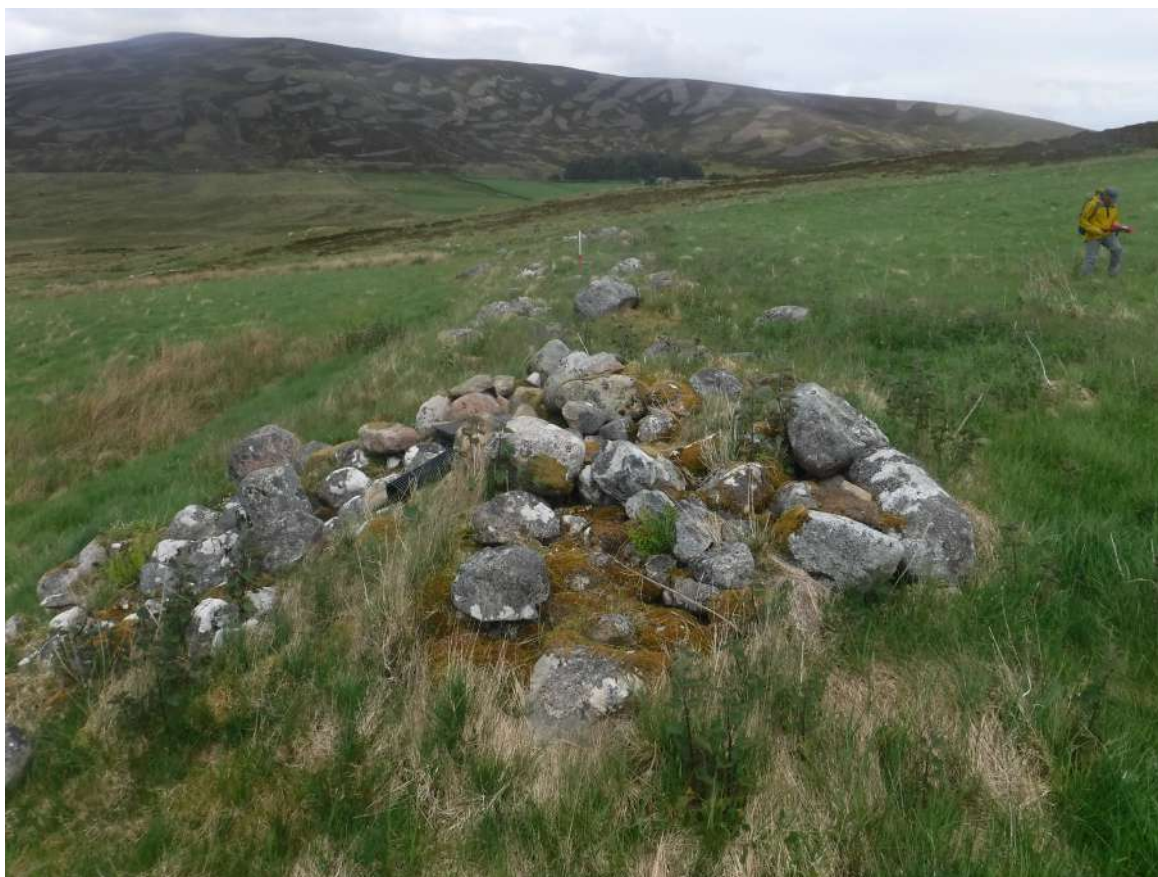
Plate 13: Linear stone clearance and possible structure 4a-b, facing NE

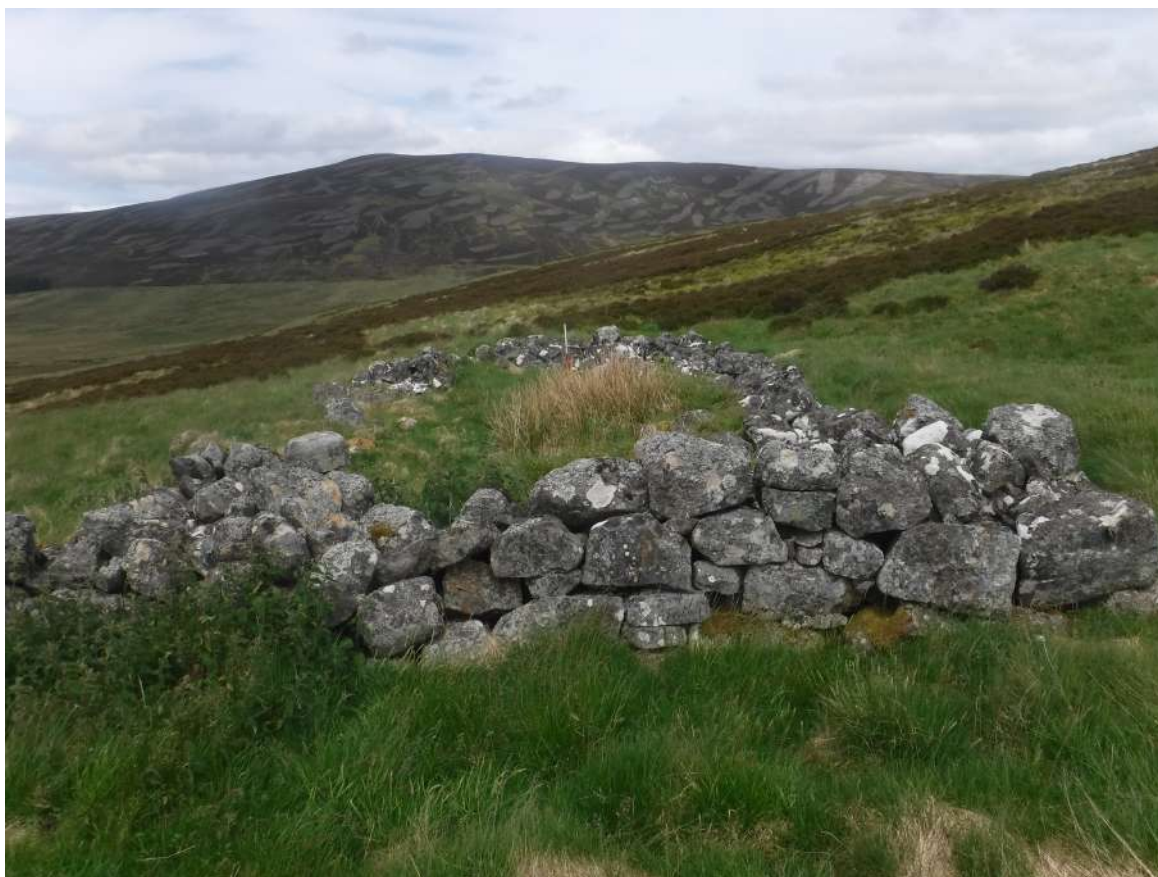
Plate 16: Degraded stone building 7, facing NNE

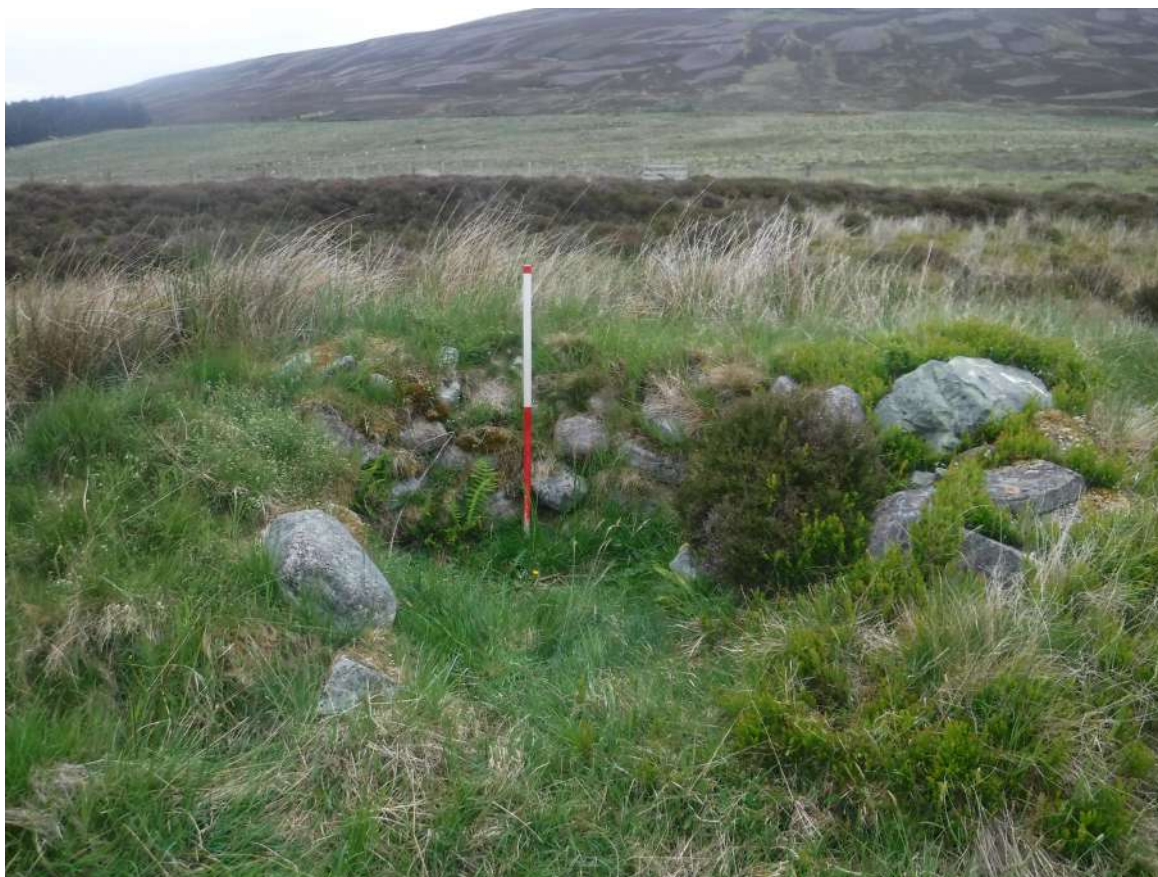
Plate 17: Stone-built kiln 75, facing N

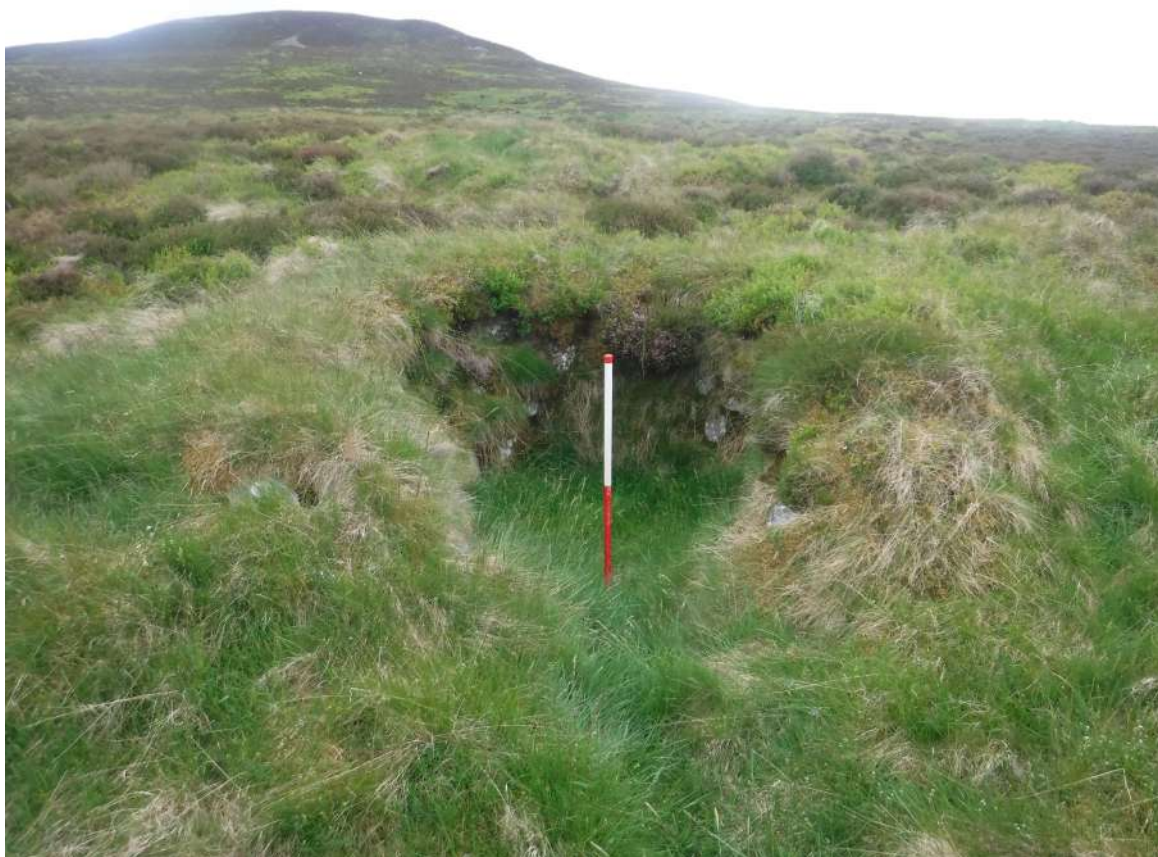
Plate 18: Turf and stone shooting butt 77h, facing SSE

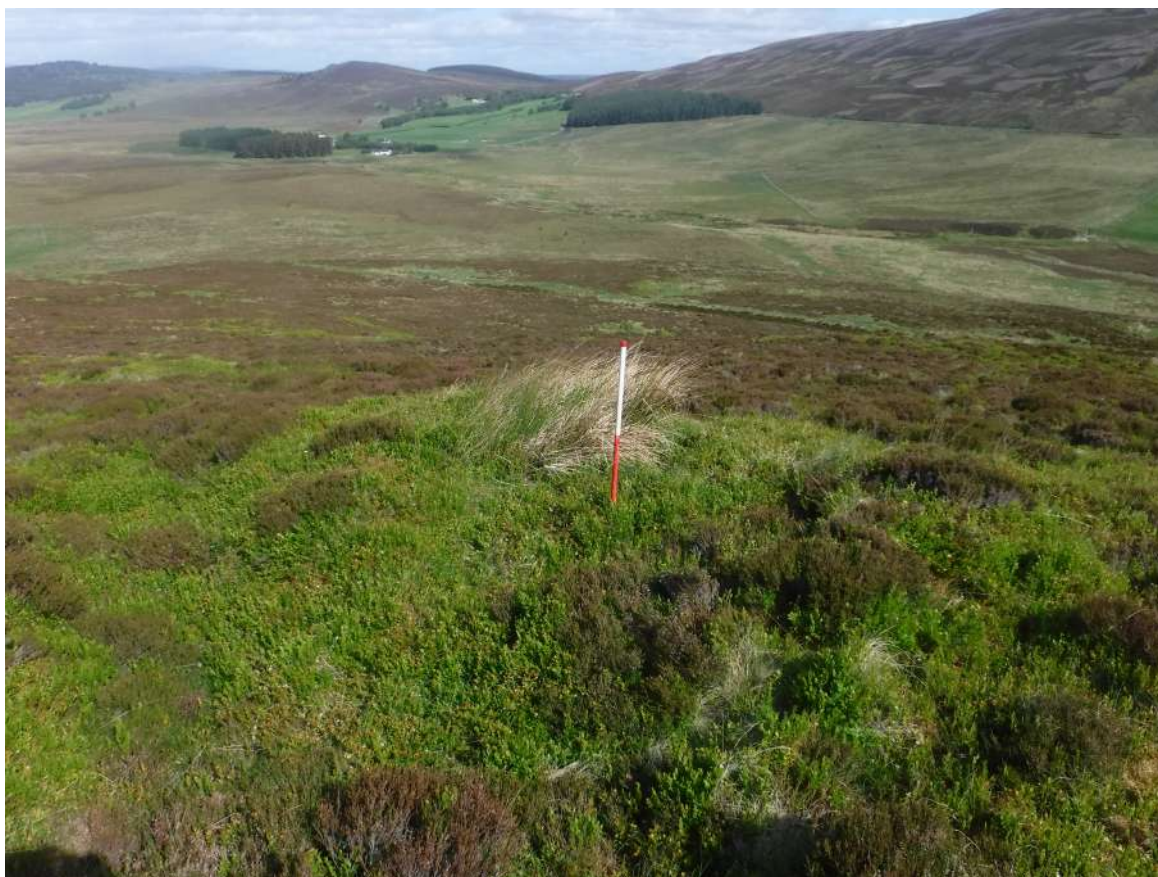
Plate 19: Possible turf structure 83, facing NW

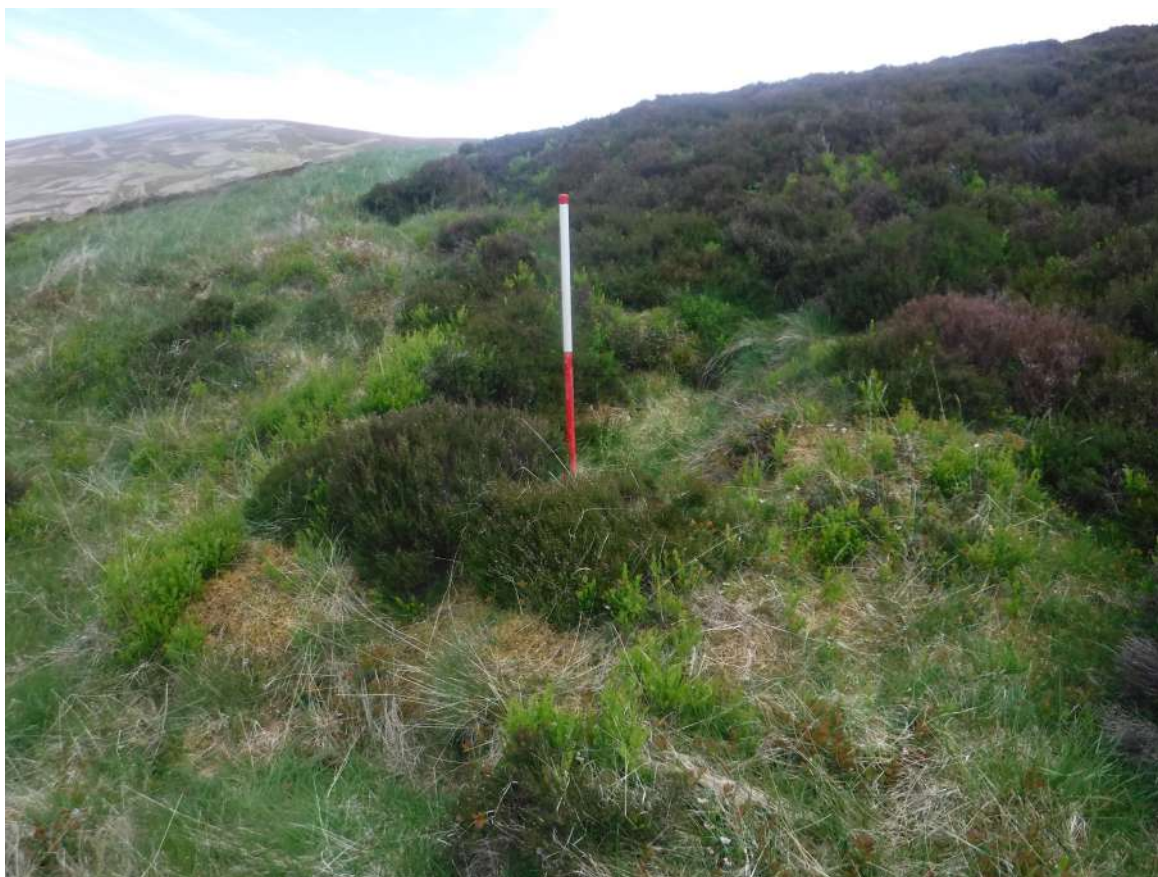
Plate 20: Possible turf structure 84, facing NNE

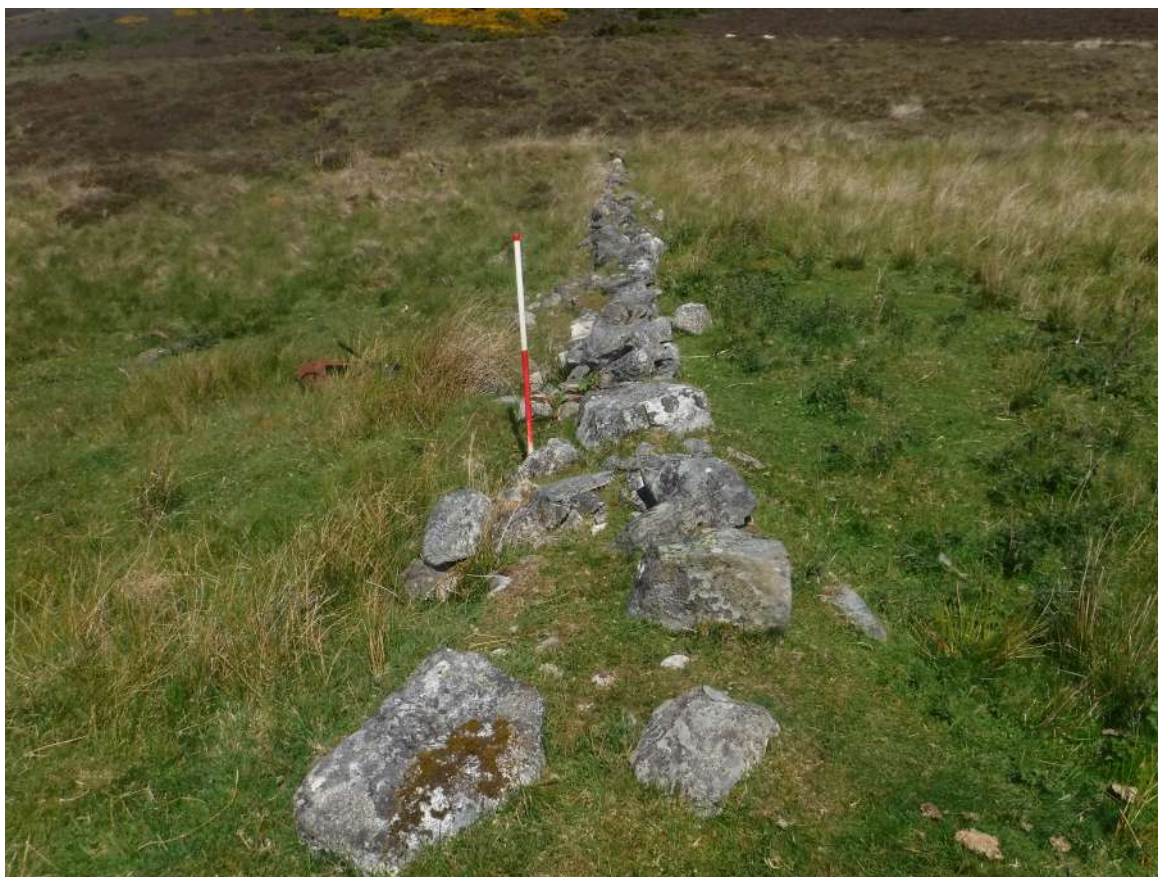
Plate 21: Stone enclosure wall 9b, facing NW

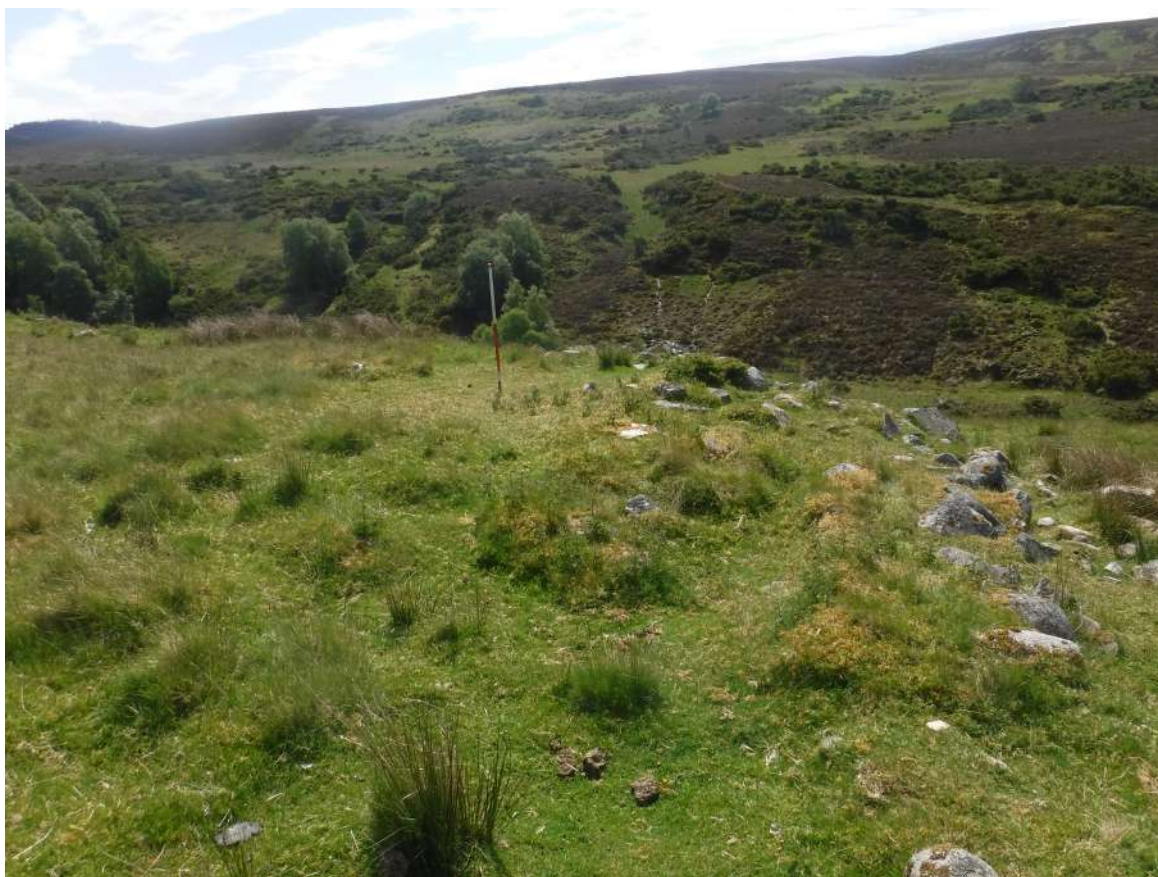
Plate 22: Very degraded remains of stone structure 9d, facing SE

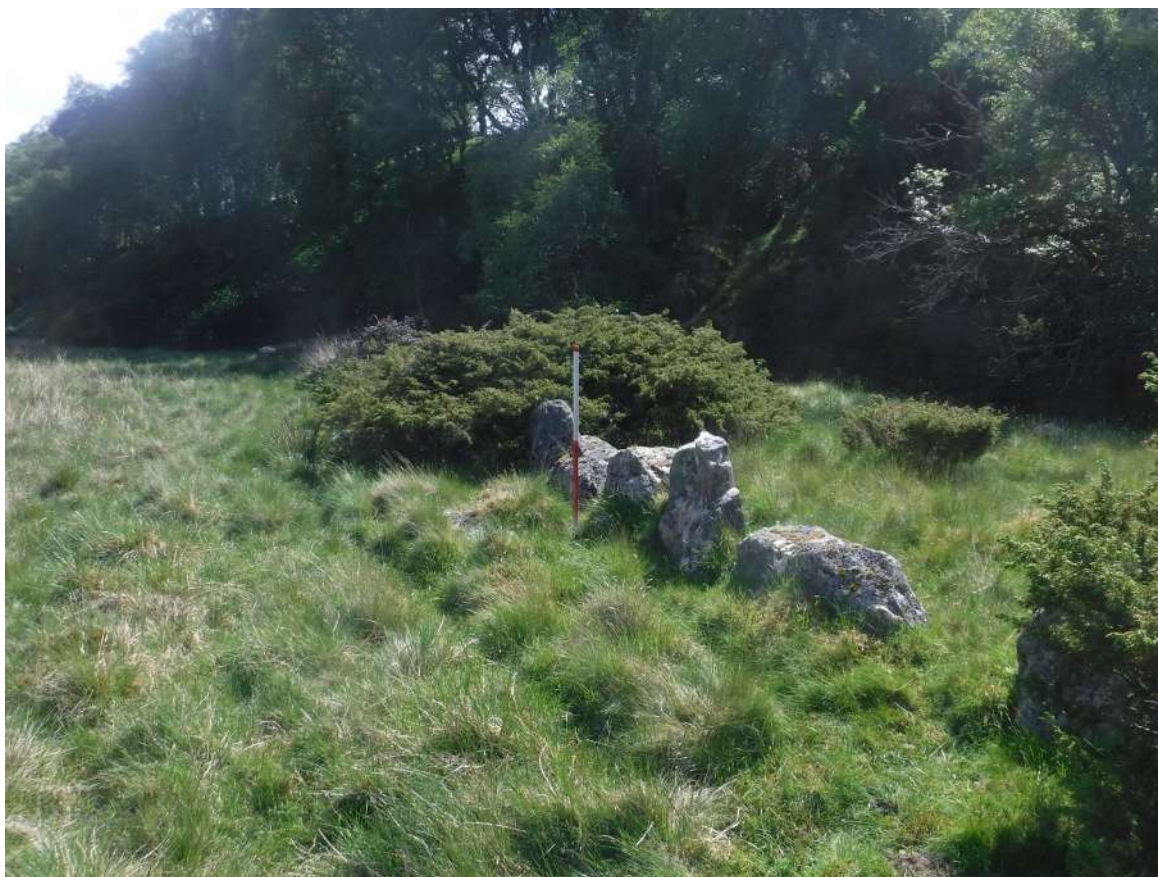
Plate 24: Stone enclosure wall 68, facing E

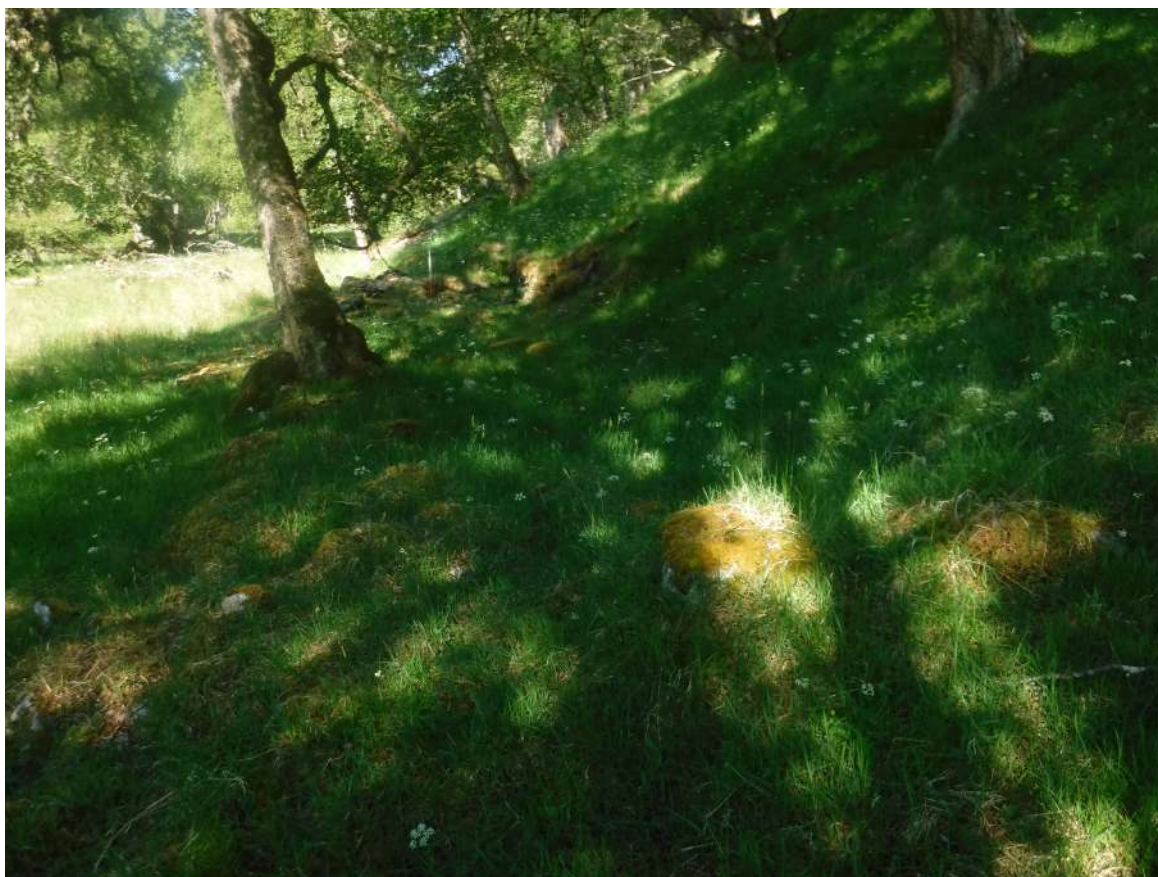
Plate 29: Revetted stone structure 11a, facing W

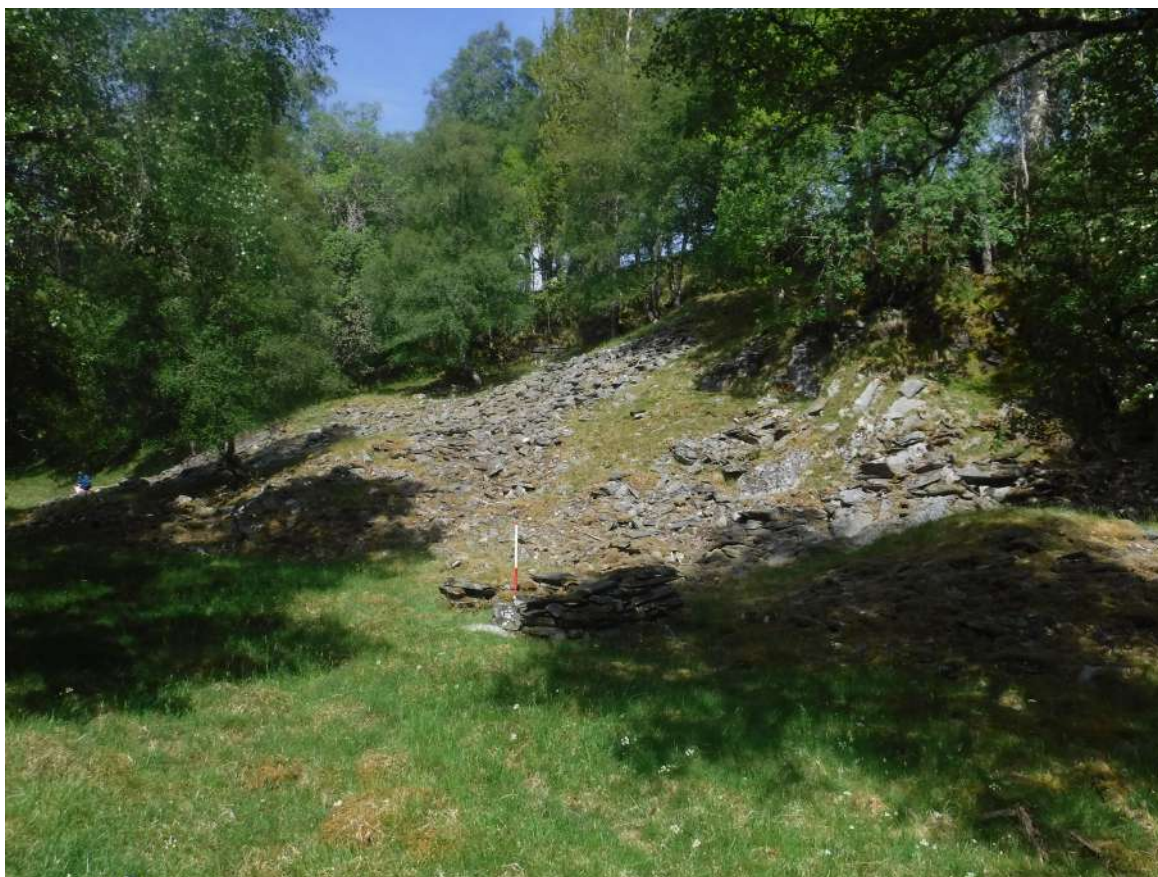
Plate 30: Stone quarry 67 with small structure 66 in front, facing NW

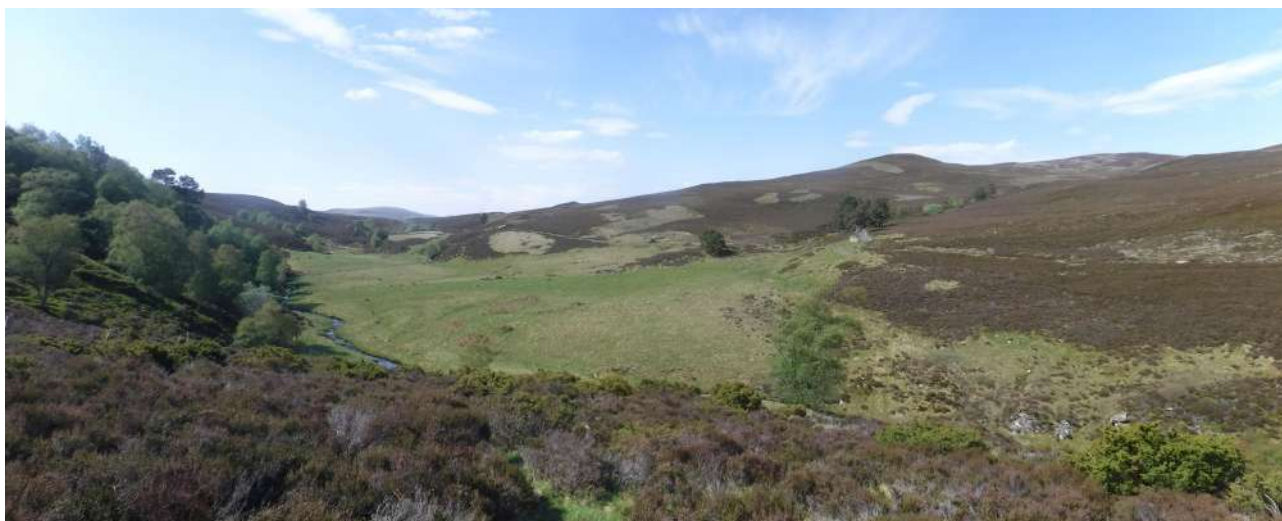
Plate 31: Landscape view over Rynelrich settlement, facing SW

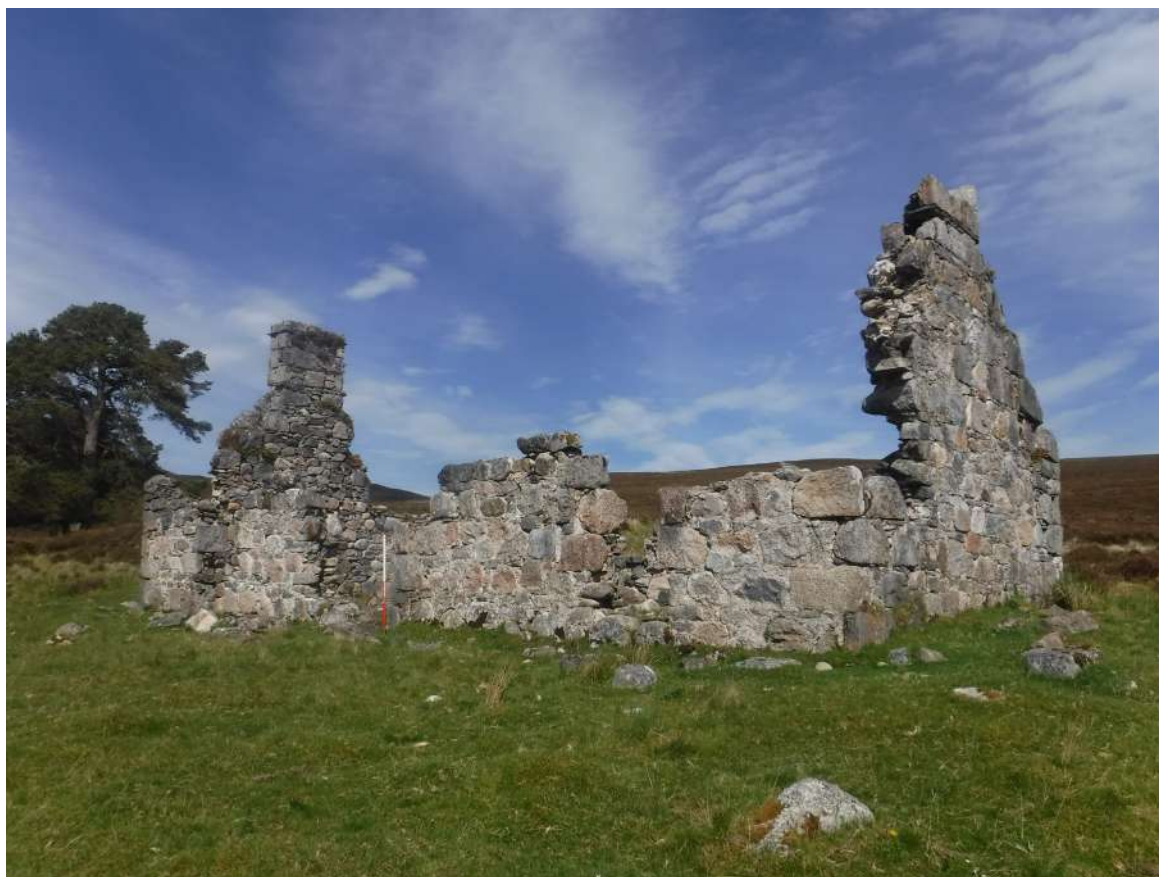
Plate 32: Ruinous stone building 13b, facing NW

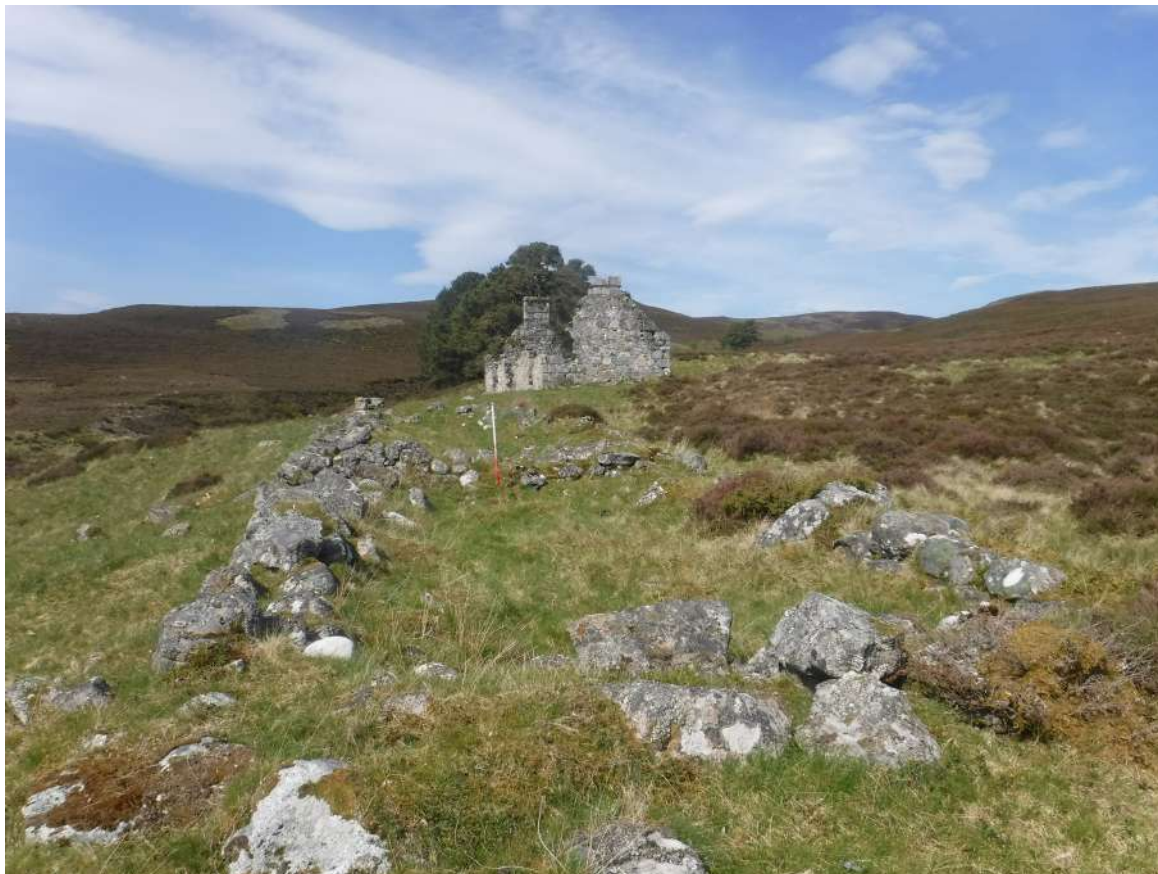
Plate 33: Degraded stone building 13c, facing W

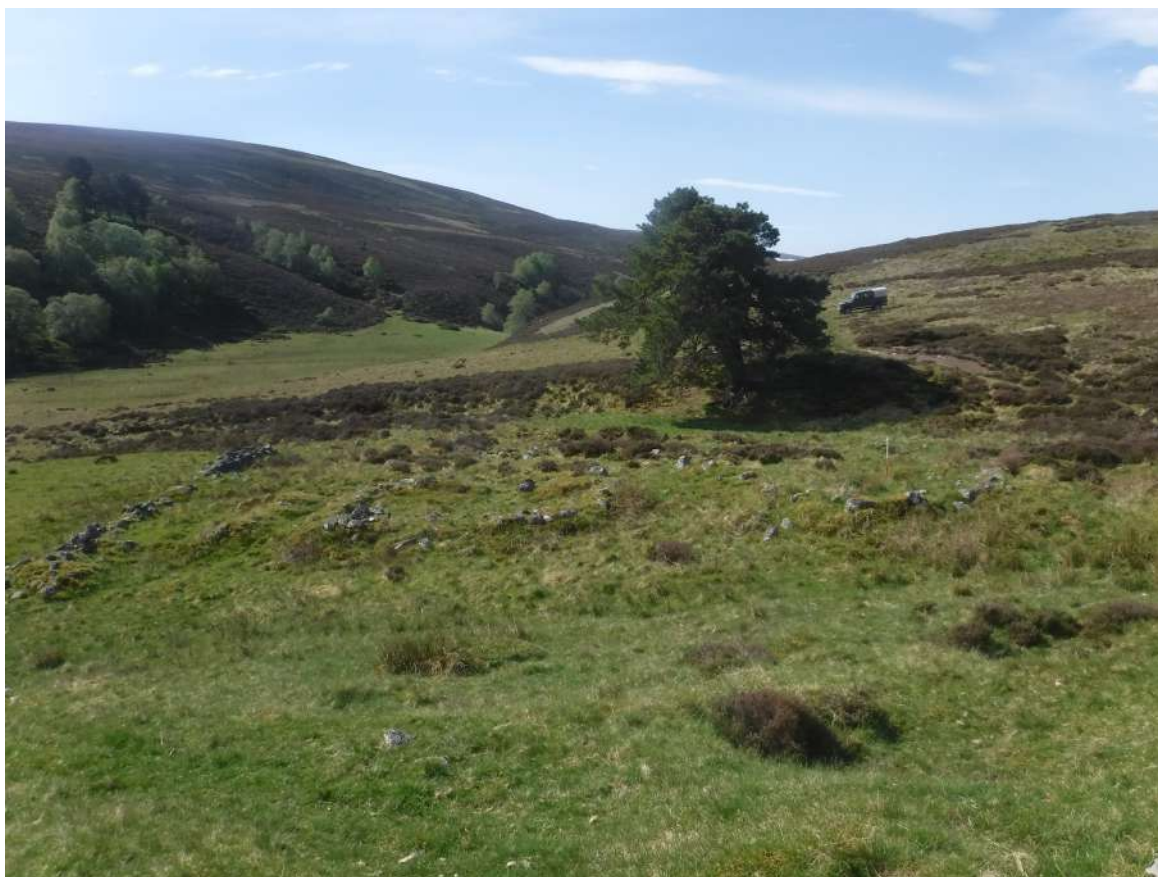
Plate 34: Overlooking structures and dykes 13e-g, facing S
