Glen Brown Woodland Creation Dorback Estate Archaeological Walkover Survey Report

AOC 70511

June 2021

On Behalf of:	Galbraith
National Grid Reference (NGR):	NJ 09811 18723 (centre)
AOC Project No:	70511
Prepared by:	Lindsey Stirling
Illustrations by:	Lindsey Stirling
Date of Fieldwork:	2 nd -4 th , 15 th -16 th & 22 nd June 2021
Date of Report:	25 th June 2021
OASIS No.:	aocarcha1-424845

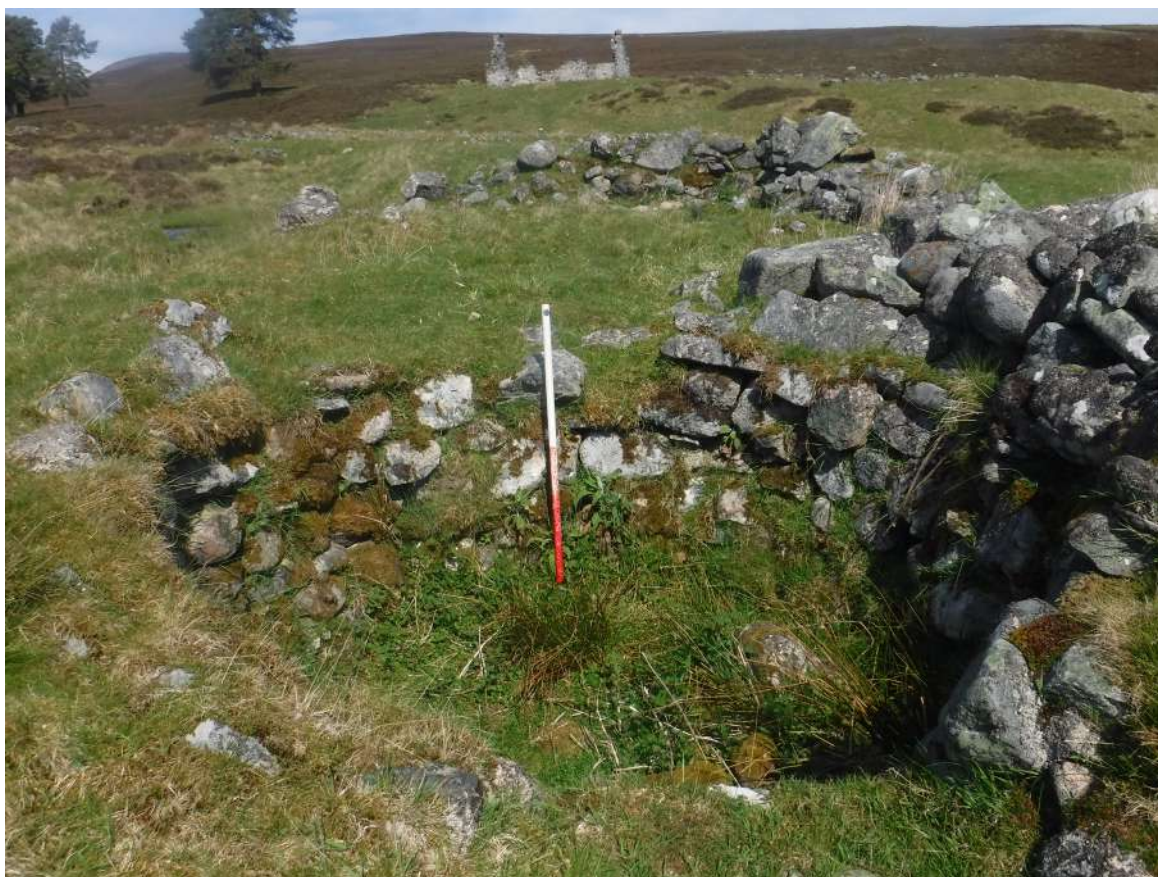
Plate 36: Degraded stone-built kiln barn 13h, facing NW

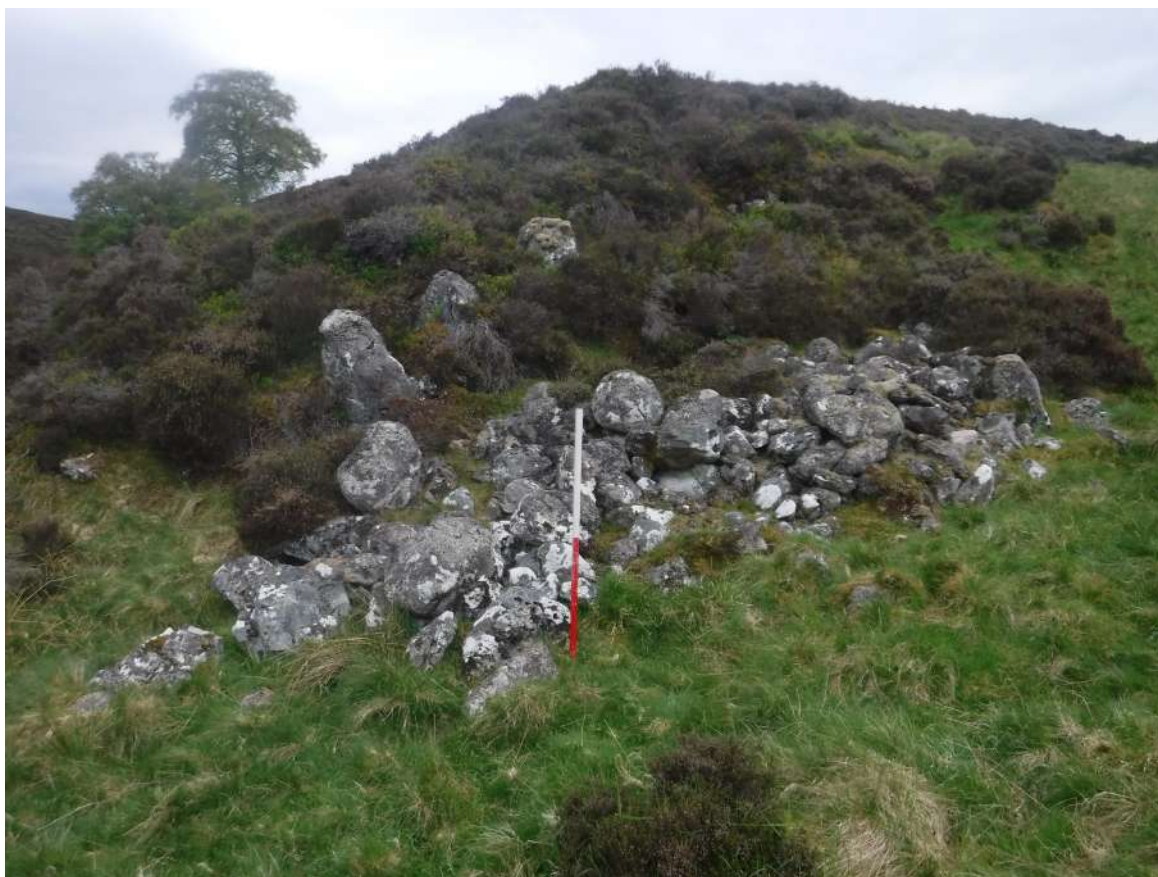
Plate 38: Stone clearance cairn 50, facing SW

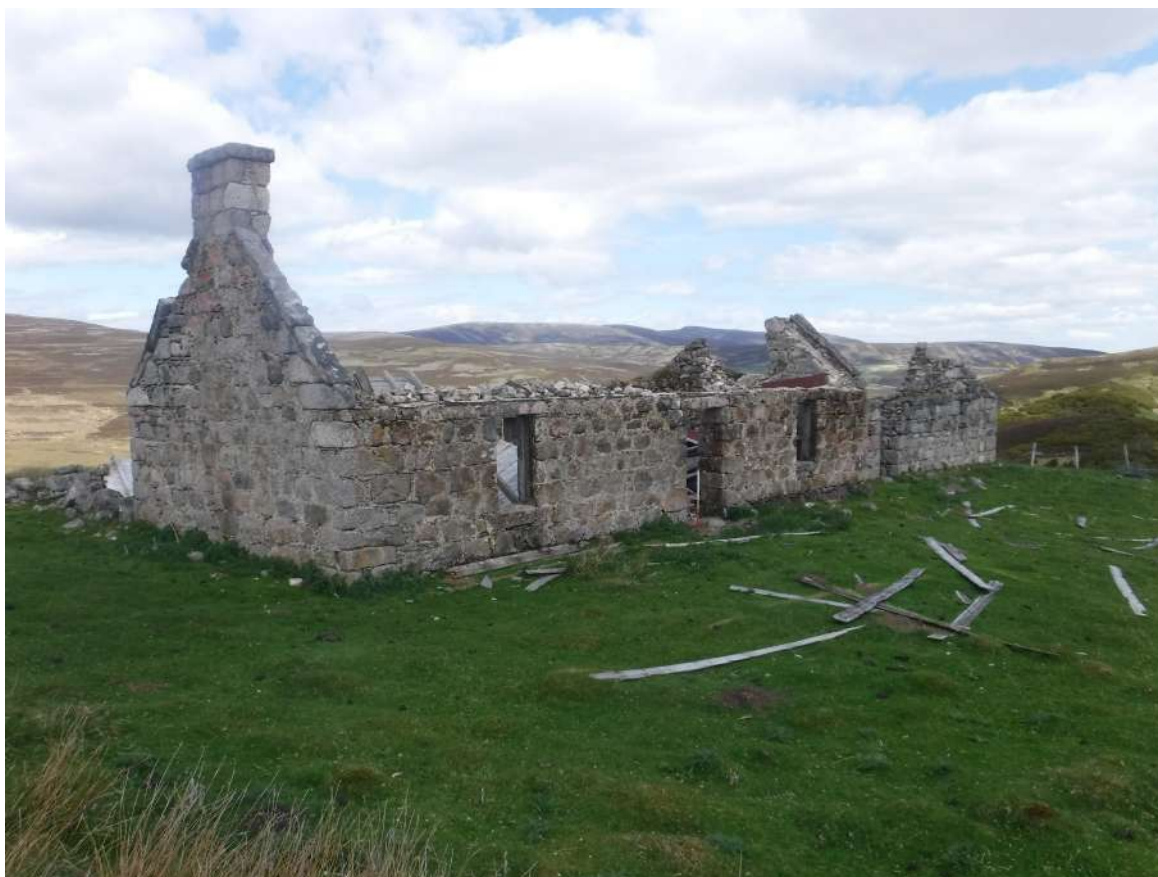
Plate 39: Ruinous stone building 24a, facing N

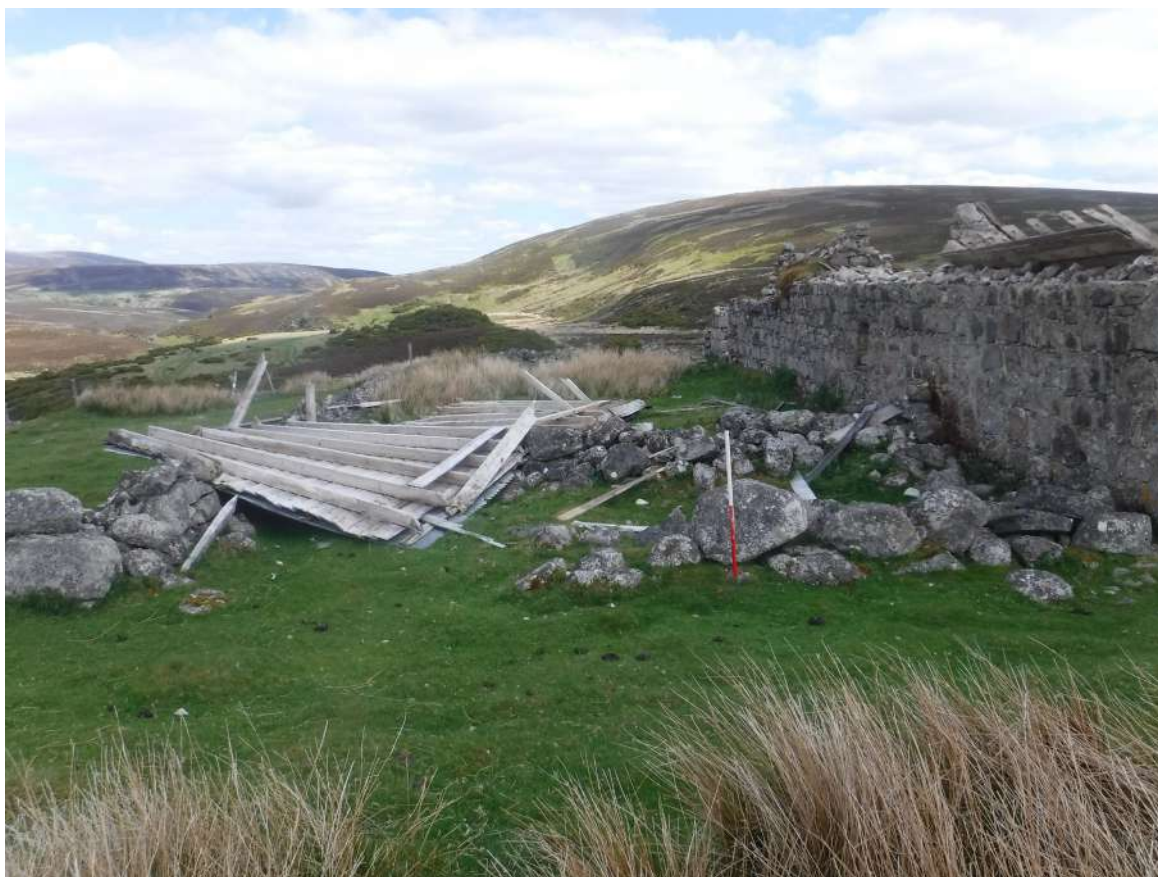
Plate 40: Stone enclosure 24b attached to structure 24a, facing NE

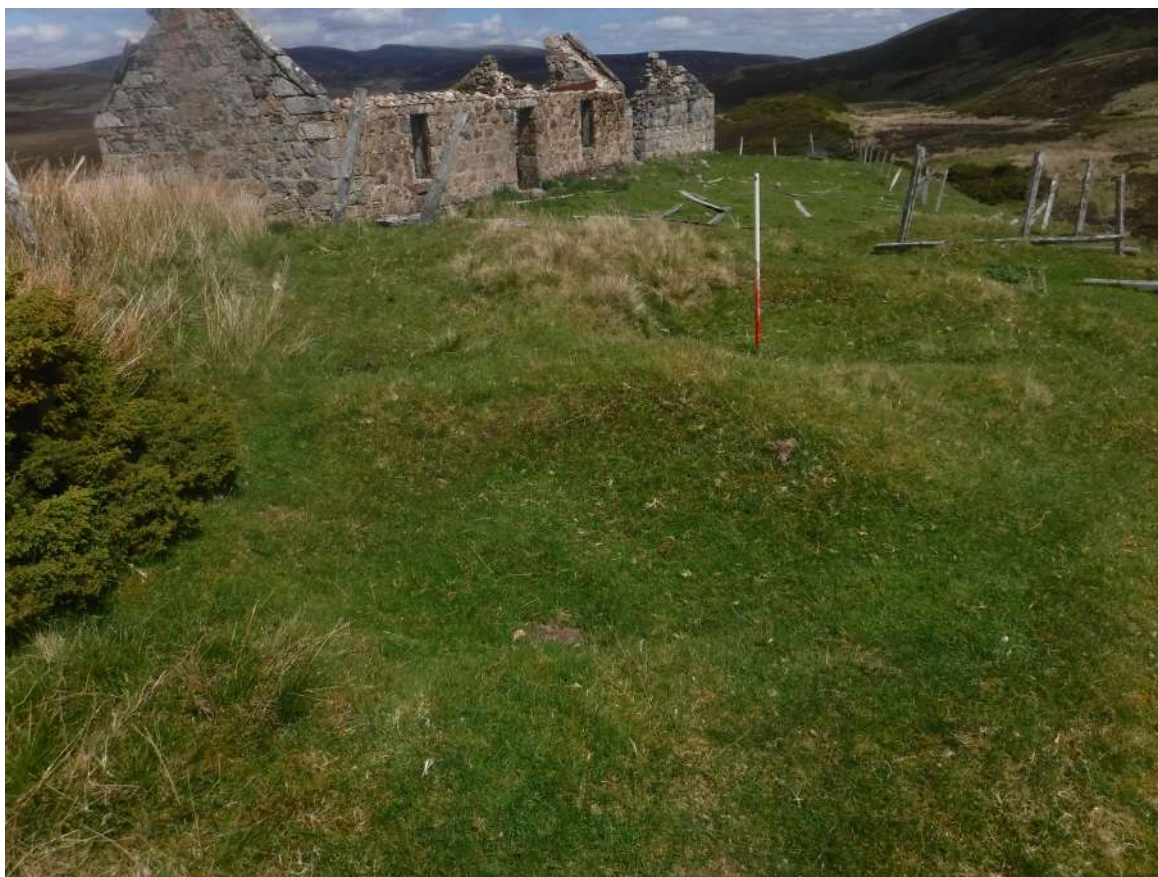
Plate 41: Turf hollows/pits 24c, facing NNE

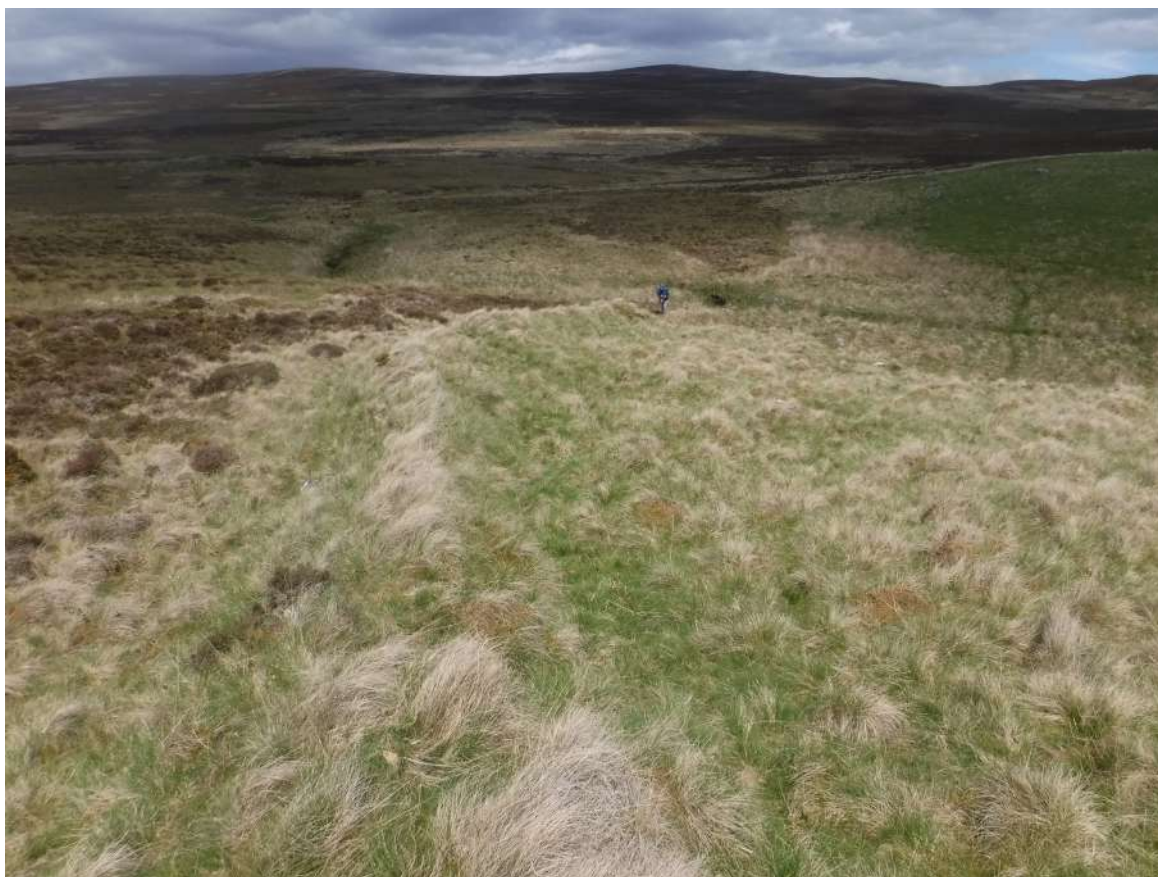
Plate 42: Turf and stone dyke 51, facing NW

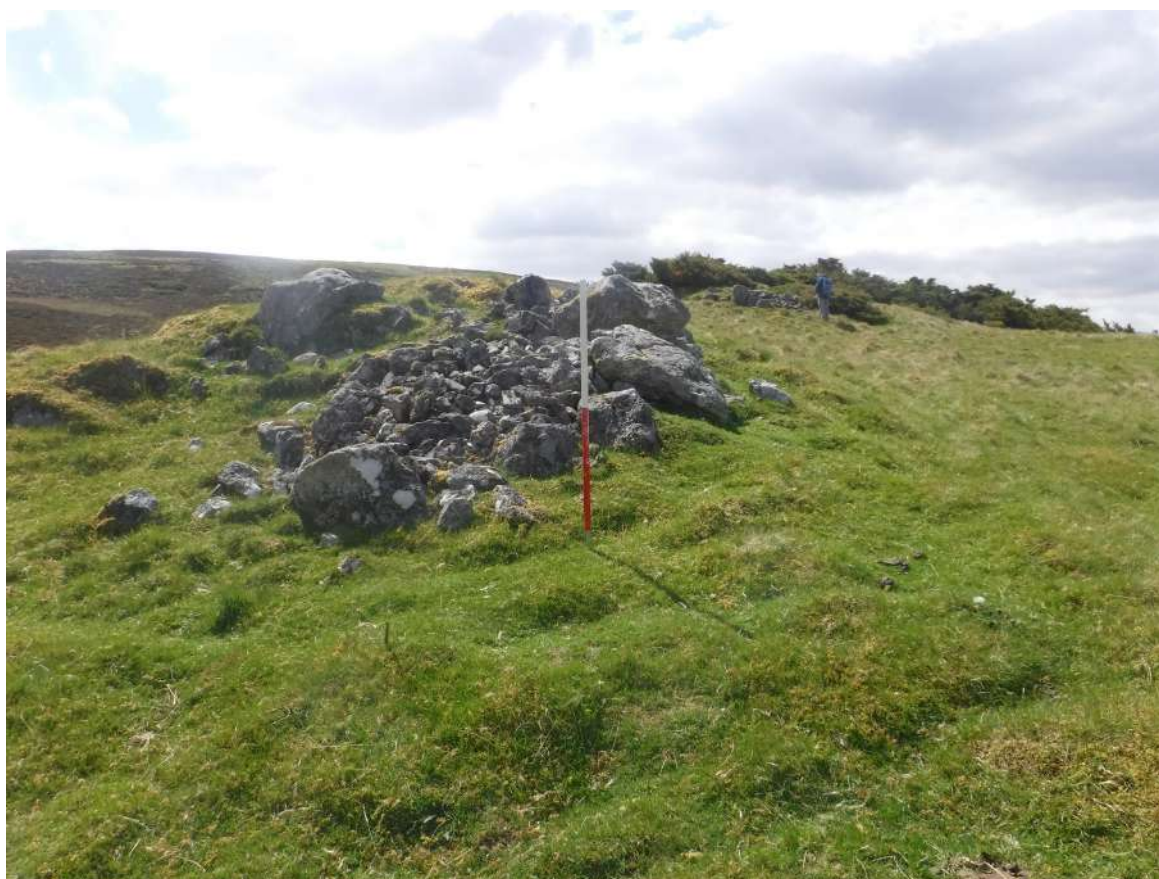
Plate 43: Stone clearance cairns 61, facing S

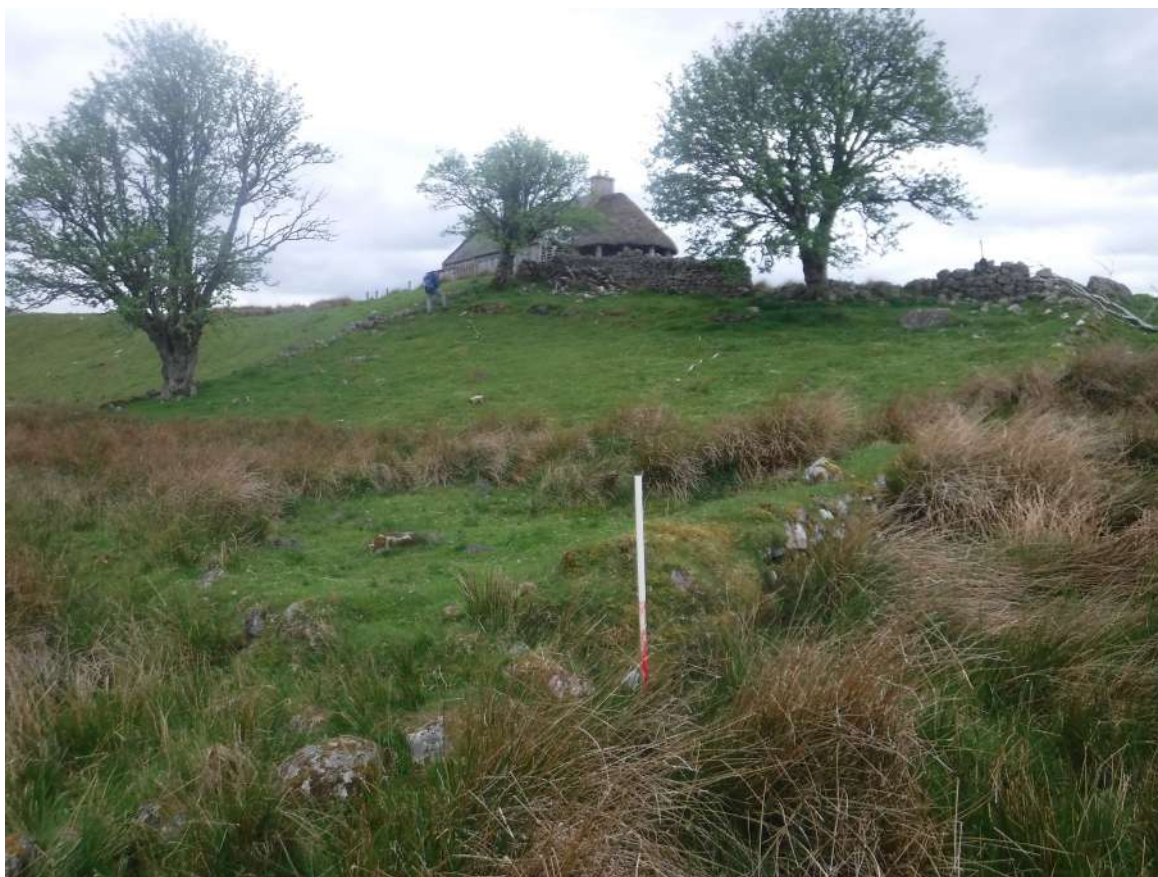
Plate 52: Stone enclosure 29c, facing SW

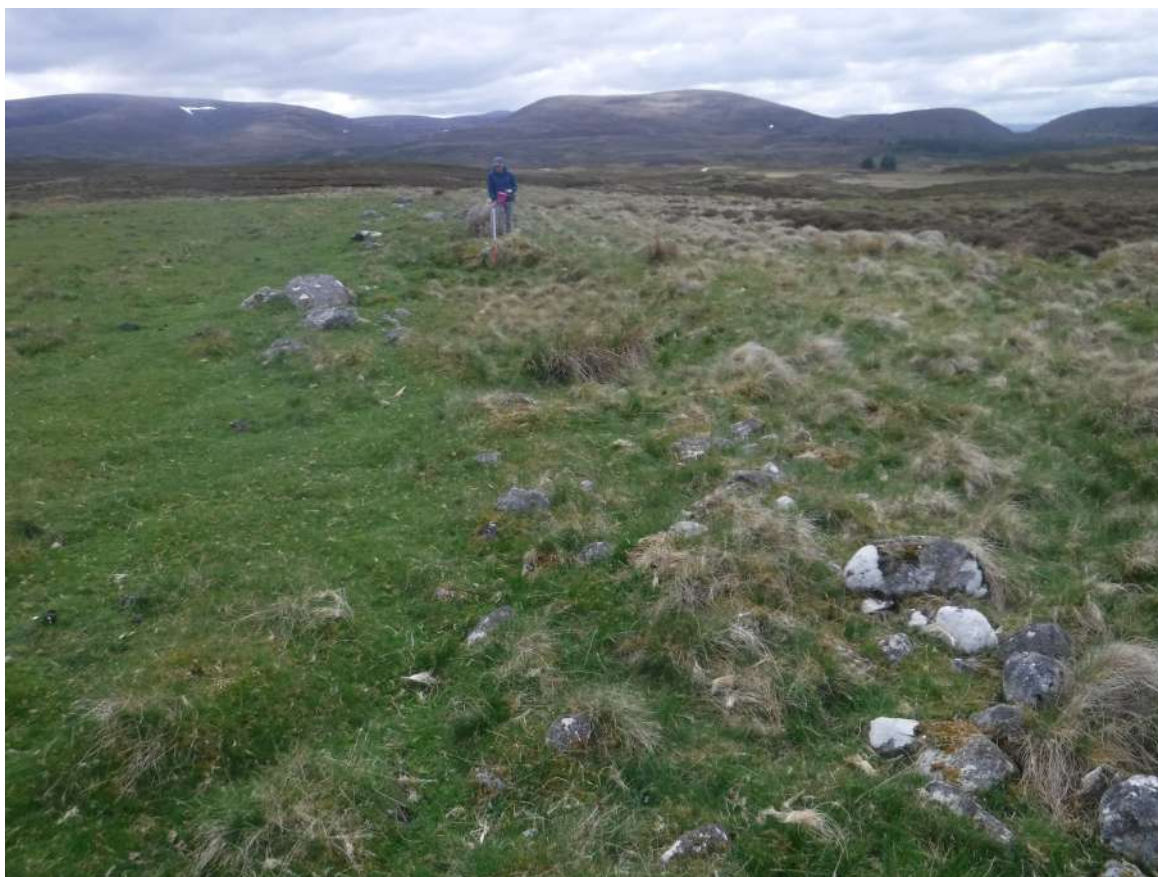
Plate 53: Possible stone pen 30b within dyke 30, facing SW

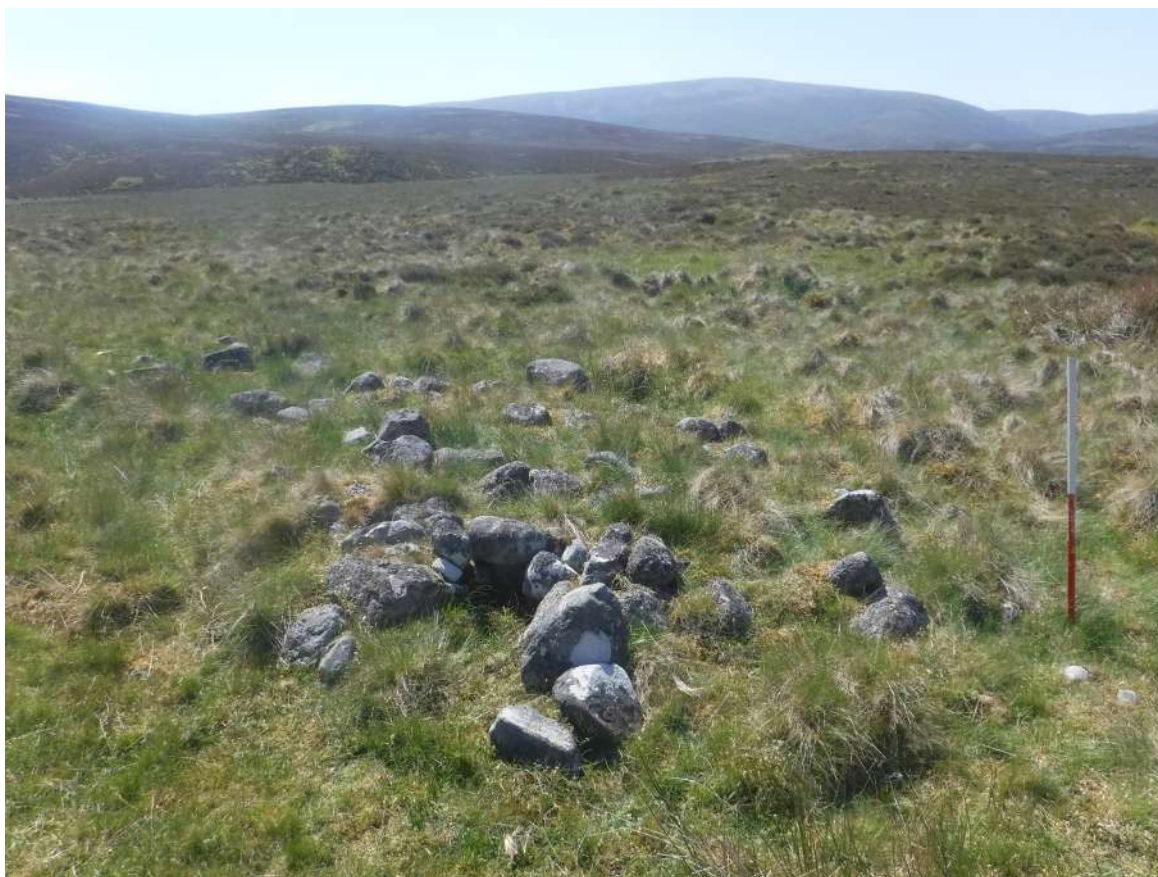
Plate 54: Possible stone pen 30c, facing S

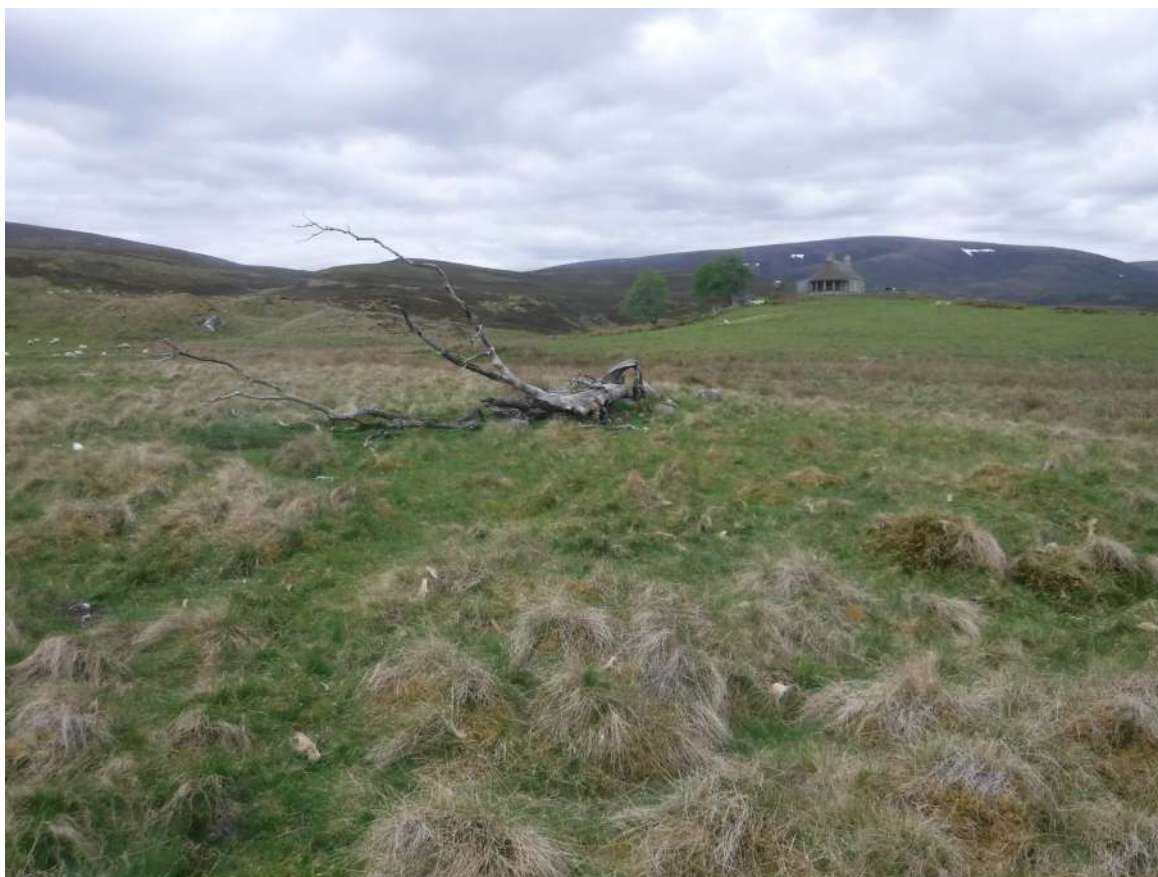
Plate 55: Ephemeral stone pen 28b, facing S

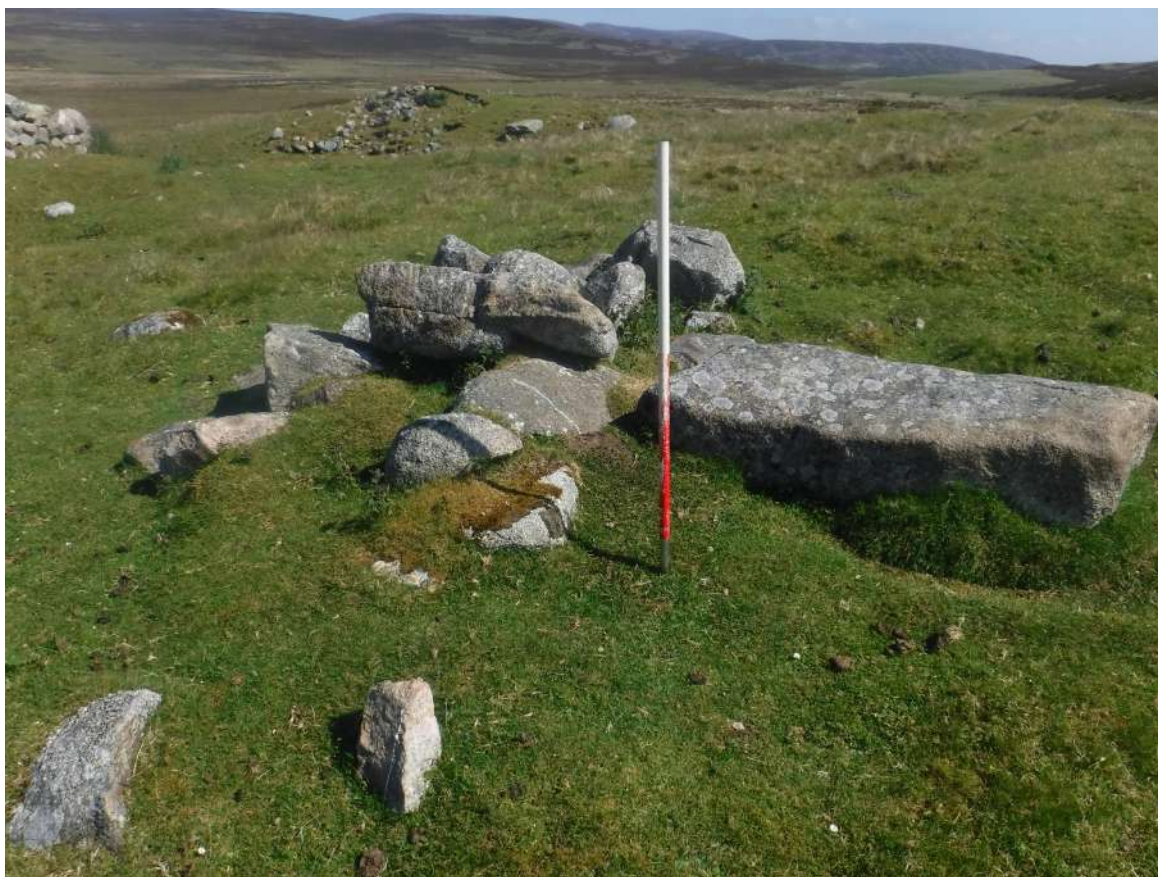
Plate 56: Possible structural remains 27a, facing N

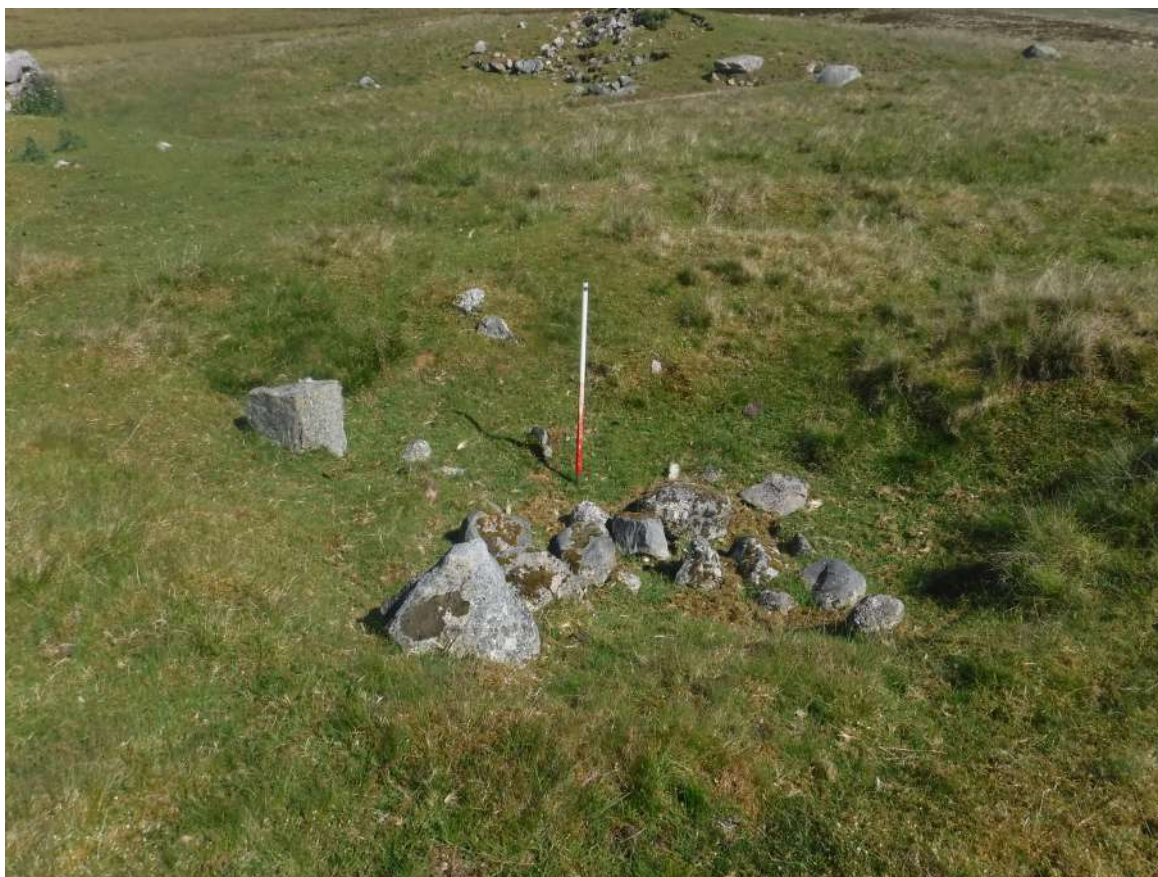
Plate 57: Circular turf hollow with stone clearance 27b, facing N

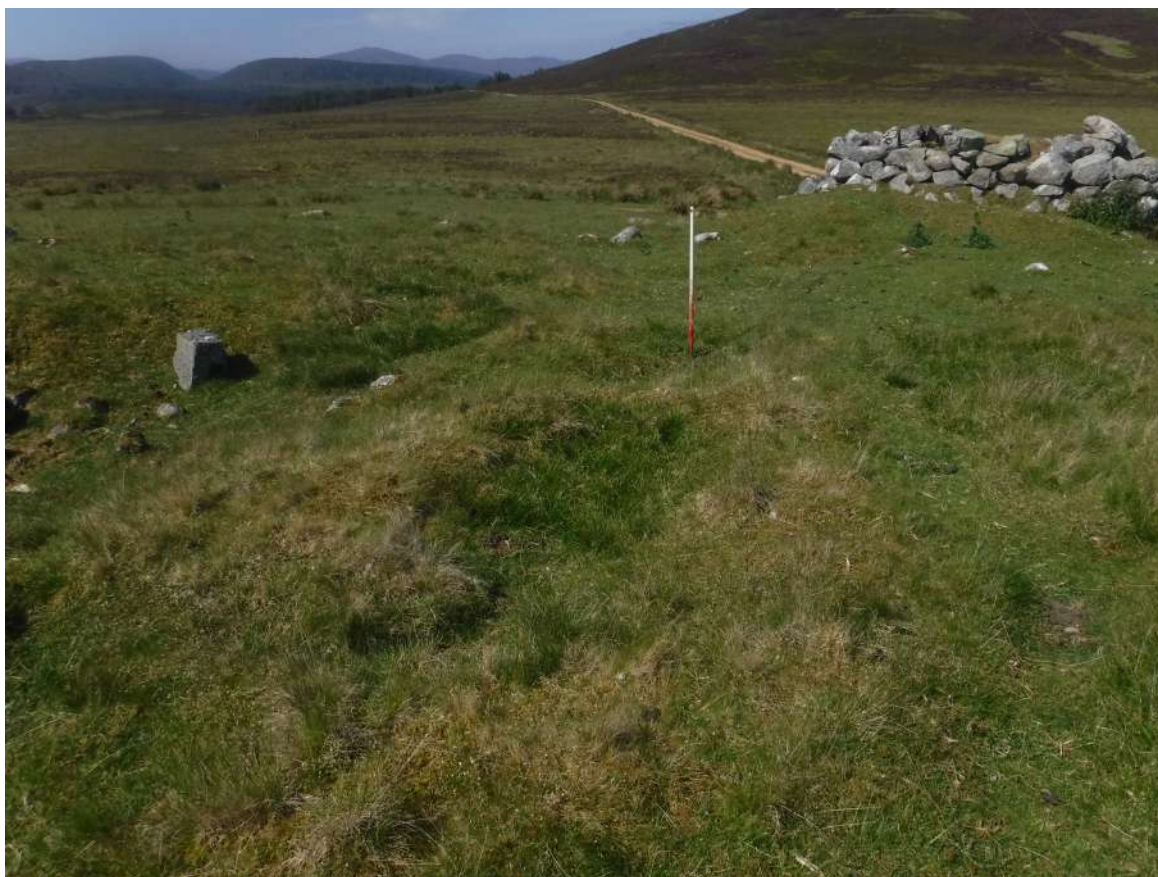
Plate 58: Turf hollows or pits 27c, facing WSW

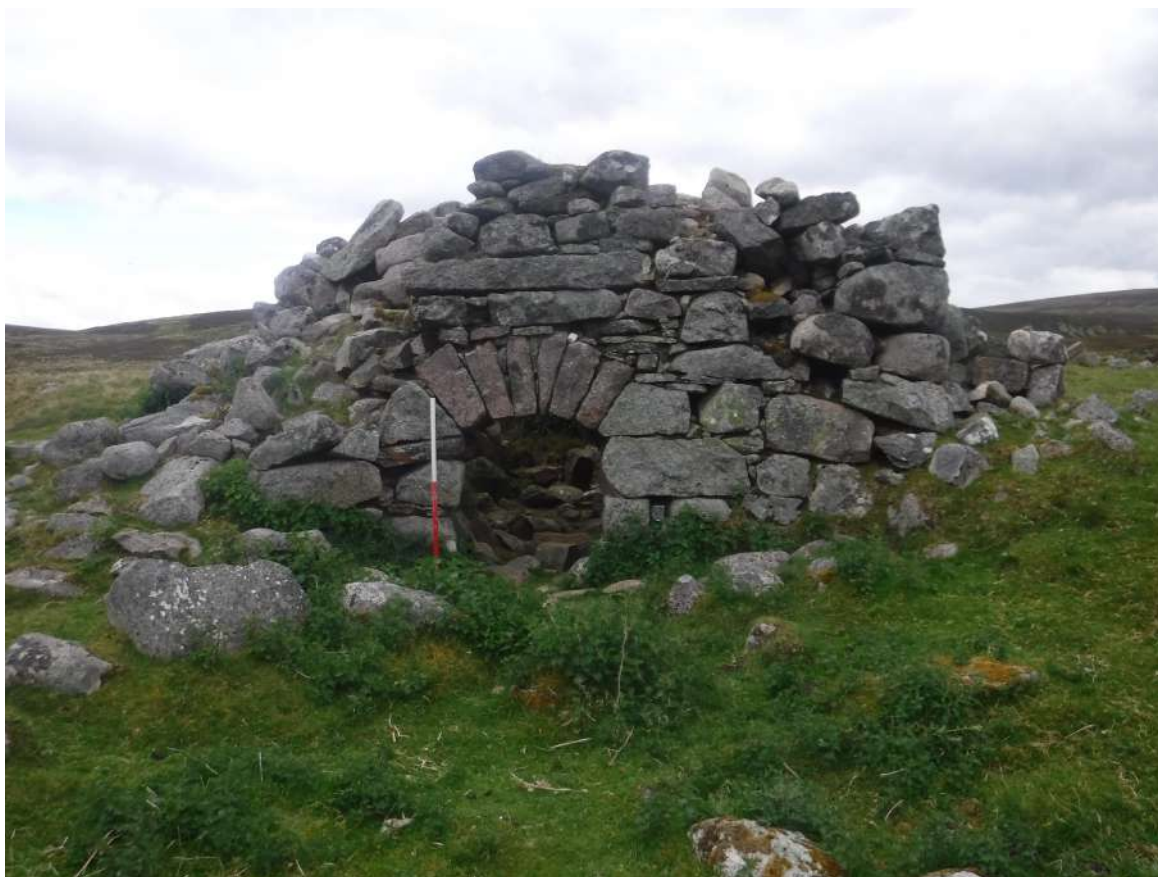
square in plan with an arched entrance and flue on the west side (**Plate 62**). The walls were built with large stones and slabs up to 1.1m wide and surviving up to 2.4m high on the west side. Kiln 25 is depicted on both 1st and 2nd edition OS mapping, with kiln 26 not shown until the 2nd edition map.

Plate 62: Ruinous stone-built lime kiln 26, facing E

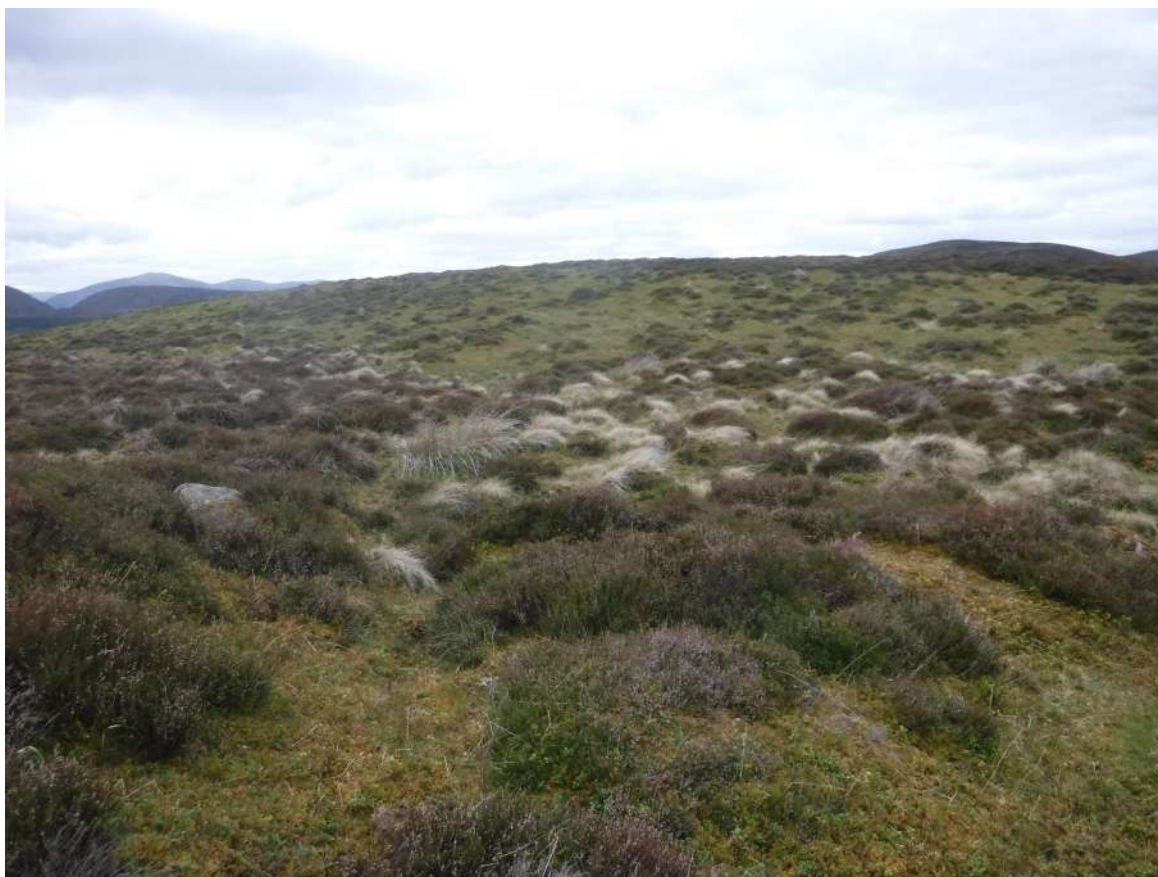
Plate 65: General view across area of possible rig and furrow 33, facing W

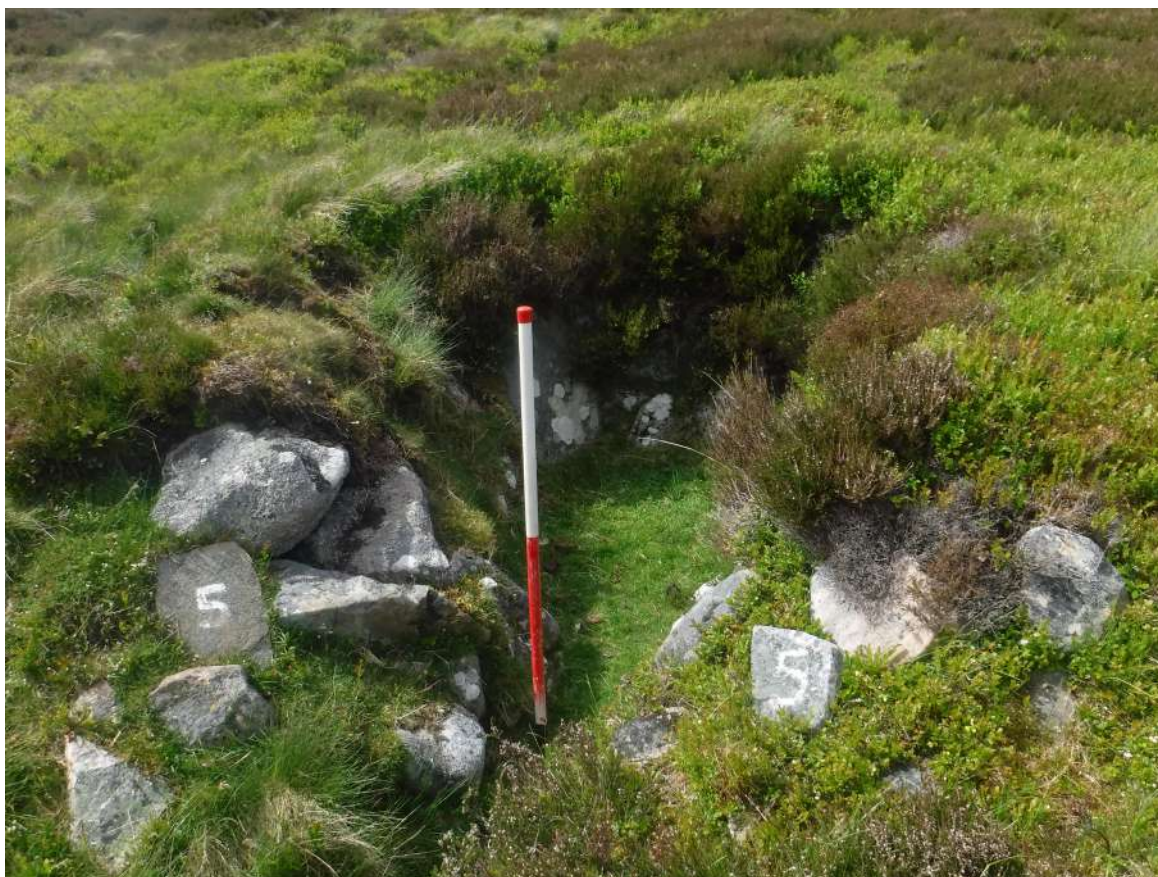
5.6.7 To the west of Fae, near the stream Caochan nan Gabhar, were the remains of a degraded turf structure (site 91) (**Plate 67**). A turf and stone dyke (92) was located nearby, running along the base of a small hill. On the steep hillside above the modern vehicle track was a row of nine shooting butts (site 90), generally sub-circular and built from turf and stone with a narrow entrance on the southeast side (**Plate 68**).

Plate 68: Turf and stone shooting butt 90e, facing NW

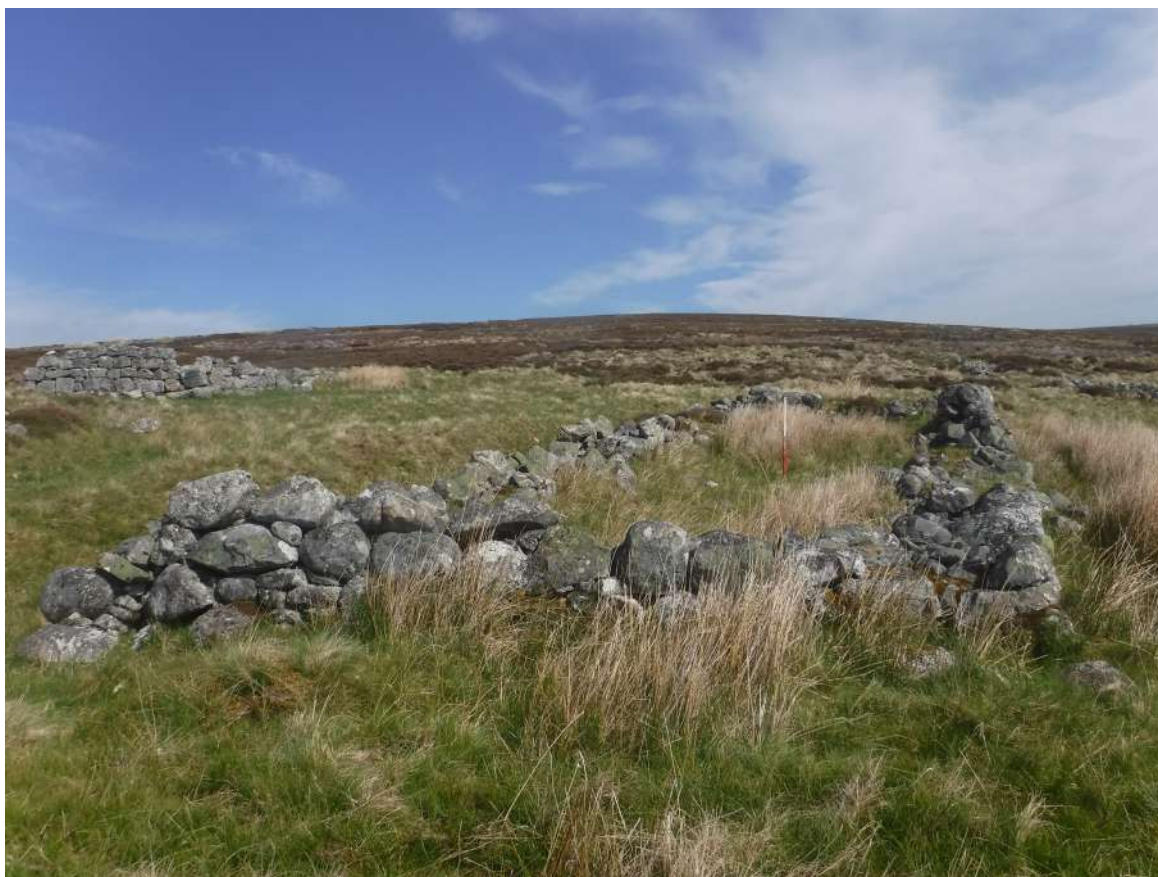
Plate 71: Ruinous stone structure 23g, facing N

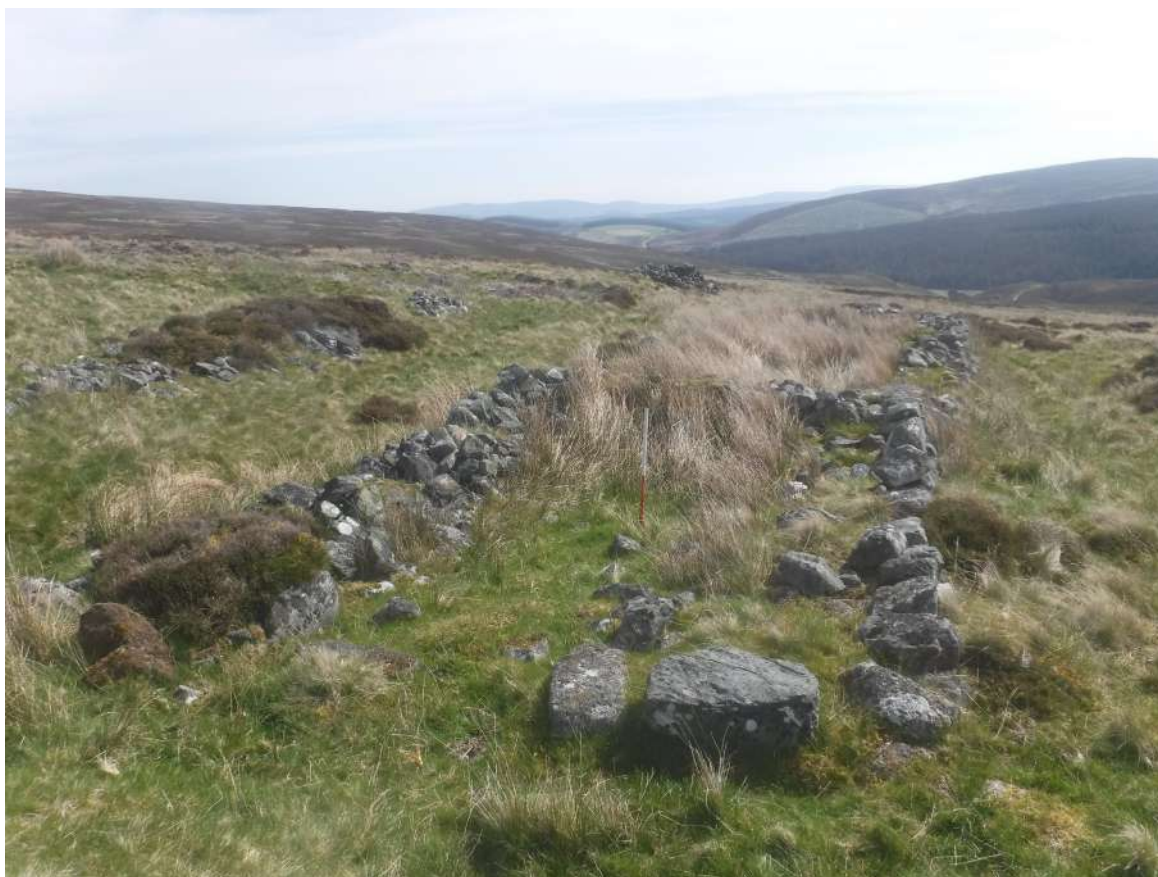
Plate 72: Ruinous stone structure 23h, facing E

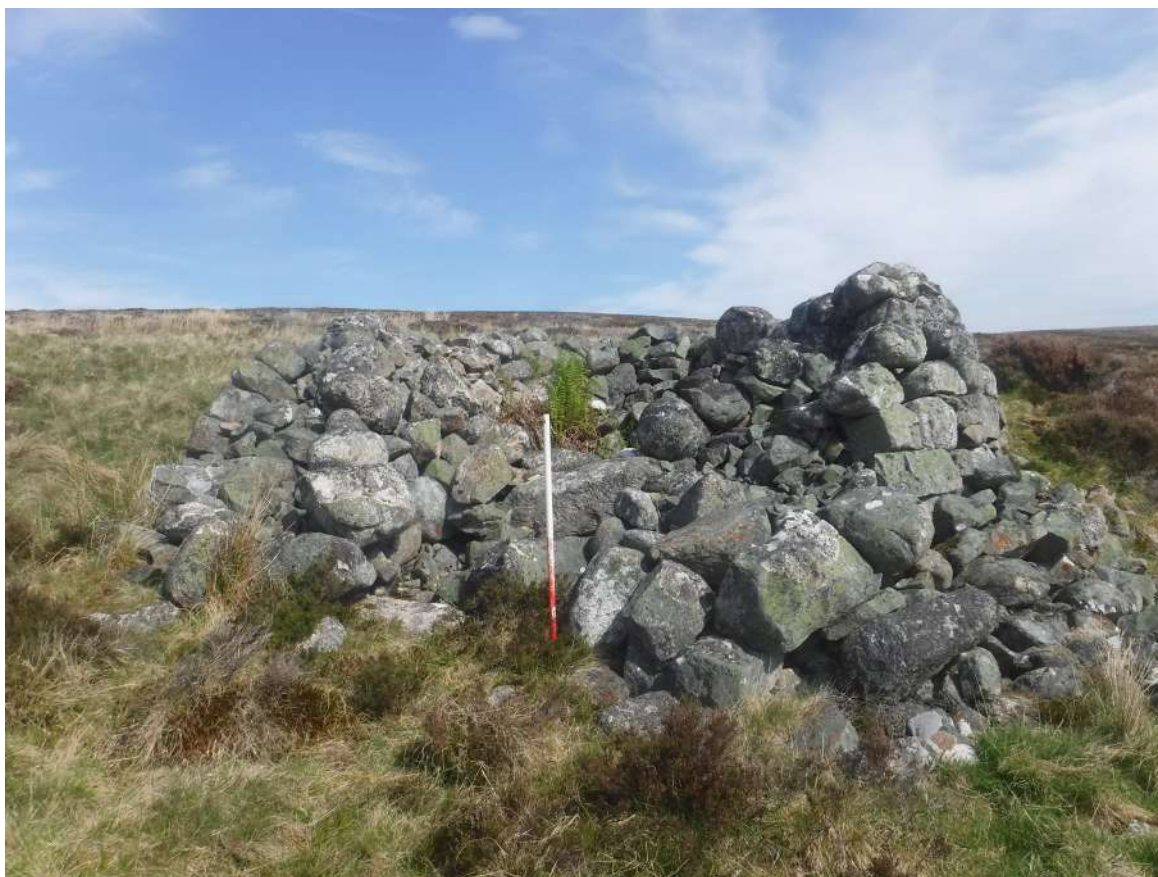
5.7.3 On the eastern edge of the settlement stood a ruinous stone-built lime kiln (23j) revetted into the hillside (**Plate 76**). The structure measured c.5m by 4m overall with an entrance and flue on the south side, capped by a lintel stone. The kiln is not depicted on historic mapping, indicating it may have no longer been in use by 1867.

Plate 76: Ruinous stone-built lime kiln 23j, facing N

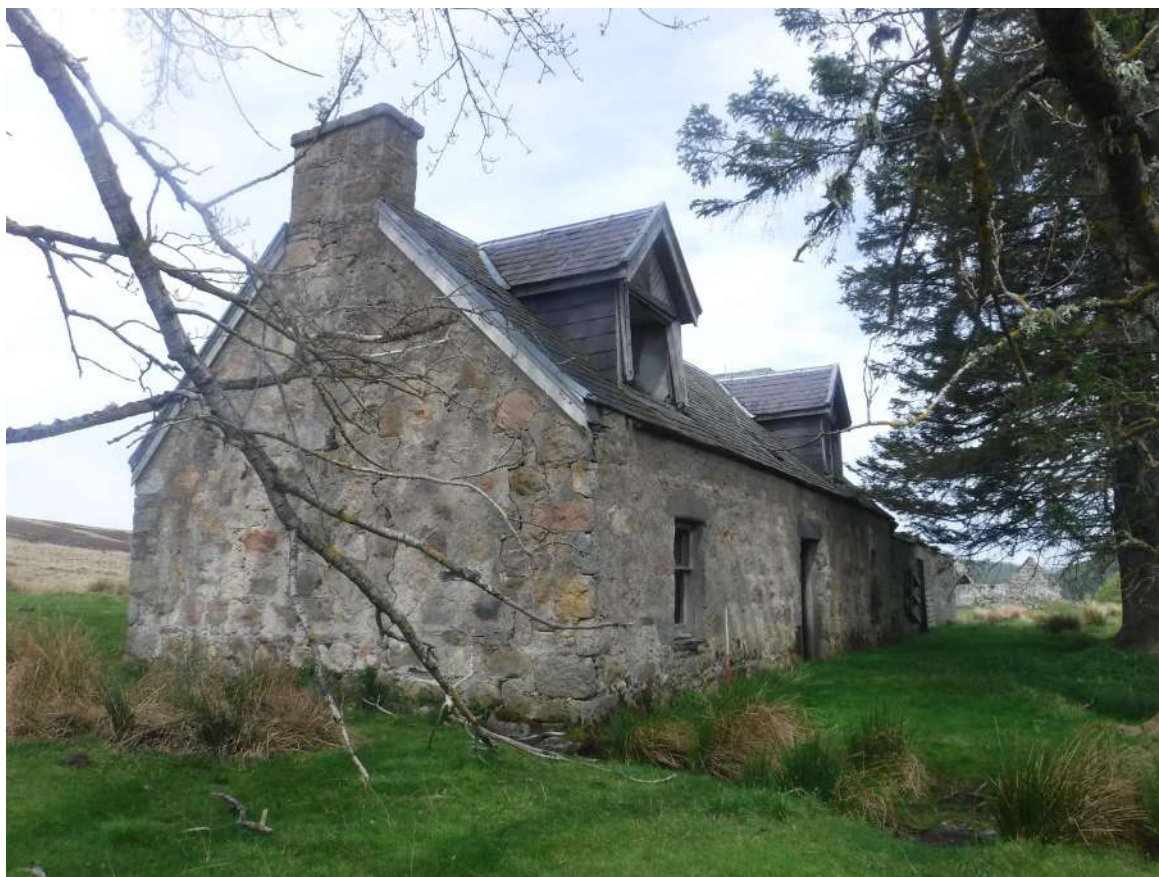
Plate 79: Ruinous stone building 15a, facing NW

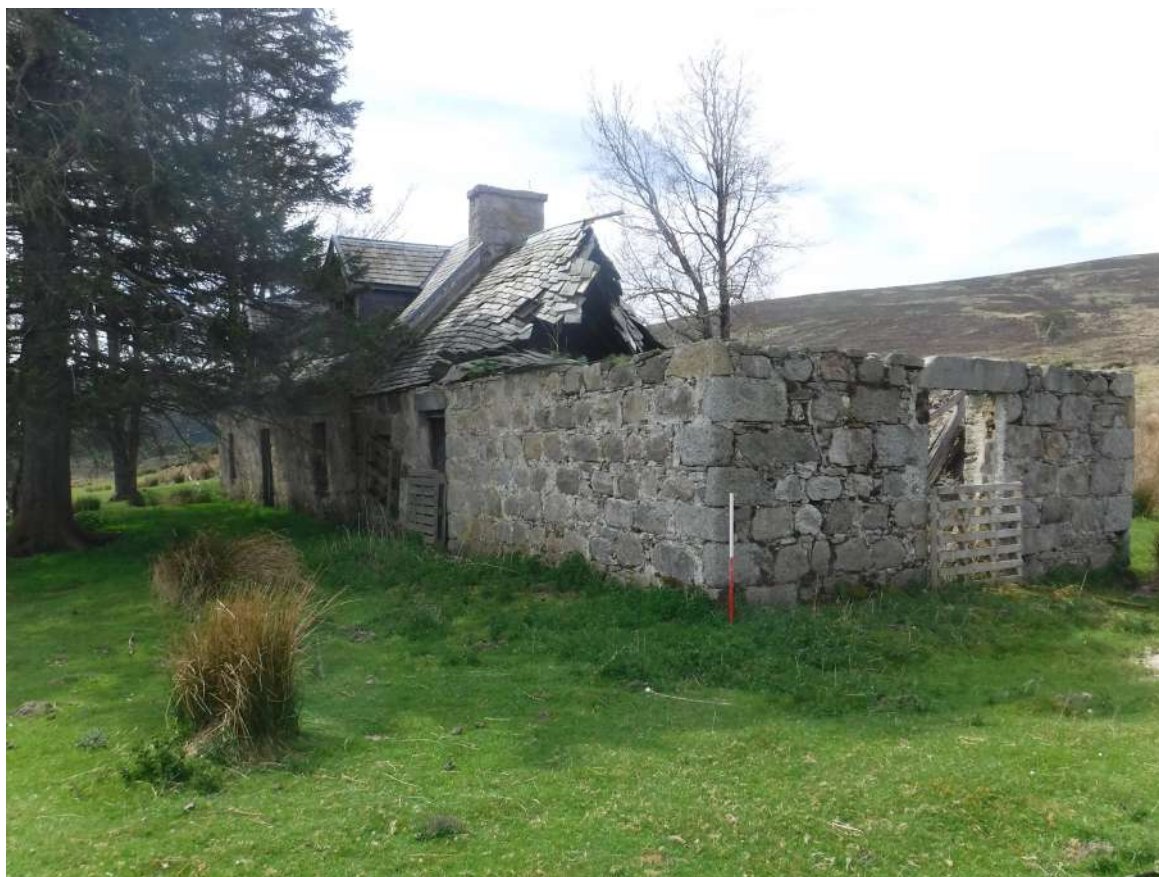
Plate 80: Ruinous stone building 15a, facing SW
