Glen Brown Woodland Creation Dorback Estate Archaeological Walkover Survey Report

AOC 70511

June 2021

On Behalf of:	Galbraith
National Grid Reference (NGR):	NJ 09811 18723 (centre)
AOC Project No:	70511
Prepared by:	Lindsey Stirling
Illustrations by:	Lindsey Stirling
Date of Fieldwork:	2 nd -4 th , 15 th -16 th & 22 nd June 2021
Date of Report:	25 th June 2021
OASIS No.:	aocarcha1-424845

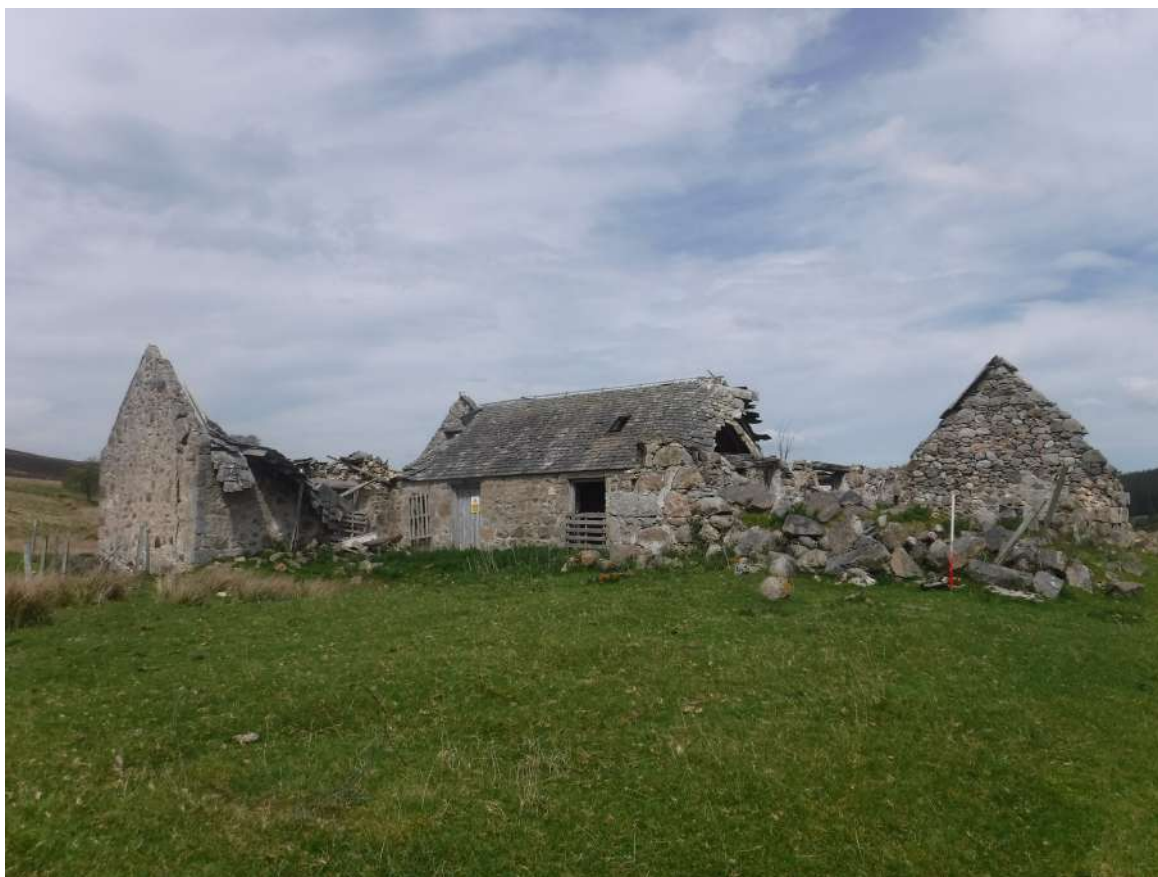
5.8.2 The northern building (15b) comprised a ruinous stone and mortar mill and steading with a slate roof (**Plates 81-82**). The buildings enclosed three sides of a small courtyard on the southwest side, within which stood a revetment wall. Four entrances opened onto the courtyard, with a fifth much wider entrance on the northwest side, possibly to facilitate a cart or vehicle. An overshot, iron mill wheel was set into a sunken stone-lined chamber on the southwest gable of the northwest building (**Plate 83**). A cast concrete mill lade (15c) ran from this chamber to the west where there lay the possible remains of a dried-up mill pond (**Plate 84**).

Plate 81: Ruinous mill building 15b, facing N

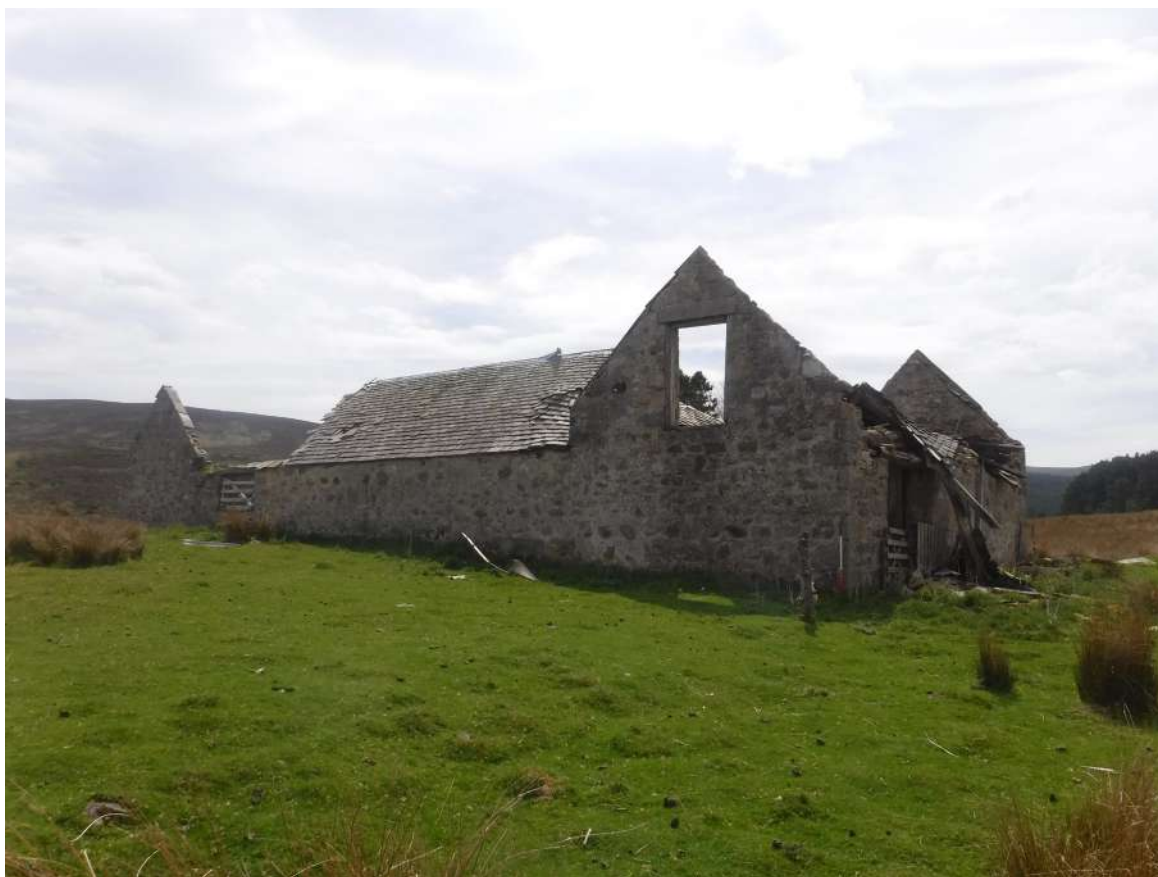
Plate 82: Ruinous mill building 15b, facing S

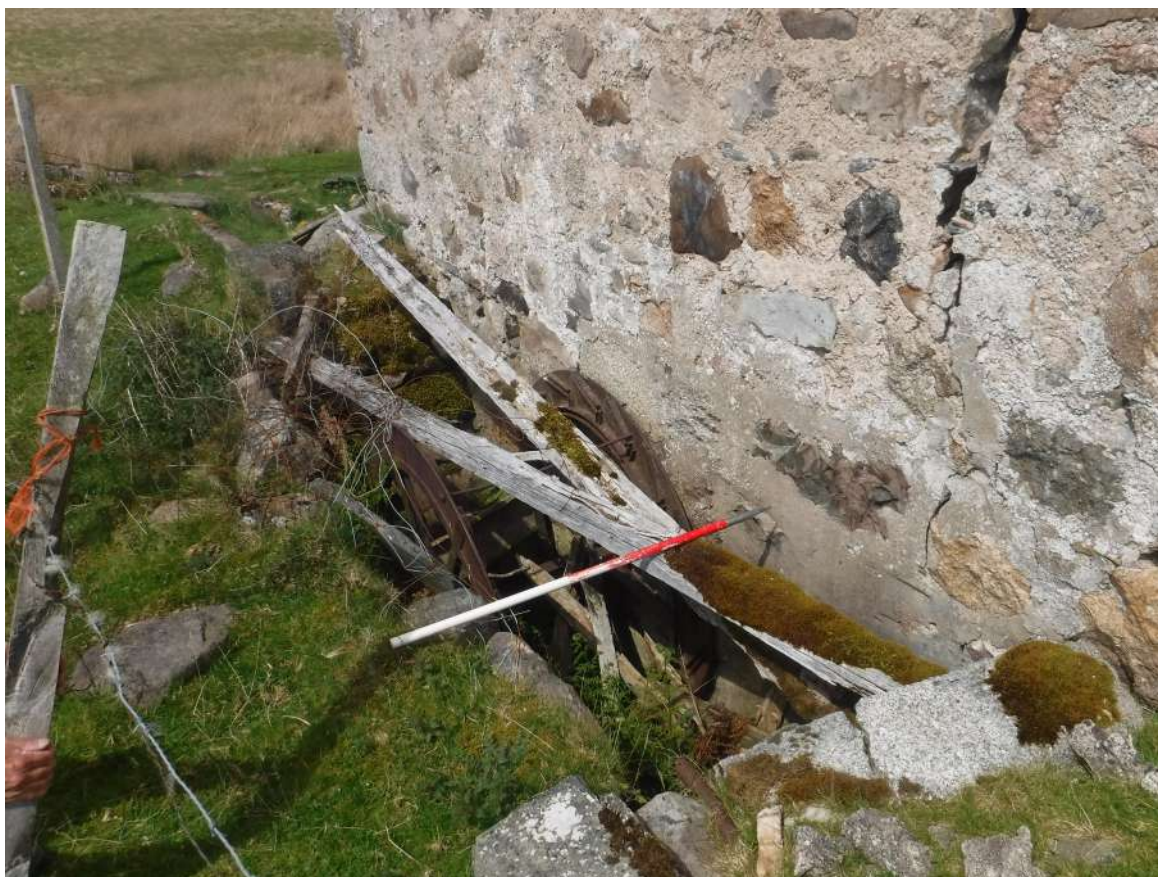
Plate 83: Overshot mill wheel at 15b, facing NNW

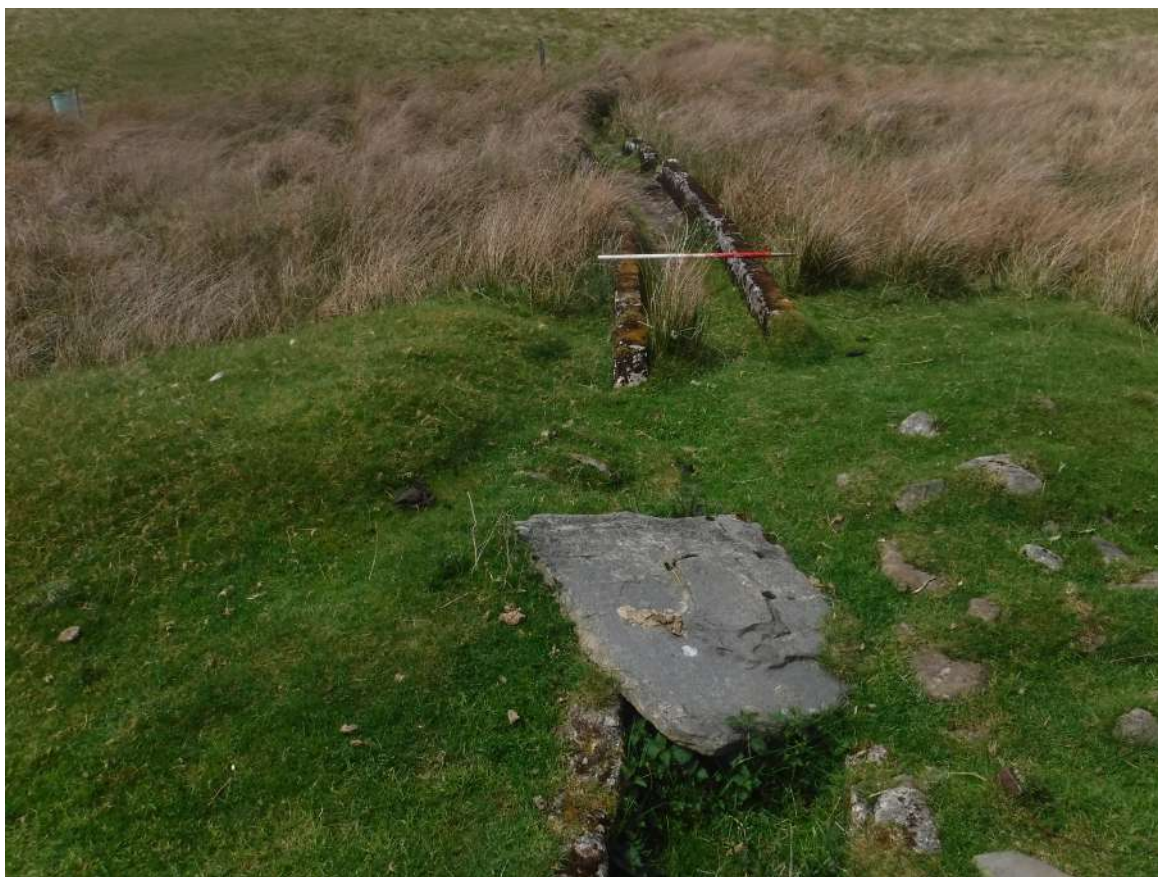
Plate 84: Concrete mill lade 15c, facing W

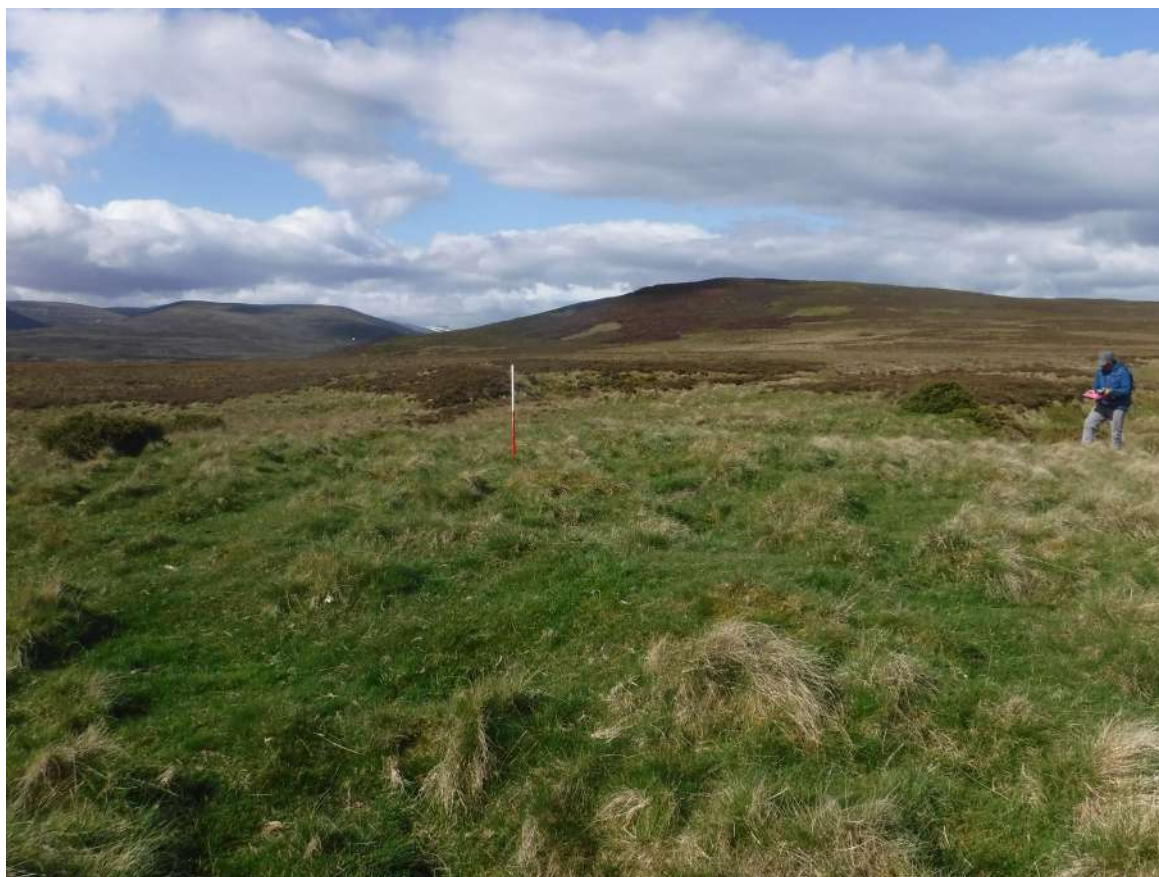
Plate 90: Degraded turf shieling hut 18, facing SW

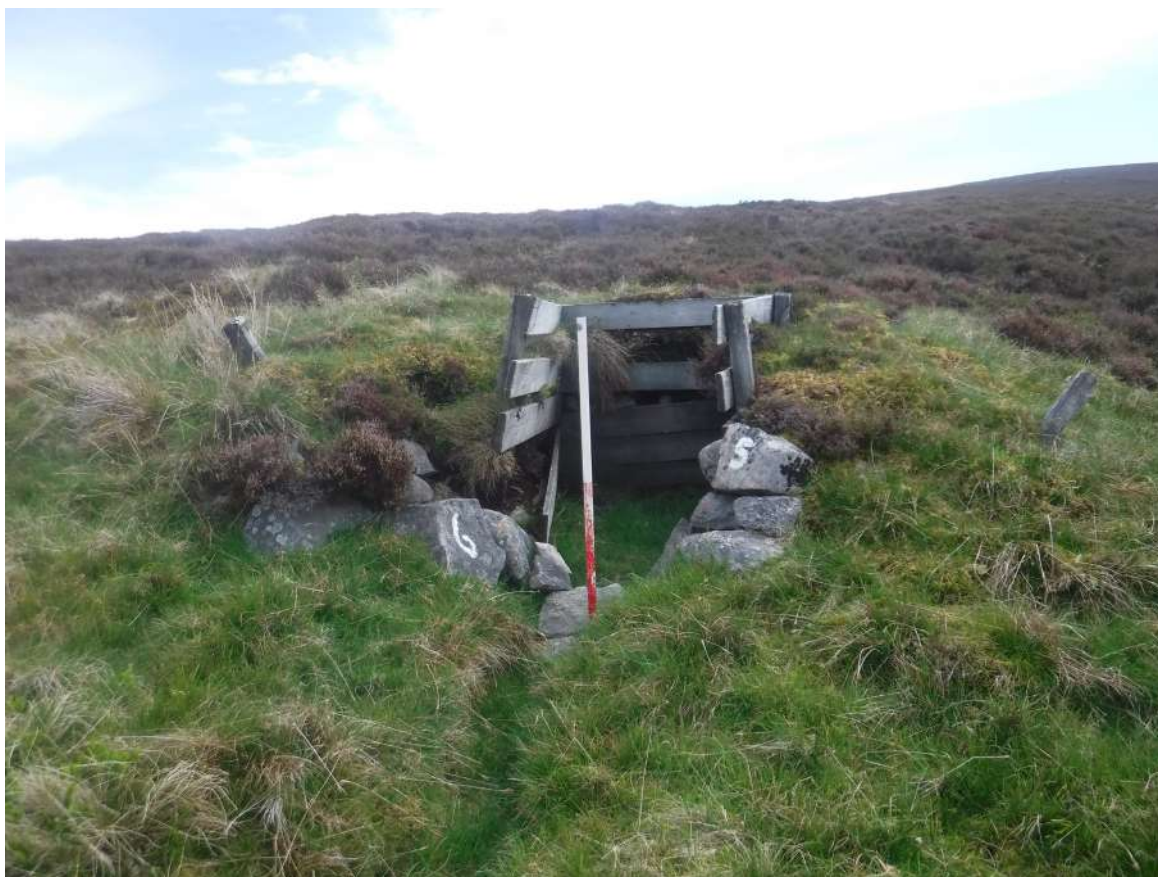
5.10.2 Site 41 comprised 17 butts on a N-S and NE-SW alignment on the north slope of Tom an t-Suidhe Mhoir (**Plate 91**). Site 42 comprised a T-shaped alignment of 15 butts on the southeast slope of Tom an t-Suidhe Mhoir (**Plate 92**). Site 93 comprised a NW-SE alignment of 16 butts on the southwest slope, with two further outlying butts. Sites 47 and 48 each comprised a WNW-ESE alignment of 11 butts running up the slope from Rynelrich towards Baddoch summit (**Plates 93-94**).

Plate 91: Timber lined shooting butt 41f, facing S

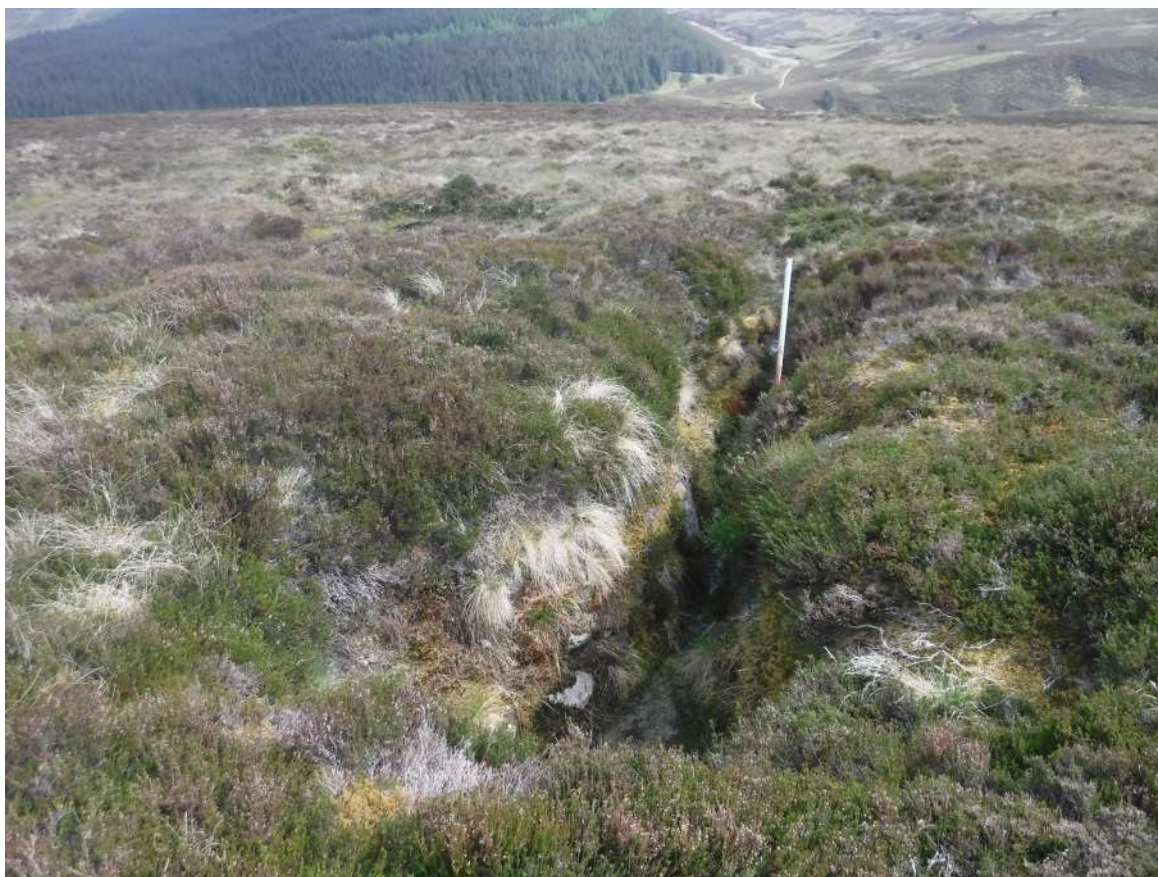
Plate 92: Shooting butt 42c with long drainage channel, facing SE

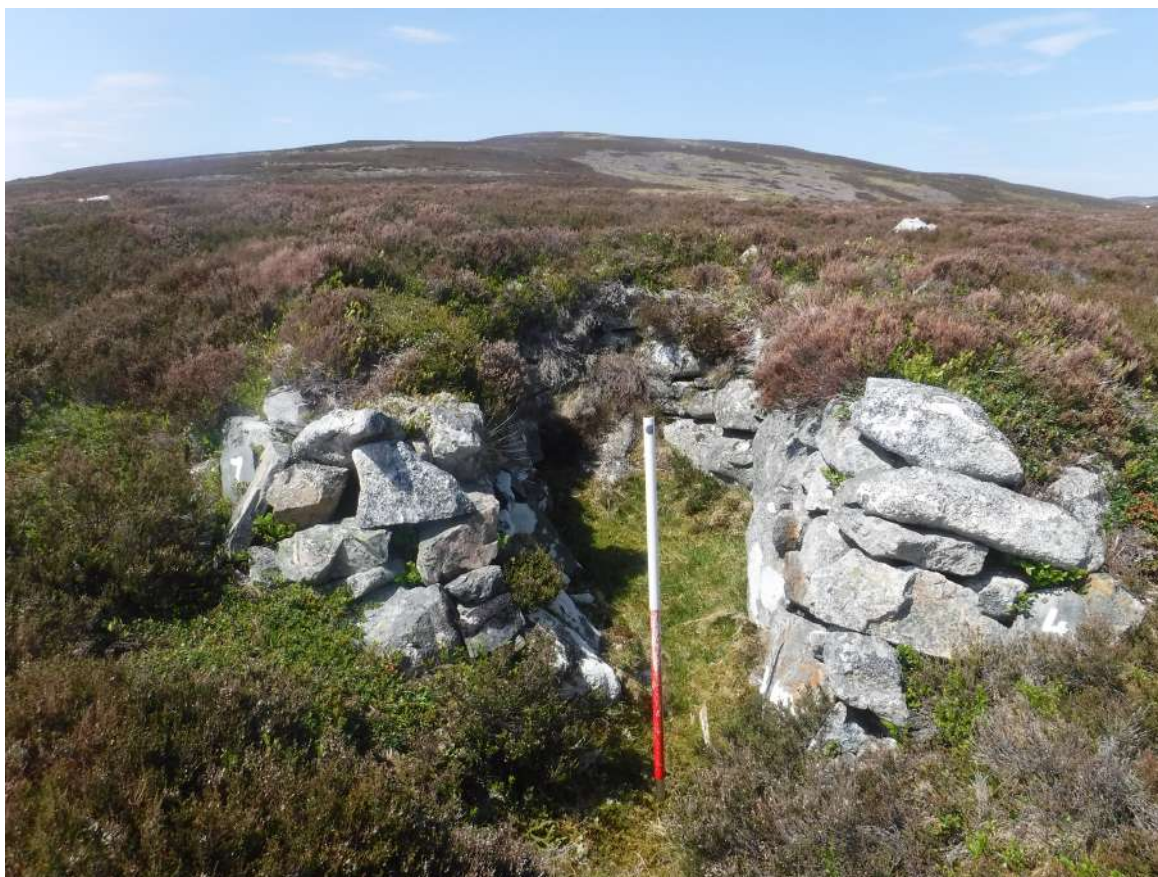
Plate 93: Stone lined shooting butt 47h, facing NW

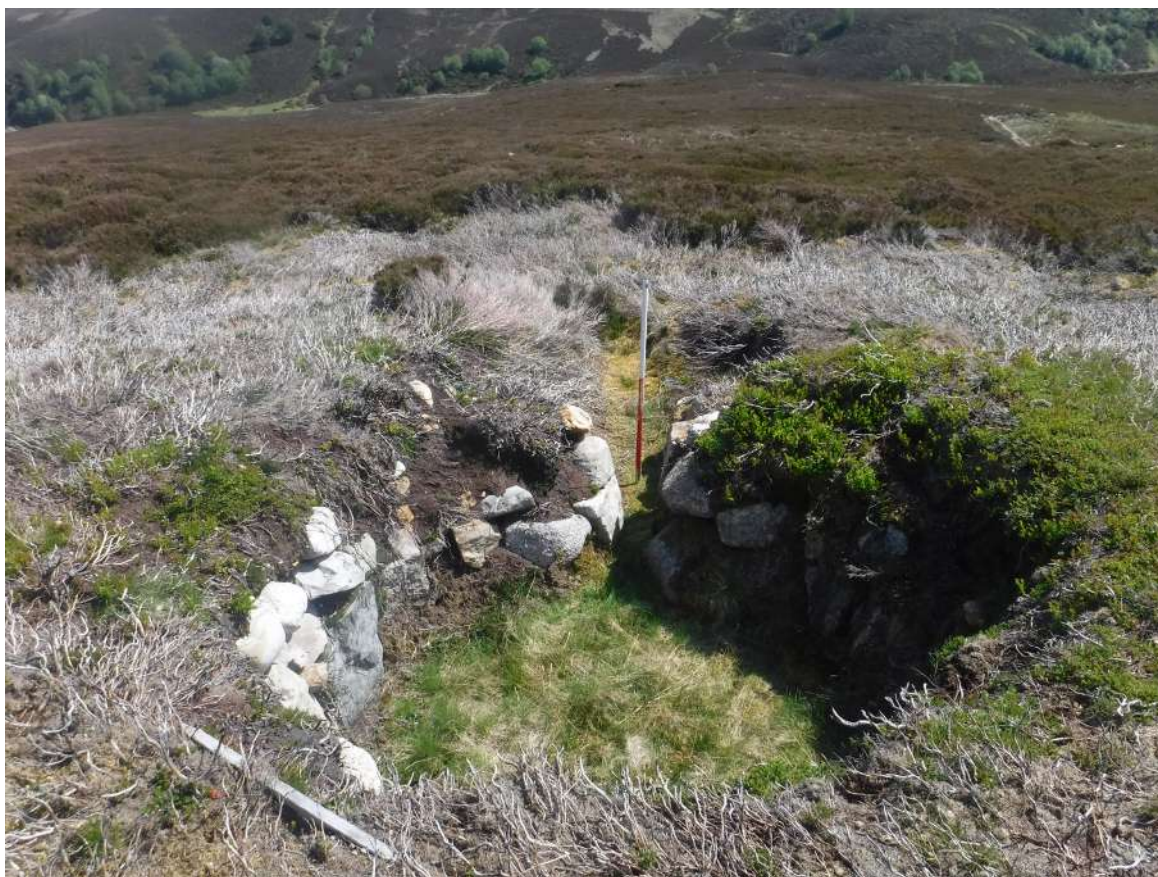
Plate 94: Stone lined shooting butt 48b, facing SE
